**BRB (Residuary) Ltd
Major Works Programme 2004/2007**

**VAR9-1220 BE4 ASSESSMENT
PROGRAMME**

**ASSESSMENT AND INSPECTION
REPORT**

BRIDGE REF: ANB 4

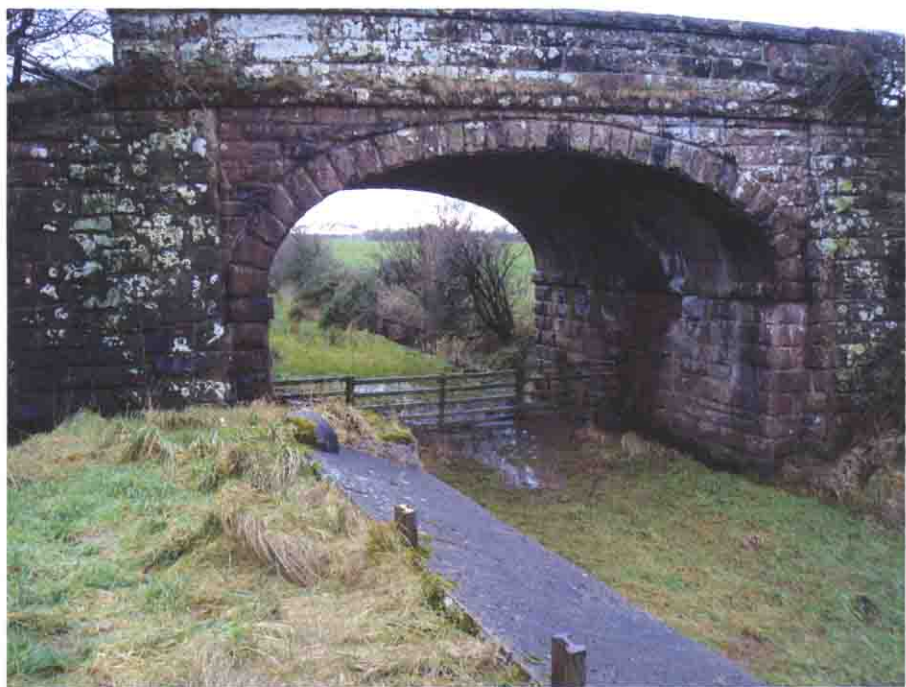
The structure is a single span brick arch with stone spandrels, abutments, parapets and wingwalls. The structure has a square span of 7.97m and the headroom below the structure is approximately 4.9m. The east elevation (photograph no. 1) a photograph looking towards the south (photograph no. 2) can be found in section 8 of the report.

1. East elevation

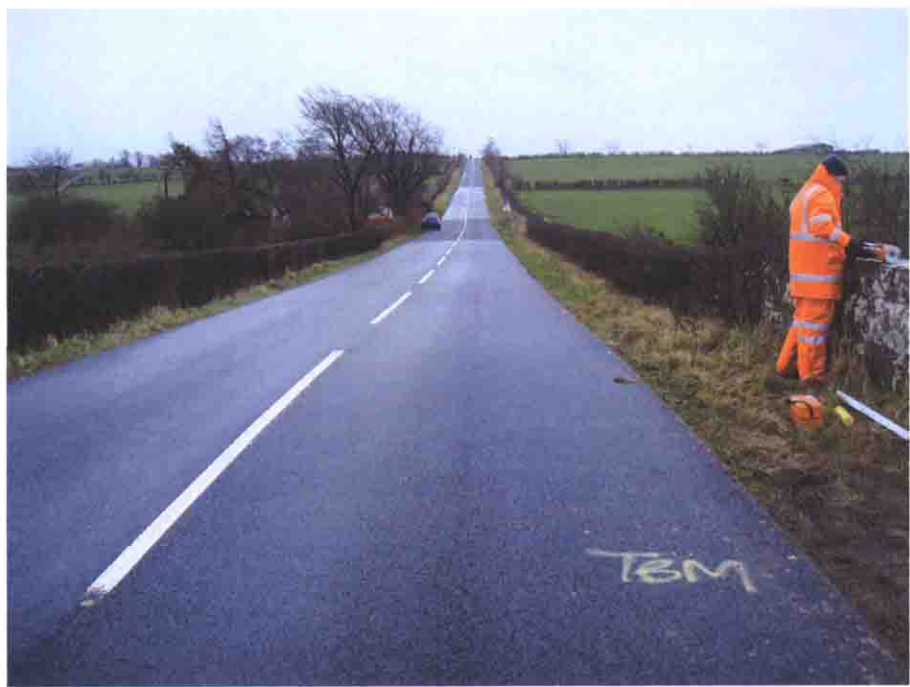
2. Looking towards the South

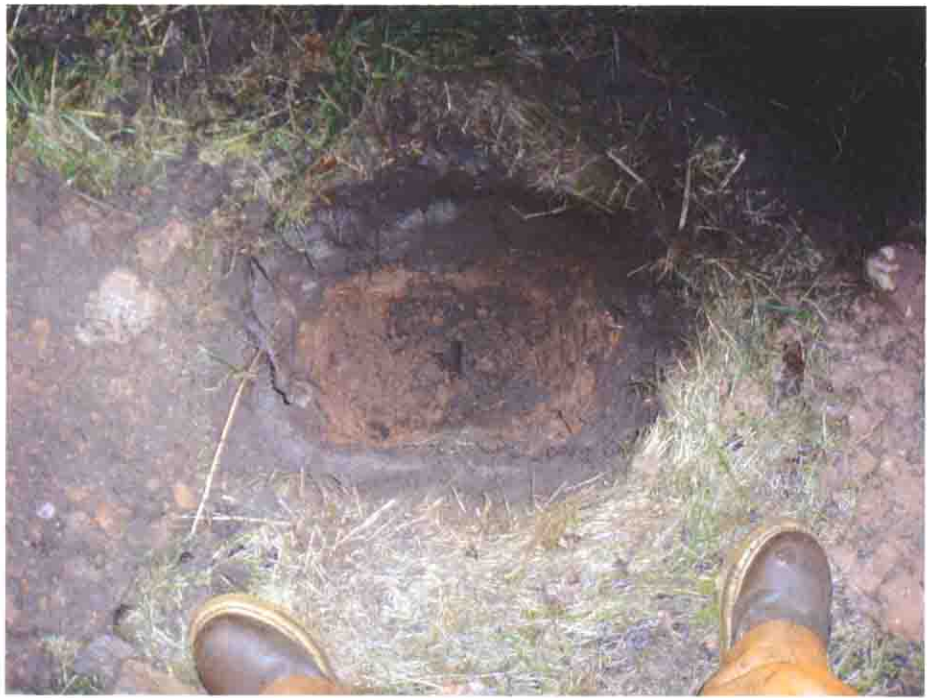
A trial pit was excavated on the bridge deck on the west verge. This determined the depth and composition of fill and the condition and level of the top of the crown.

3. Trial pit on the west verge over the crown of the arch

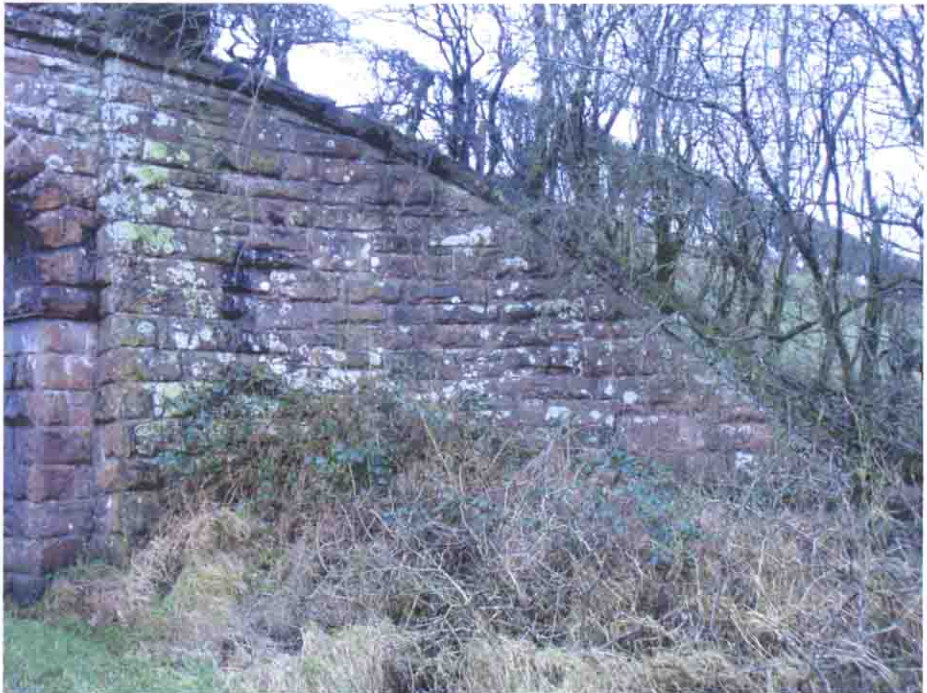
There were isolated open joints totalling an area of 0.5m² in the wingwall, of 10mm wide and up to 20mm deep. There were also approximately 12 No. trees of girth less than 500mm growing on top. There was also a fair amount of vegetation growth.

4. Vegetation growth around the northeast wingwall

There was vegetation growth on top of the wingwalls which was causing displacement of some bricks in the wall and so will need to be removed.

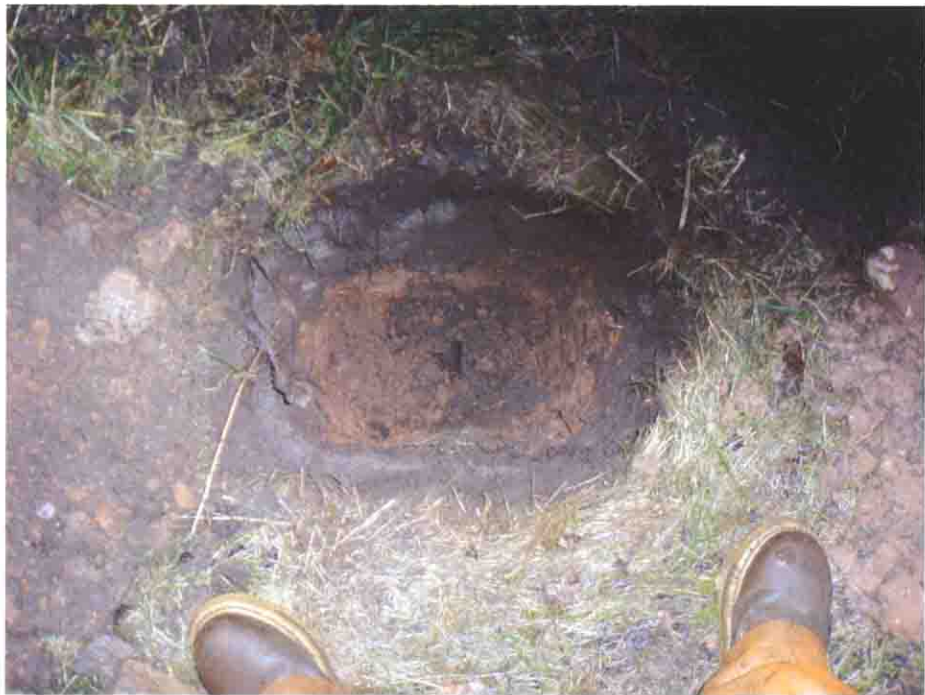
3. Trial pit on the west verge over the crown of the arch

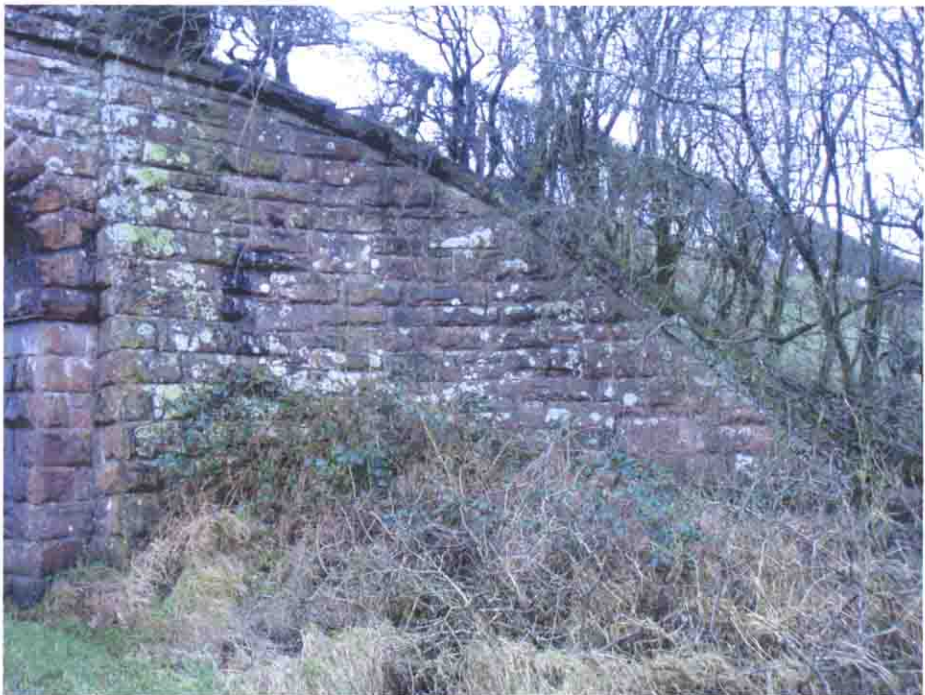
4. Vegetation growth around the northeast wingwall

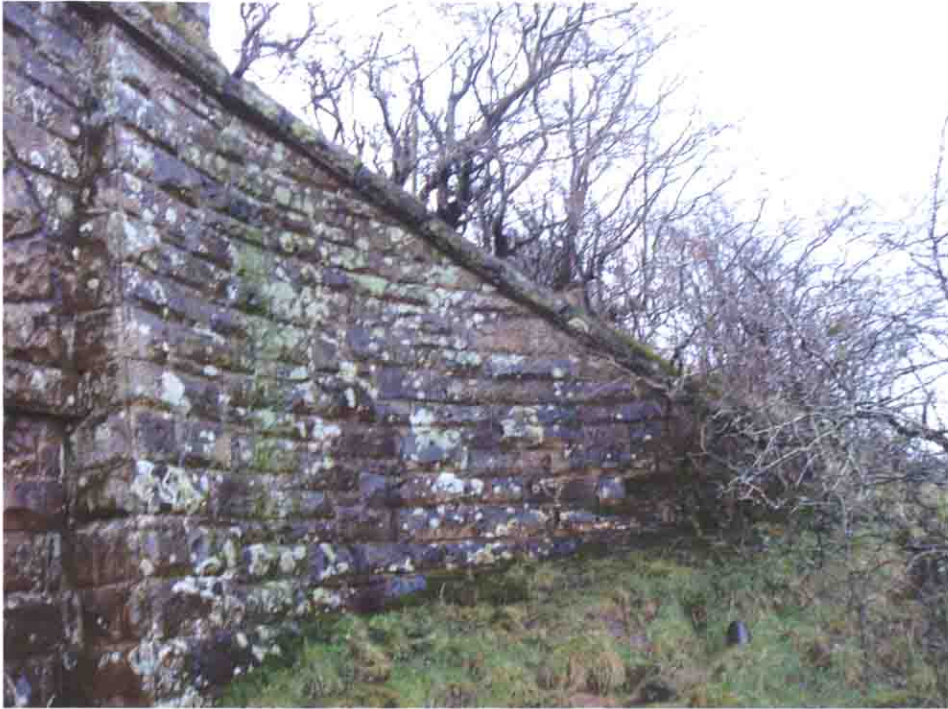
The wingwall contains an area, 2m² of open joints, of depth 20mm and of width 10mm. There was also approximately 3m² of vegetation growth.

7. Southwest wingwall, which showed areas of open joints

The structure was found to be in good condition with no major repair work required. Areas of open joints were present in the structure however, mainly in the wingwalls which, would need to be re-pointed.

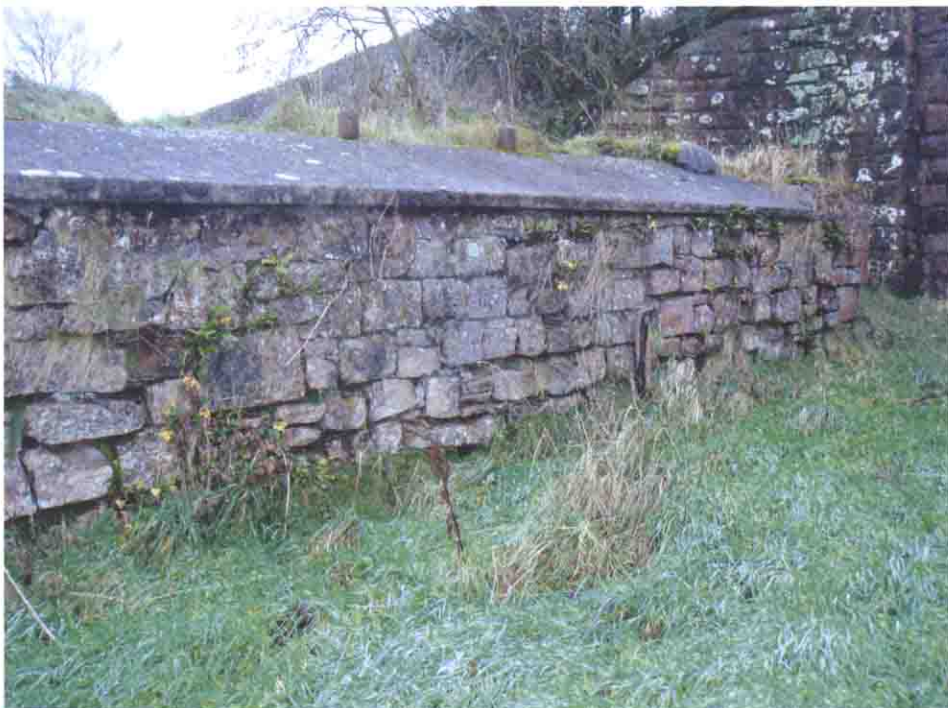
The formation to the east of the structure is generally dry, but slightly overgrown with a retaining wall to the south edge.

8. Retaining wall located to the east of the structure
