Highways Agency, Historical Railways Estate Major Works Programme 2012 - 2015

BD21 ASSESSMENT REPORT

Crawley Hall Bridge,
Crawleyside, County Durham

BRIDGE REF: ASS/2

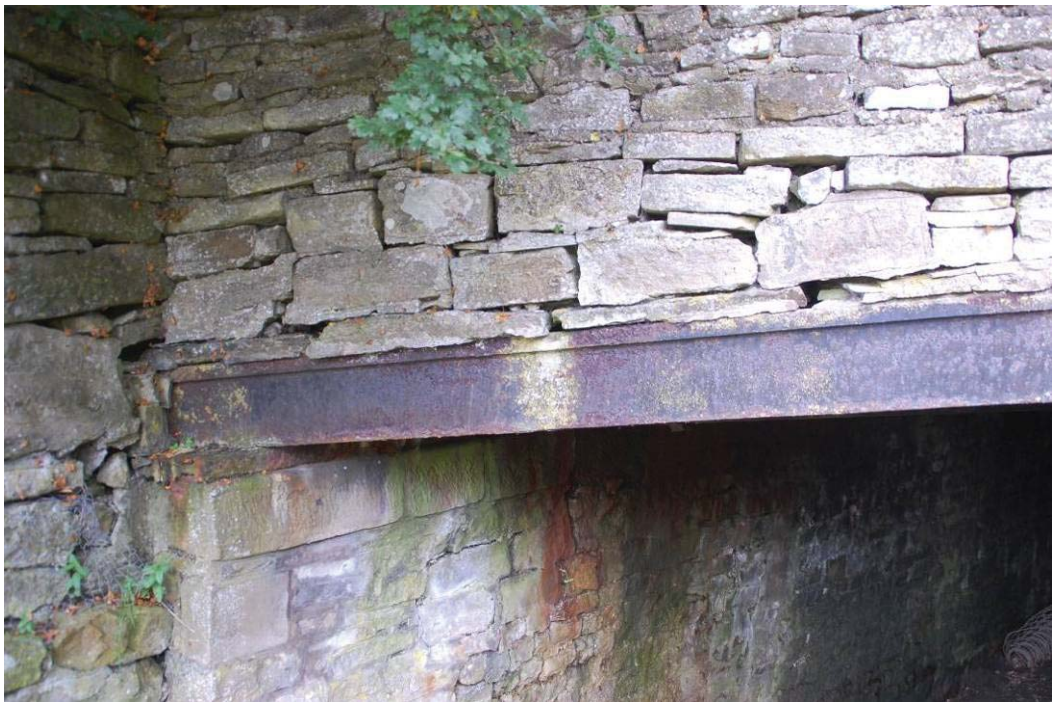
The south edge girder is in fair condition. The paint system is failing on the outer face and has completely failed on the bottom face. Pitting was noted on the outside face and the bottom flange has deep pitting corrosion evident along the full length with up to 2mm loss of thickness (Photograph 4 and 5).

4. South Edge Beam

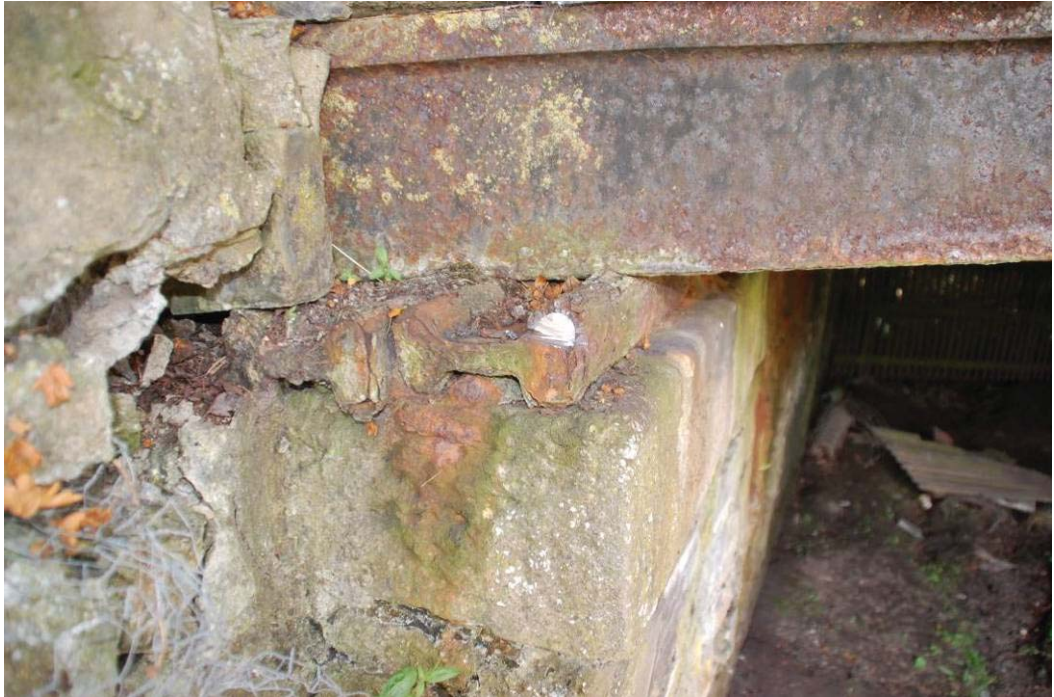
There is heavy corrosion and de-lamination to the west abutment bearing rails. A sample of the first bearing rail was taken and revealed de-lamination and loss of section of up to 4mm on all faces (Photograph 5). The east abutment bearing at the south face was in a fair condition; the paint system was still intact on the end face with up to 1mm of section loss across the exposed west face.

5. South West Bearing Point

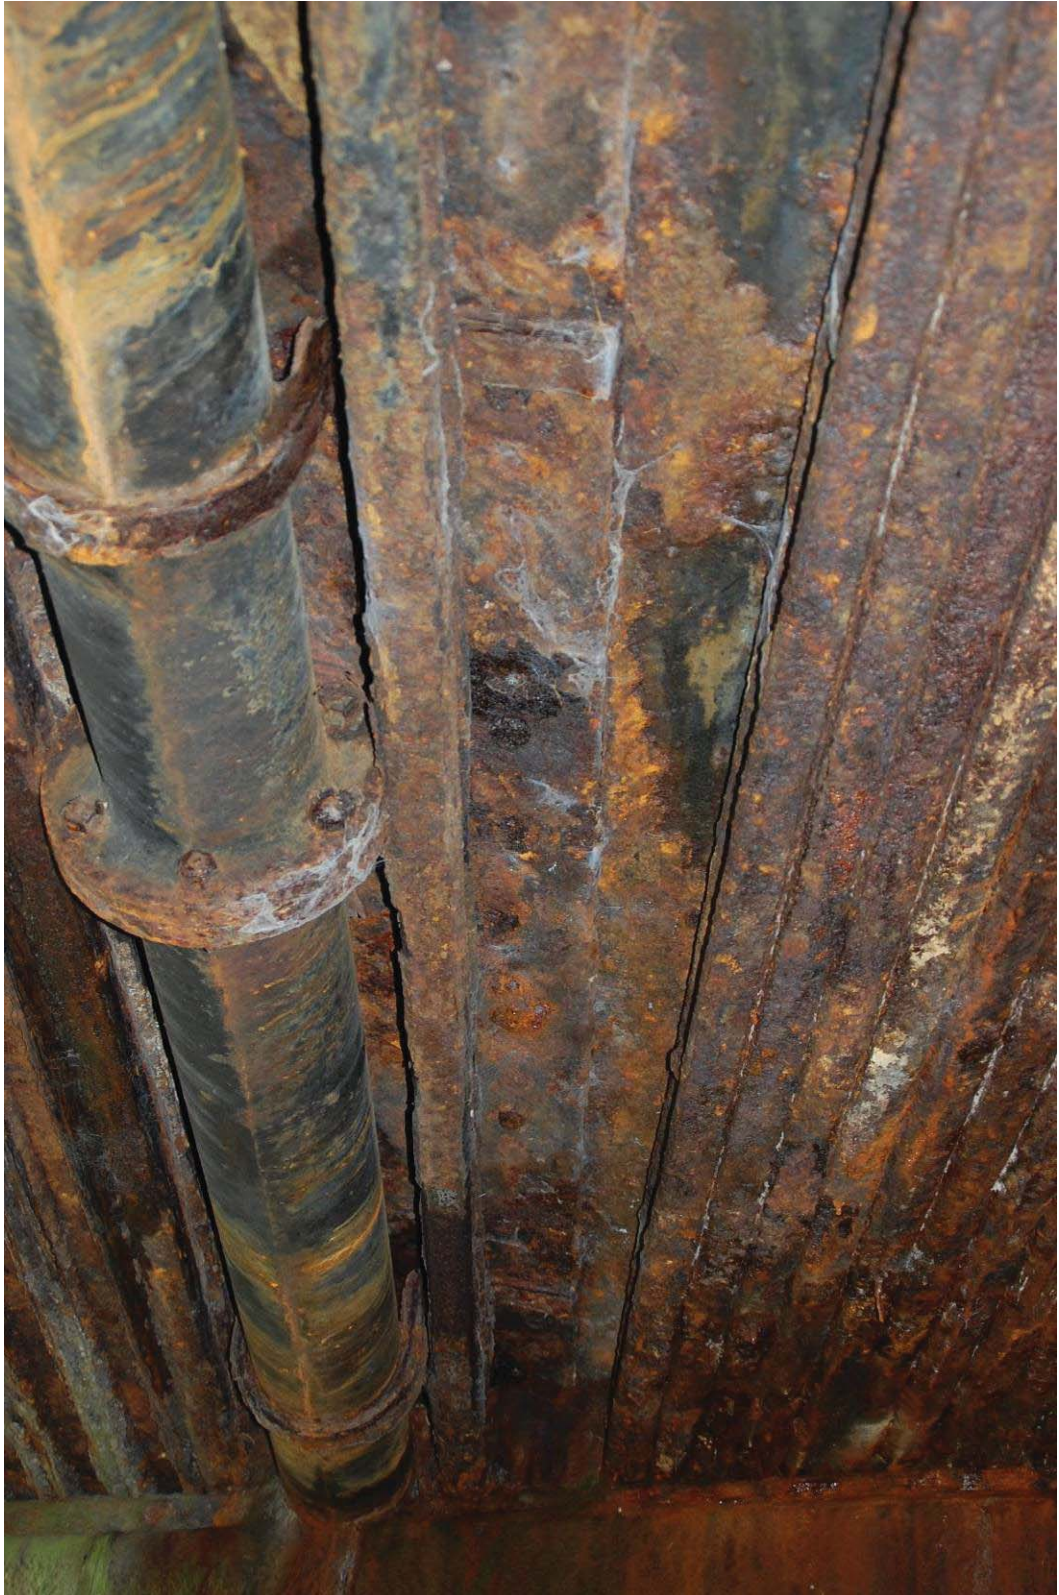
One of the rails supporting the steel plate was heavily corroded on all visible faces. There was up to 5mm section loss on all faces (Photograph 9).

The deck plates are heavily corroded with a total breakdown of the paint system. Damp staining and build-up of leachate deposits were noted throughout. Corrosion of up to 4mm was noted along the length of both plates (Photograph 9).

9. Service Bay with 9" Pipe, Single Rail and Plate

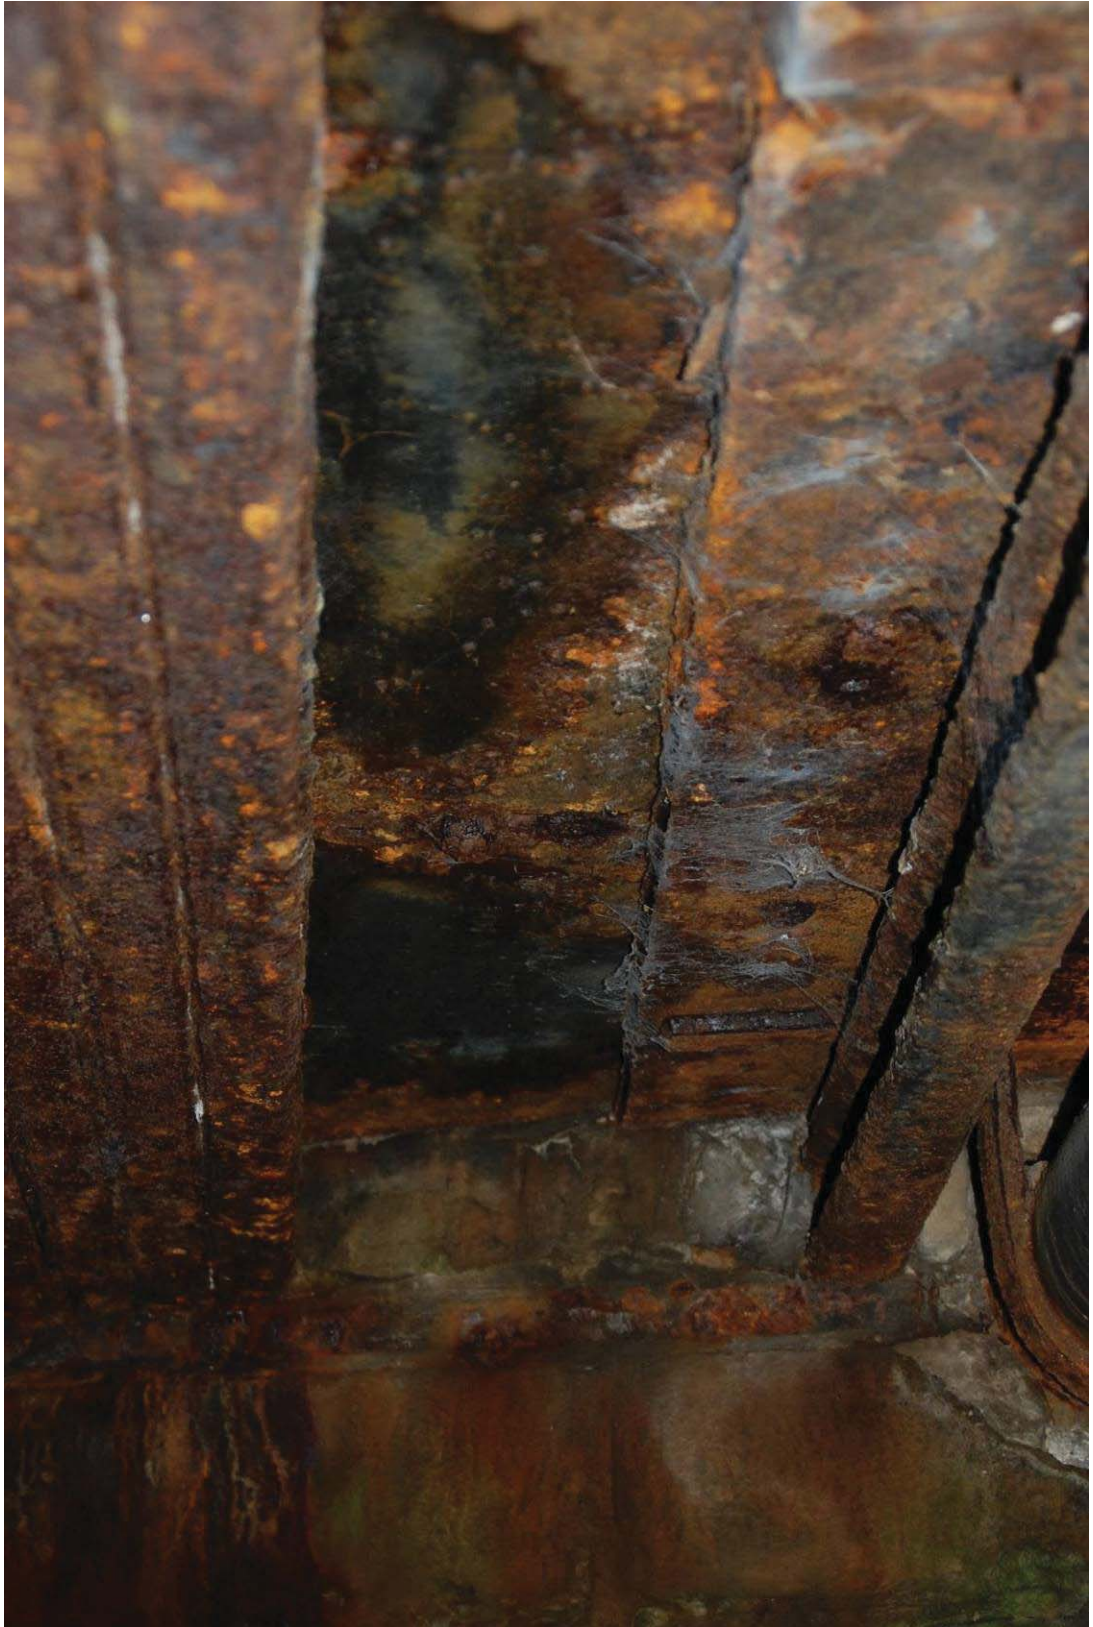
The service bay under the south footway is constructed of $\frac{5}{8}$ " thick steel plate and supports a 9" diameter steel service pipe suspended from bolted hangers. The $\frac{5}{8}$ " plate is simply supported on two upright rails, one each side of the service pipe. This plate does not extend to the continuous section of upright rails. An additional plate of unknown thickness spans between the $\frac{5}{8}$ " plate and the edge of the upright rails (Photograph 10).

10. $\frac{3}{8}$ " Plate and Plate of Unknown Thickness

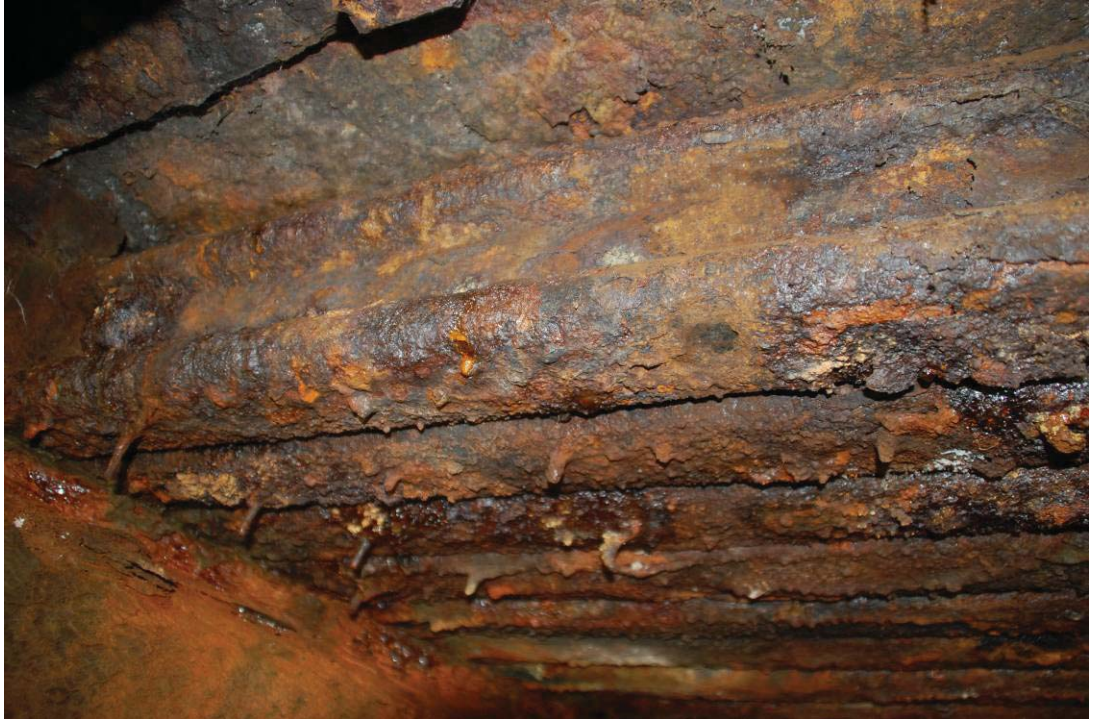
The longitudinal rails are heavily corroded on the bottom flanges with damp staining noted along the length of the span. The paint system has completely failed across the span except for localised sections towards the centre of the deck and east support area where it remains intact. There is heavy damp staining and build up of leachate along the length of the span; stalactites up to 60mm in length were noted towards the west support area (Photograph 6). Up to 5mm section loss to the bottom flange of the rail was noted across the span. The north and south edges of the rail construction were exposed; up to 5mm section loss was evident along the faces (Photograph 11).

11. Exposed Rail Edge

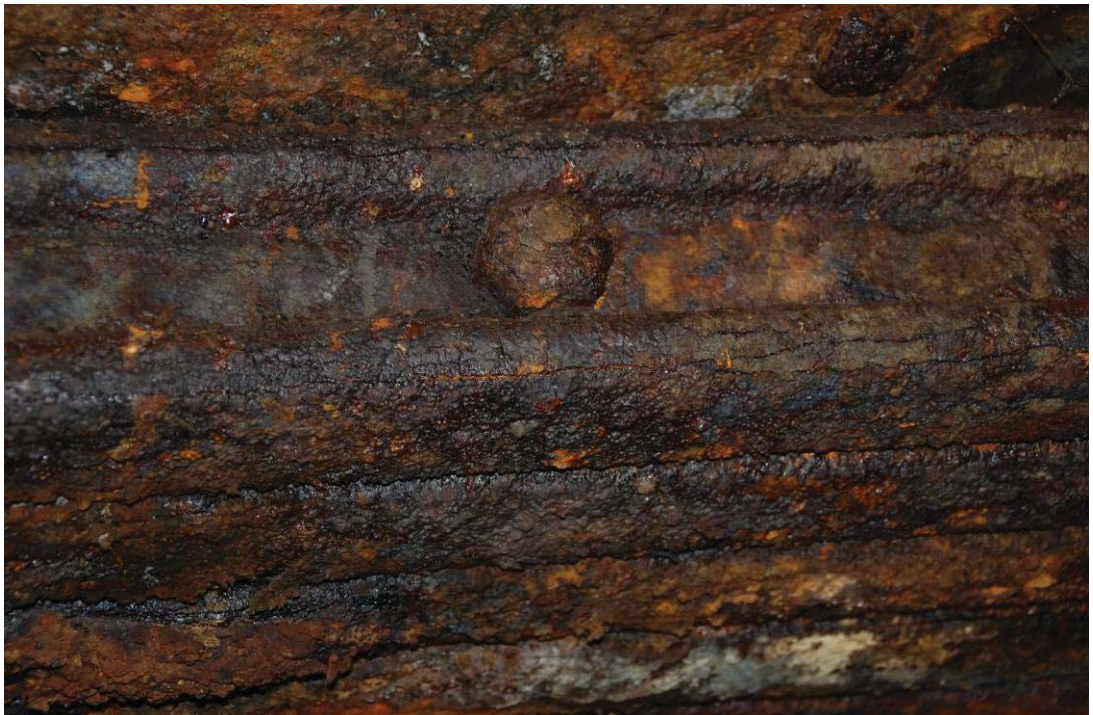
The tie bolt heads are in poor condition. Surface corrosion and de-lamination was observed throughout the bolt heads with up to 3mm resultant section loss (See Photograph 12).

12. Tie bolt Head

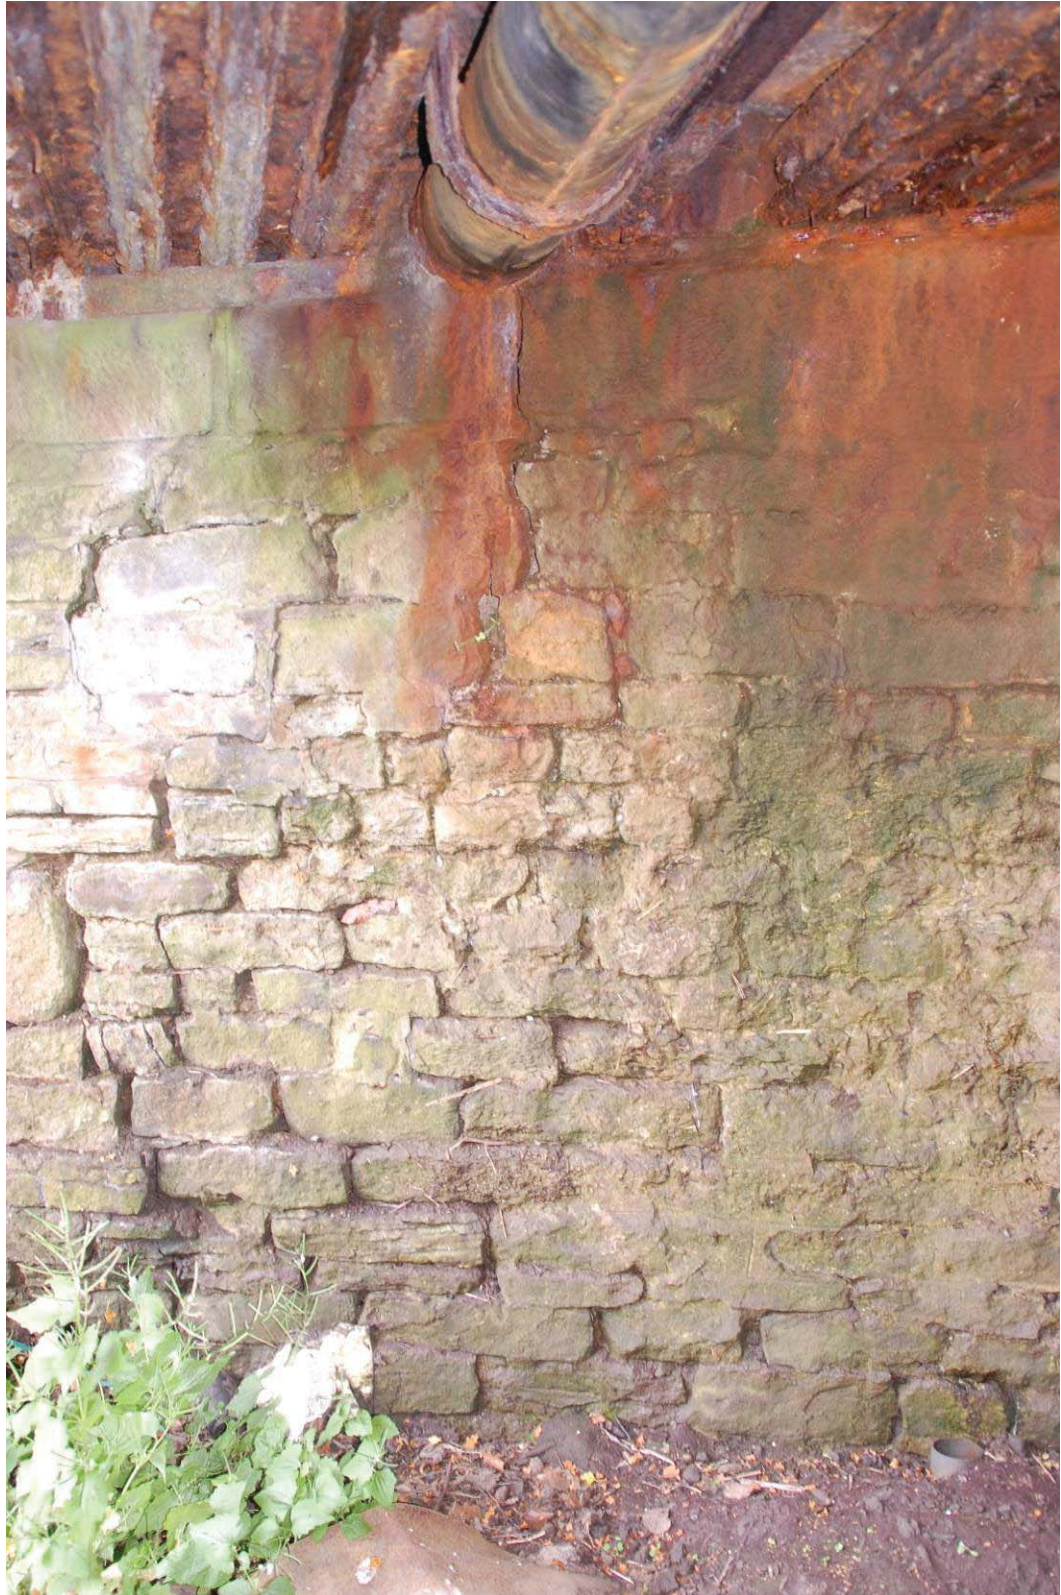
The west abutment is in fair condition, damp staining, rust and leachate deposits were noted across the width of the abutment from the bearing points 1000mm in length. There is an area of deep outward bulging 1m², 1000mm from the south face. There is a fracture extending vertically through the joints though the bulging stonework open to 30mm (Photograph 15). There is a fracture open to 3mm from the base of the service pipe extending vertically 1000mm through the joints. At the centre of the abutment there is a fracture extending vertically 1100mm through the joints and below the bearing stones there is a horizontal open to 3mm fracture through the joint 900mm in length. There are localised areas of open joints to 50mm deep. There is a 3.5m wide band of damp extending the full height at the centre of

15. Area of Bulging and Cracking to West Abutment

If the bridge is to be retained, it is recommended that the deck is re-waterproofed to eliminate seepage. Corrosion protection to the old rails is probably impractical. Repairs to the abutments are also recommended.

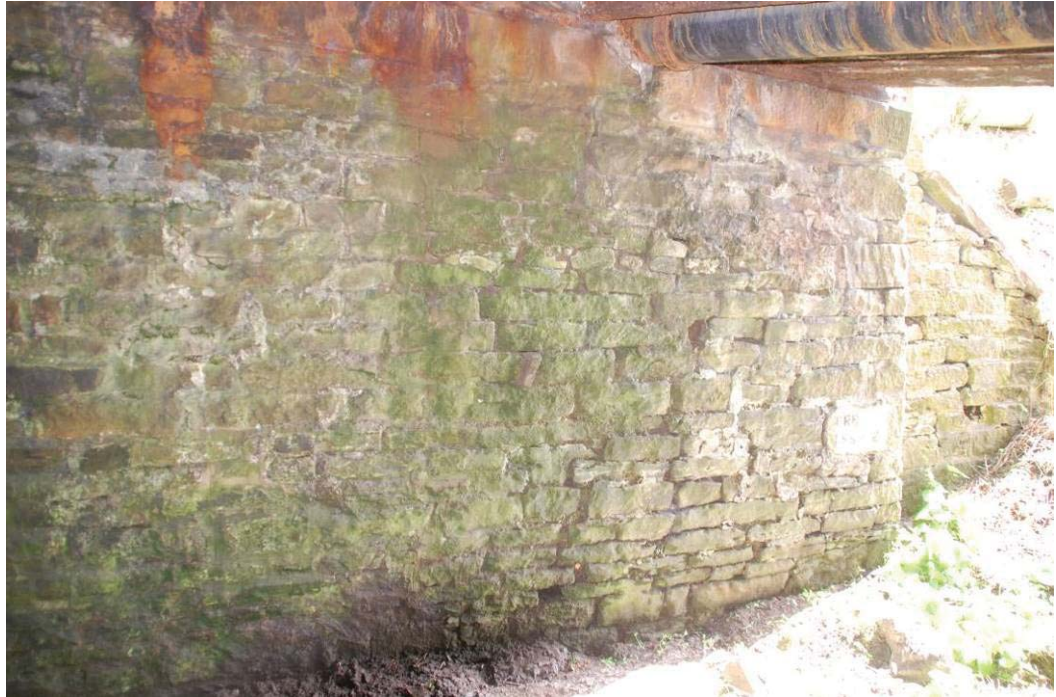
The east abutment is in whole in fair condition, damp staining and rust from the supported rails is evident along the top 700mm across the width of the abutment. Towards the north end of the abutment there is leachate staining over the full height of the abutment. There are deep open joints across the face of the abutment with several vertical fractures; there is a joint fracture open to 5mm, starting from the base of the service pipe approximately 1100mm from the south face, extending vertically down to ground level. There are several spalled stones with loss up to 90mm deep associated with the fracture. At the centre of the abutment there is a gap between the bearing stones 30mm wide. There is a fracture open to 5mm extending from the gap through the joints down to ground level. There is a 2.5m² area of bulging approximately 1000mm from the north end surrounded by deep open joints. There is a 6.5m² damp area from ground level approximately 2000mm from the north face.

16. Cracking to East Abutment

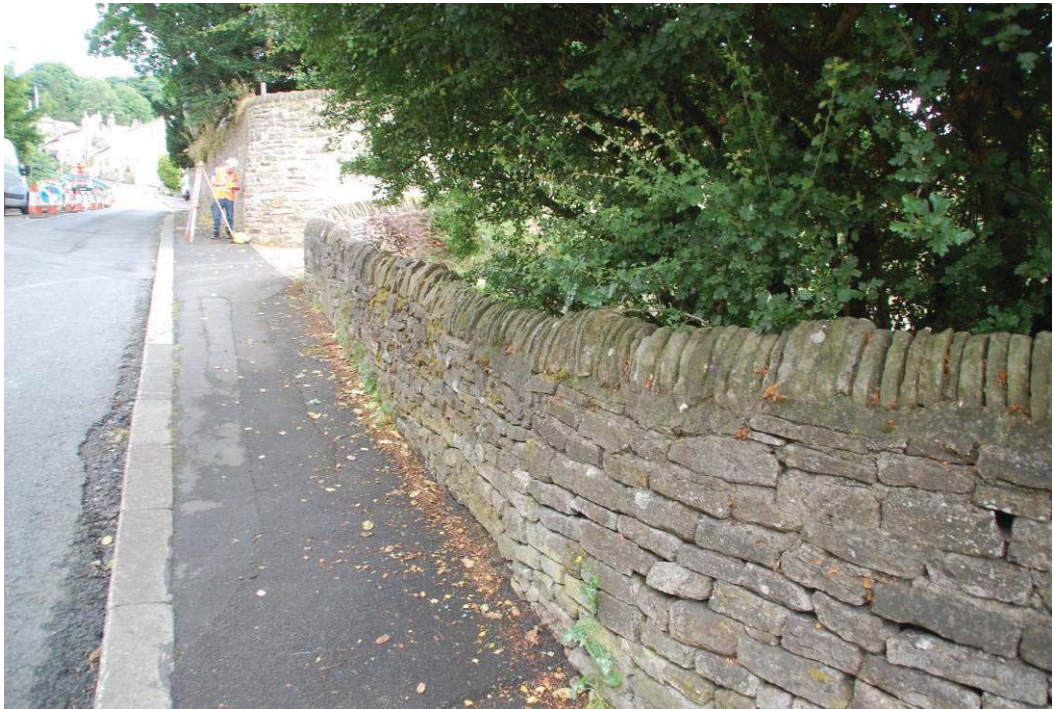
The parapets are in fair to poor condition. The south parapet has had repairs to the coping stones and the joints are generally well filled in the top 500mm. Below that, the joints are open to the deck level on the inner face. On the outer face there are deep open joints to the coursed stonework and loose stones. There is light weathering to both the inside and outer faces (Photograph 17 and 21).

21. South Parapet

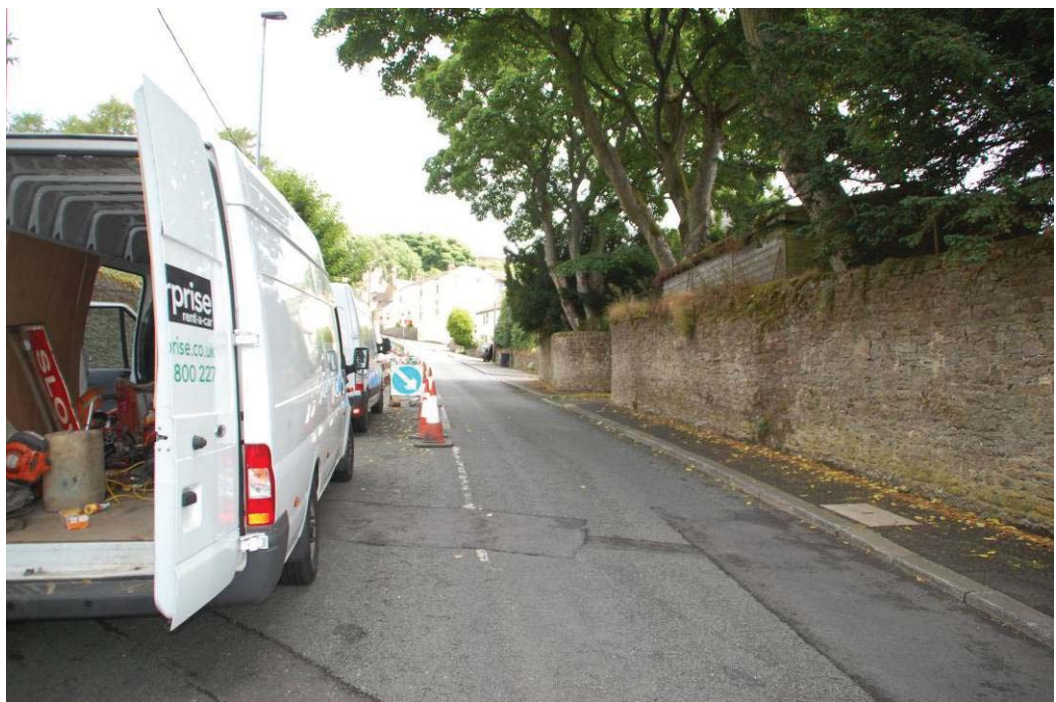
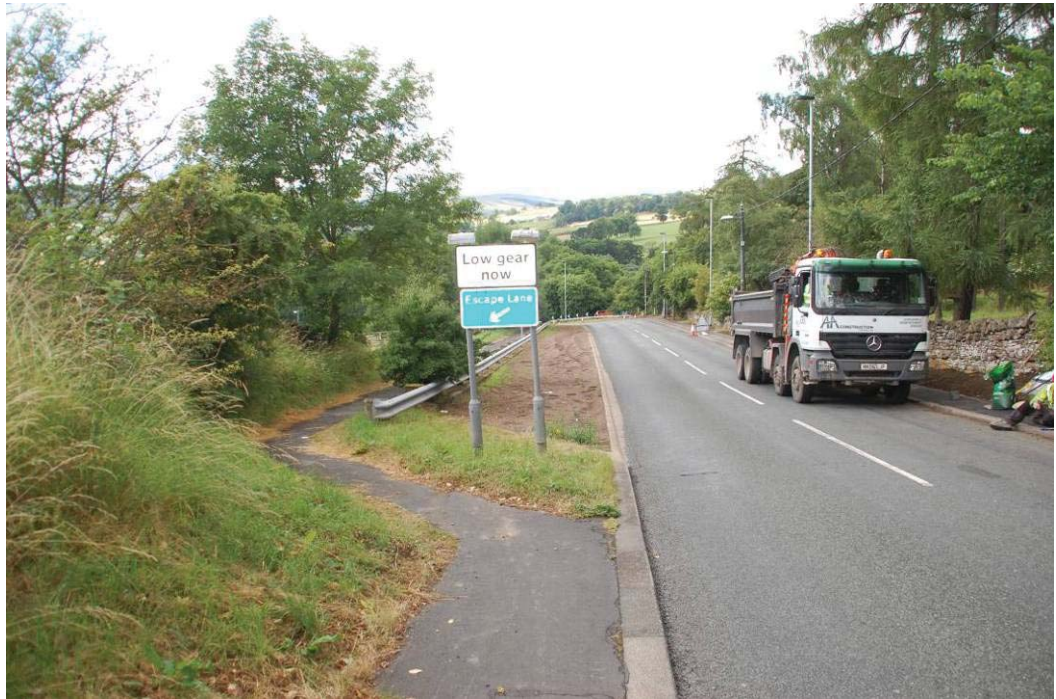
The road surfacing across the bridge deck is in good condition with minor wear towards the outer edges (Photograph 23 and 24).
