Highways England - Historical Railways Estate

AYT/55 Pont - Llanio Station, Ceredigion

BE4 Assessment and Inspection Report

January 2016

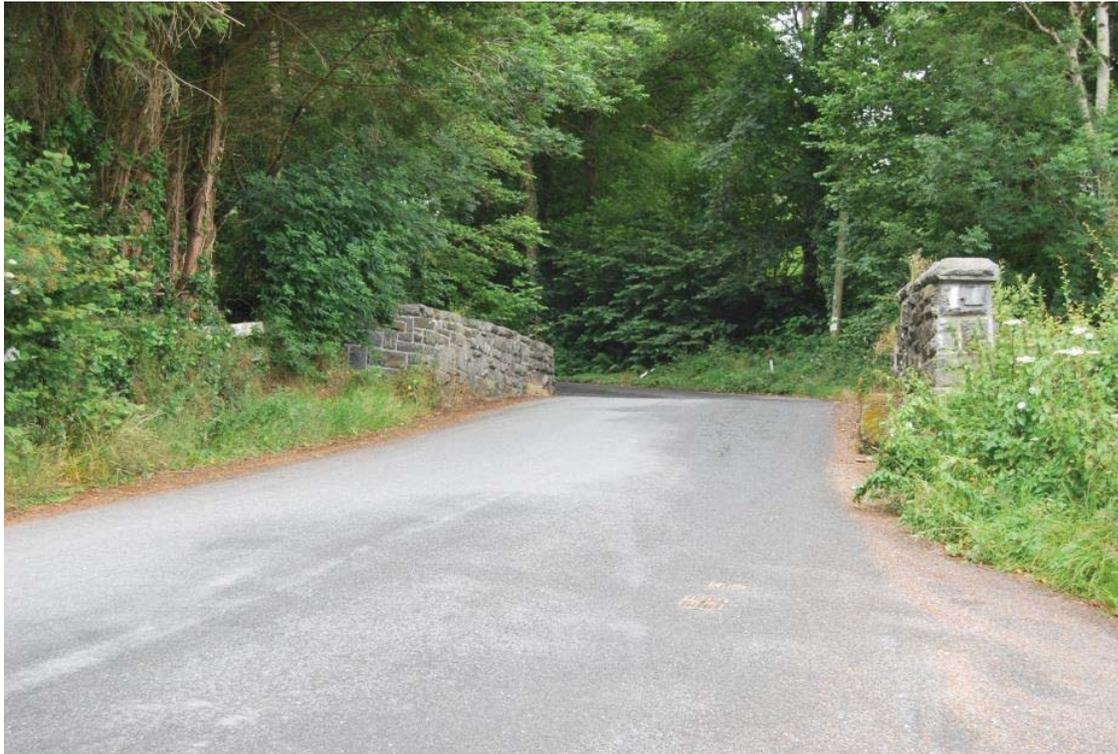
The road surface is in good condition with no signs of settlement, cracking or tracking. It is on a fairly constant slight gradient downwards from north to south with an increase in gradient at the south end. However there is no prominent 'hump' over the bridge and therefore no axle lift off will need to be considered (Photographs 3 and 4).

3) View of carriageway approach looking north

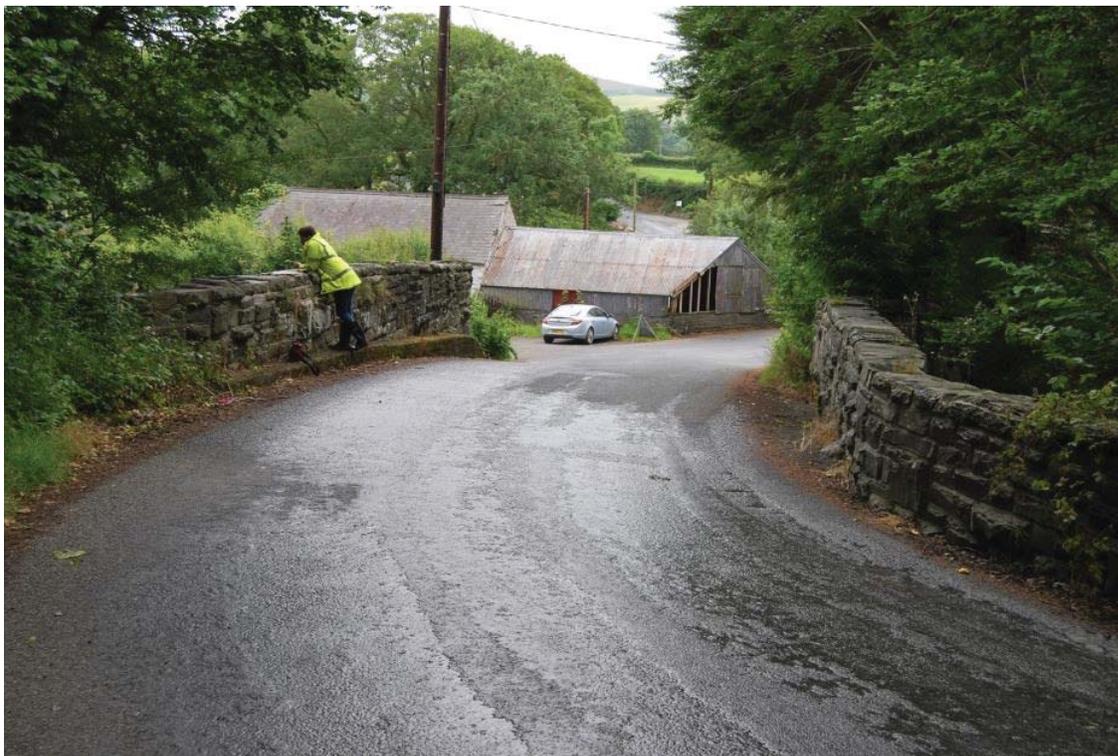
4) View over bridge looking south

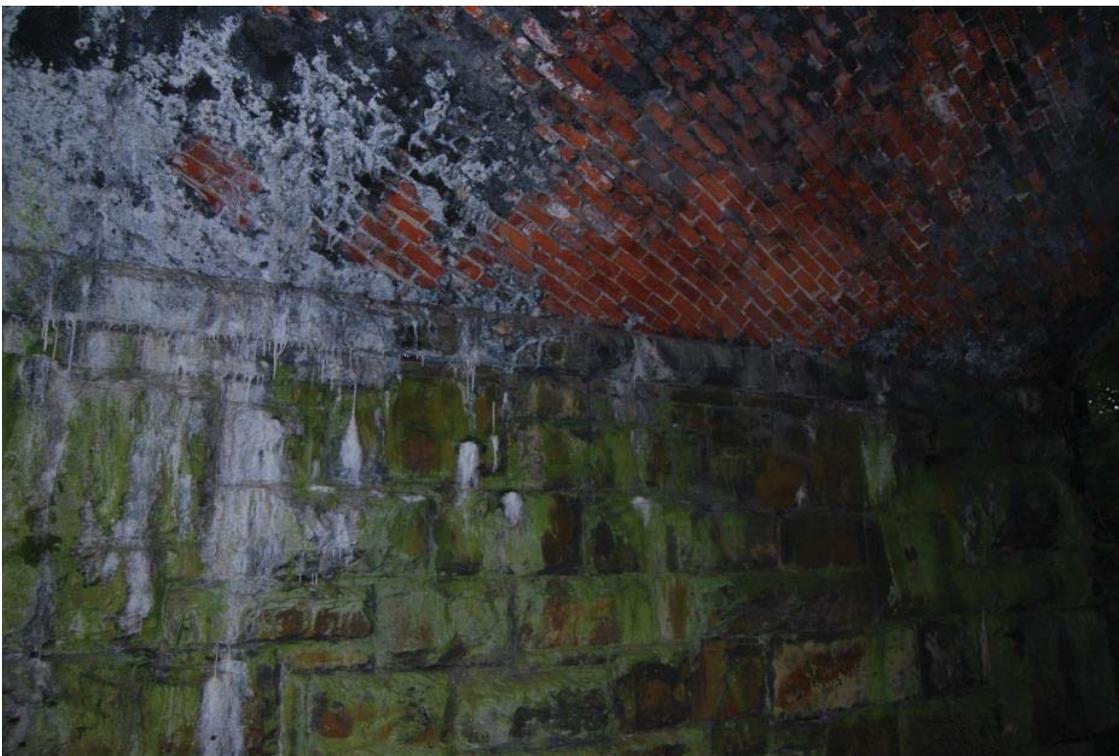
The arch is constructed from common brick. There is extensive surface deterioration of bricks above the springing lines at both abutments. There are some old calcareous deposits on the arch above the west springing line (photograph 6) and to a lesser extent, above the east springing (photograph 7). There are areas of soot, algal staining and leachate throughout the arch barrel soffit (photograph 5 & 7). No signs of cracking can be seen. A barrel factor of 0.85 is considered appropriate for the arch ring in this condition (Table 3/1 of BA16/97). There are no signs of spandrel wall separation.

The abutment faces are in a fair condition with both abutments exhibiting moderate algal, soot and leachate staining (Photograph 6).

6) South abutment, springing and arch barrel above – shows damp, calcareous deposits and algal staining

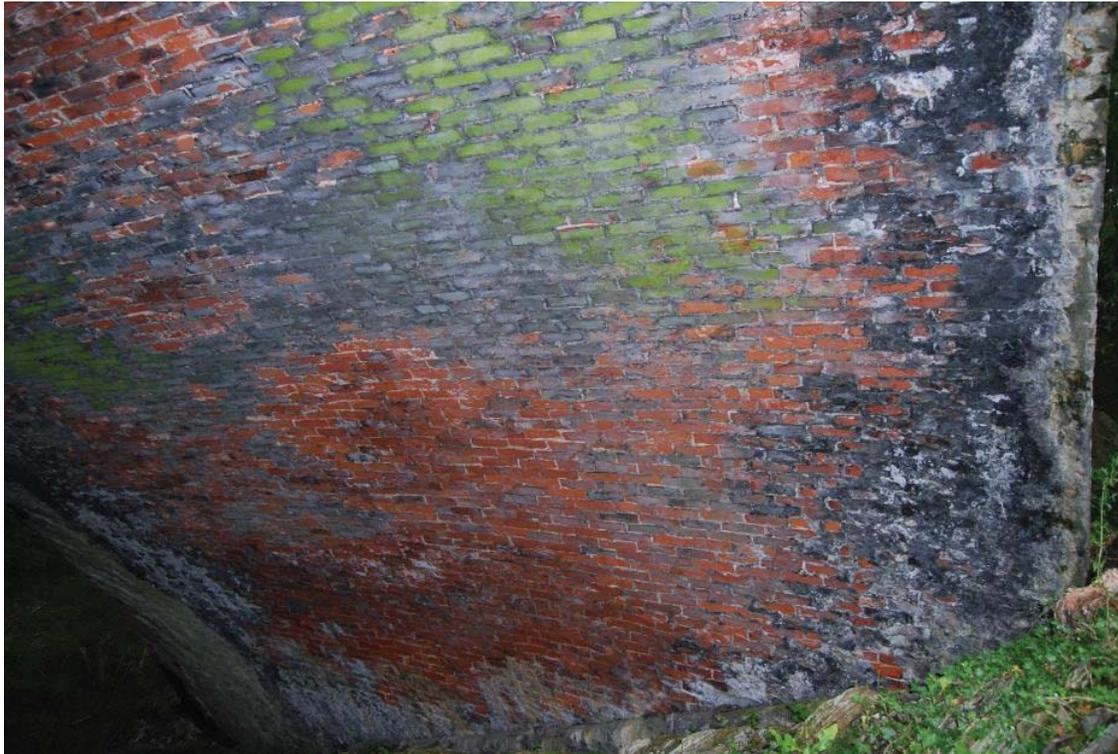
7) Arch soffit at north abutment - shows damp, leachate and algal staining

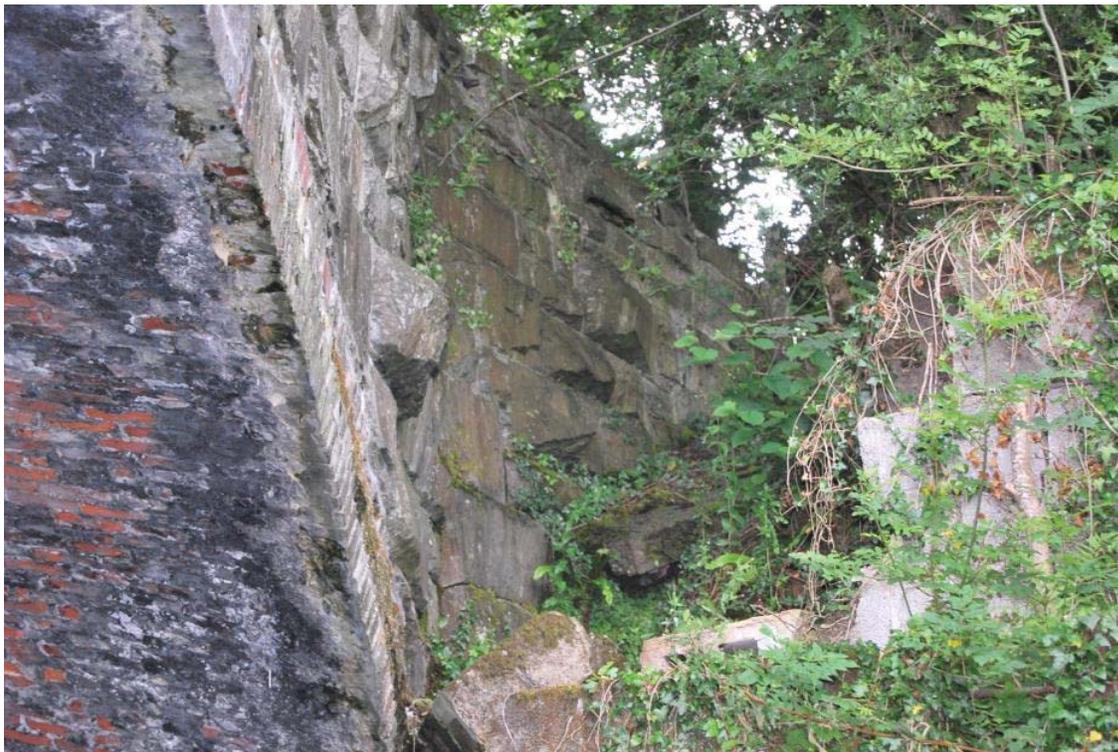
8) North east wingwall

The wingwalls are all in good condition apart from with some encroaching vegetation and moss. A substantial bush was growing on the northeast wingwall

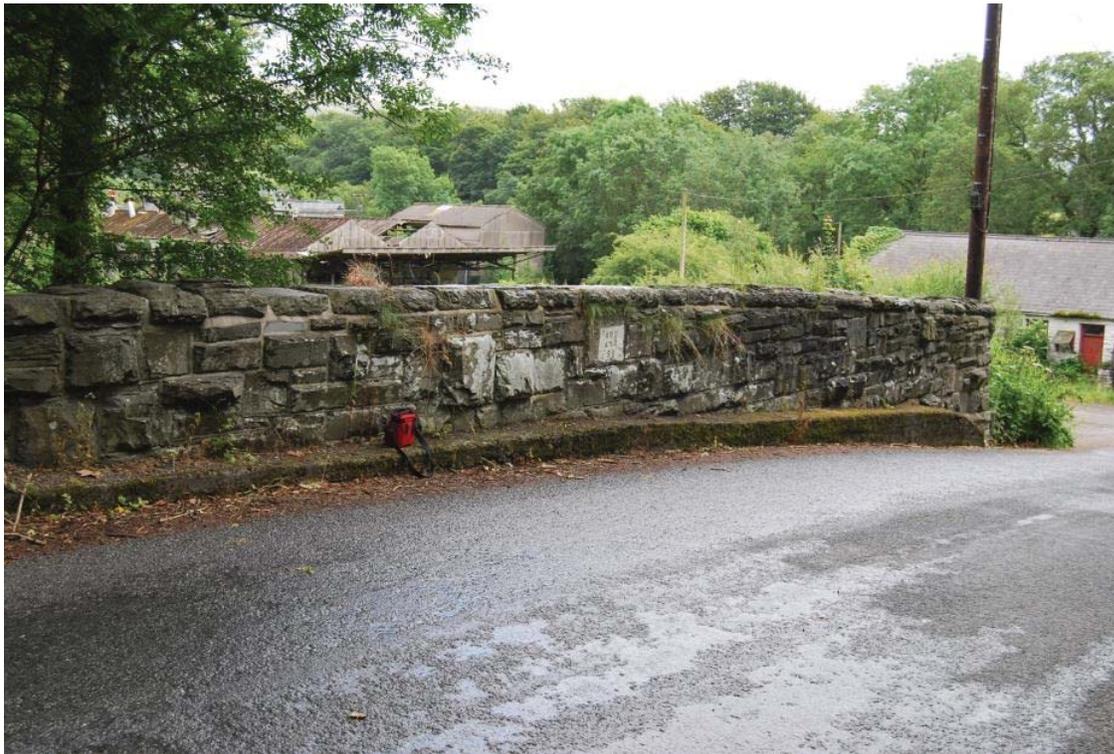
9) East parapet

The east and west side parapets are both low stone walls (Photographs 9 and 10). Both are in satisfactory condition. The east parapet is protected against errant vehicles coming down the hill by a raised kerb plinth.

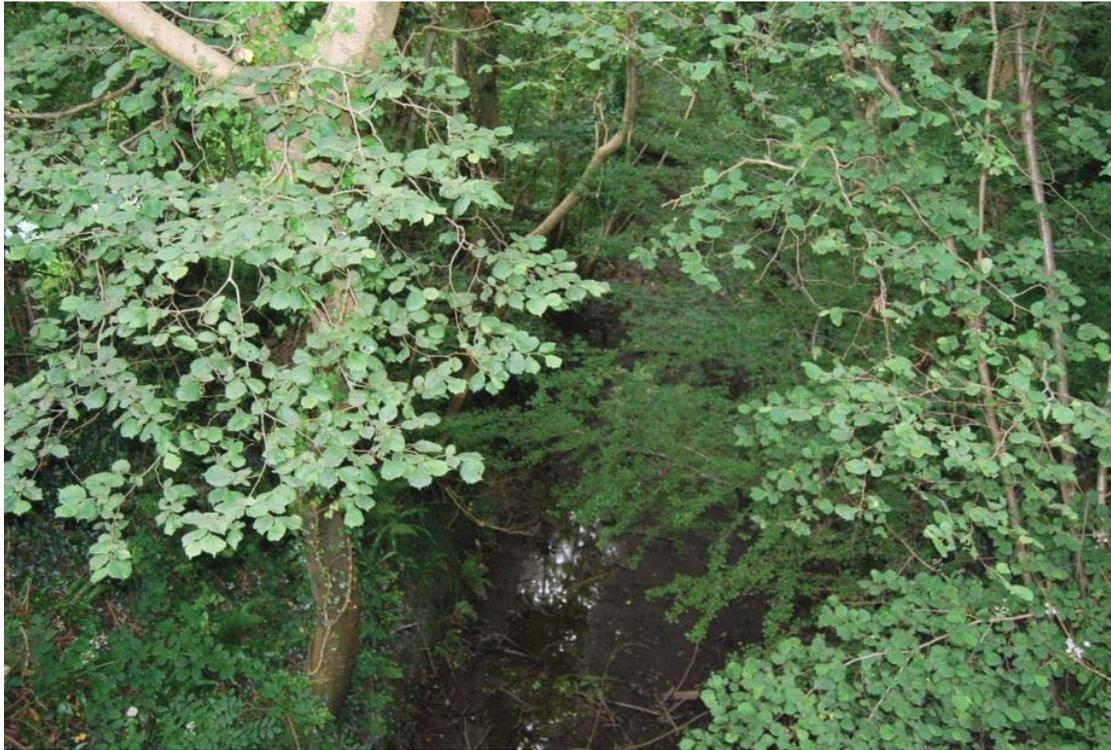
The formation is extensively overgrown on both sides of the bridge. The formation under the structure is very wet. There is an old water tank adjacent to the bridge which appears to be fed by a stream or spring. The overflowing water from the tank collects below the bridge.

11) Formation looking west from carriageway – shows vegetation coverage
