VAR9/3299 ASSESSMENT PROGRAMME

BE4 ASSESSMENT AND INSPECTION REPORT

**Montgreenan, Benslie
North Ayrshire**

BRIDGE REF: DAK/81

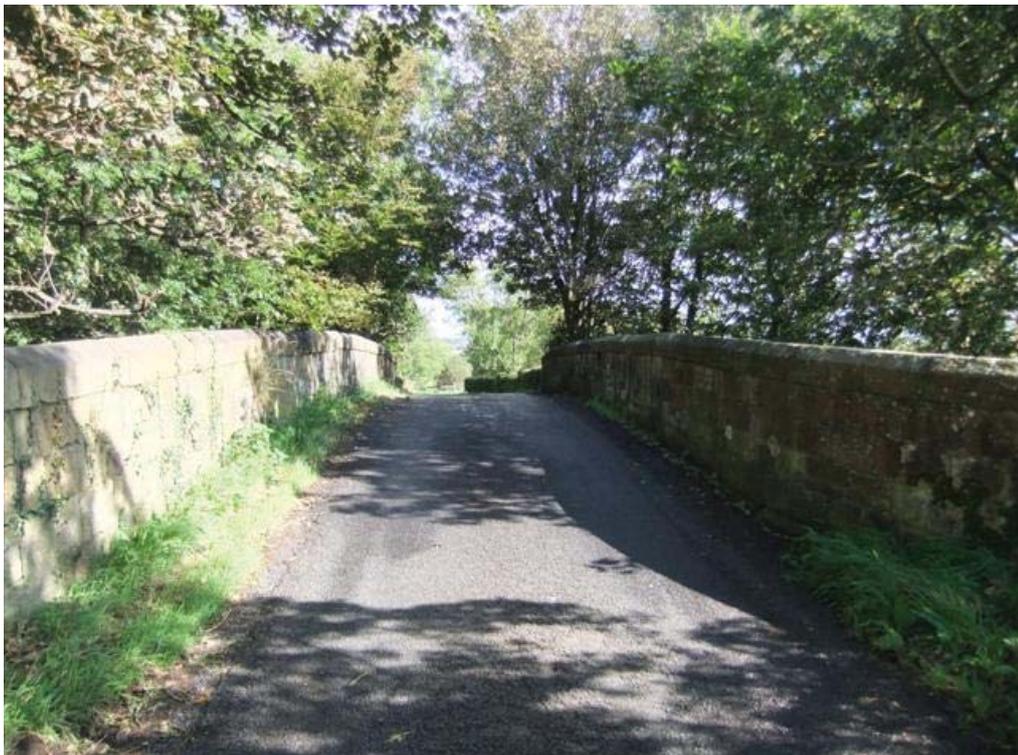
The road surface is in good condition with some areas of superficial wear (Photographs 2 and 3). The vertical alignment of the road is such that the humped profile restricts the vision of oncoming traffic.

Photo 2 – View over bridge looking east

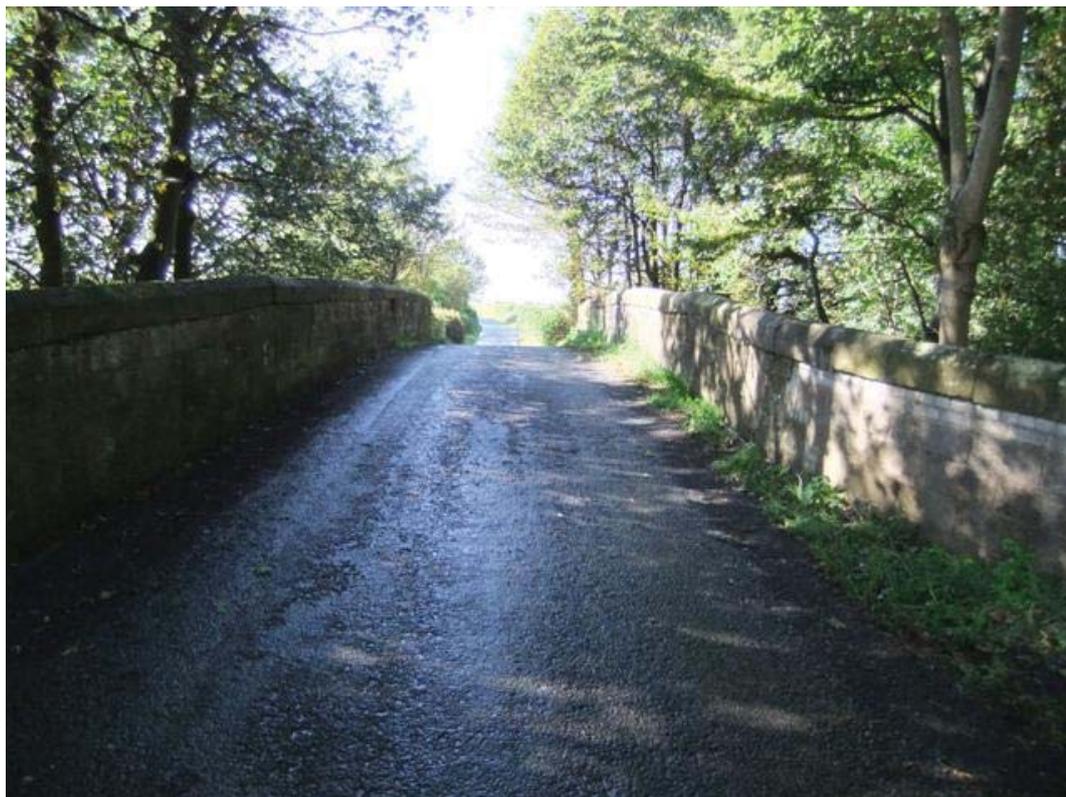
Photo 3 – View over bridge looking west

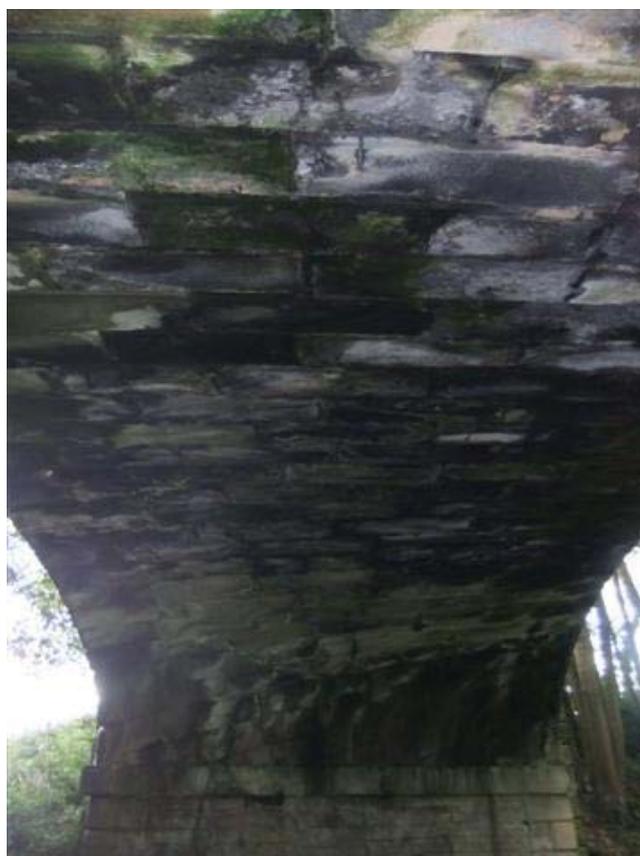
The arch barrel is generally in fair condition with no distortion of the profile. Two significant longitudinal cracks were observed within the arch barrel. The first towards the north east springing level, 1mm wide x 2000mm long; the second towards the centre of the arch crown, 1mm wide by 1250mm. As the cracks are less than 3mm wide and not in close proximity to each other, the effects of the arch barrel splitting into sections will not be considered. The arch is constructed from ashlar sandstone blocks, a ring factor of 1.4 is considered appropriate for this material (table 3 of BE4). The sandstone blocks are subject to algae and damp staining throughout the arch barrel face (Photograph 4). There are localised areas of water ingress throughout the arch barrel, with the majority of the barrel found to be wet during the inspection.

The joints appear to be well filled, a joint depth factor of 1.0 would normally be applicable; however, widespread areas of damp suggest there is active water ingress through the arch barrel. A depth factor of 0.95 (table 6 of BE4) is taken as a conservative estimate to account for hidden areas of insufficient filling due to mortar washout. The mortar appears to be in fair condition; therefore a mortar factor of 1.0 is appropriate (table 7 of BE4). The joints are less than 6mm wide, giving a width factor of 1.0 (table of 5 BE4).

With two significant cracks noted and no signs of spandrel separation, a general condition factor of 0.8 is considered appropriate.

Photo 4 – Arch barrel (looking east)

Assignment of a general condition factor for the assessment is somewhat subjective and has a large influence on the result. Within this assessment the effects of the arch barrel splitting into sections were not considered due to the size and locations of the two longitudinal cracks. If the two cracks are found to be active and deteriorate over time, these effects should be accounted for via a reduction in the general condition factor. A significant reduction of the condition factor may lead to the necessity of mitigation/repair works. The condition of the two longitudinal cracks in the arch barrel should be monitored as part of all future inspection works.

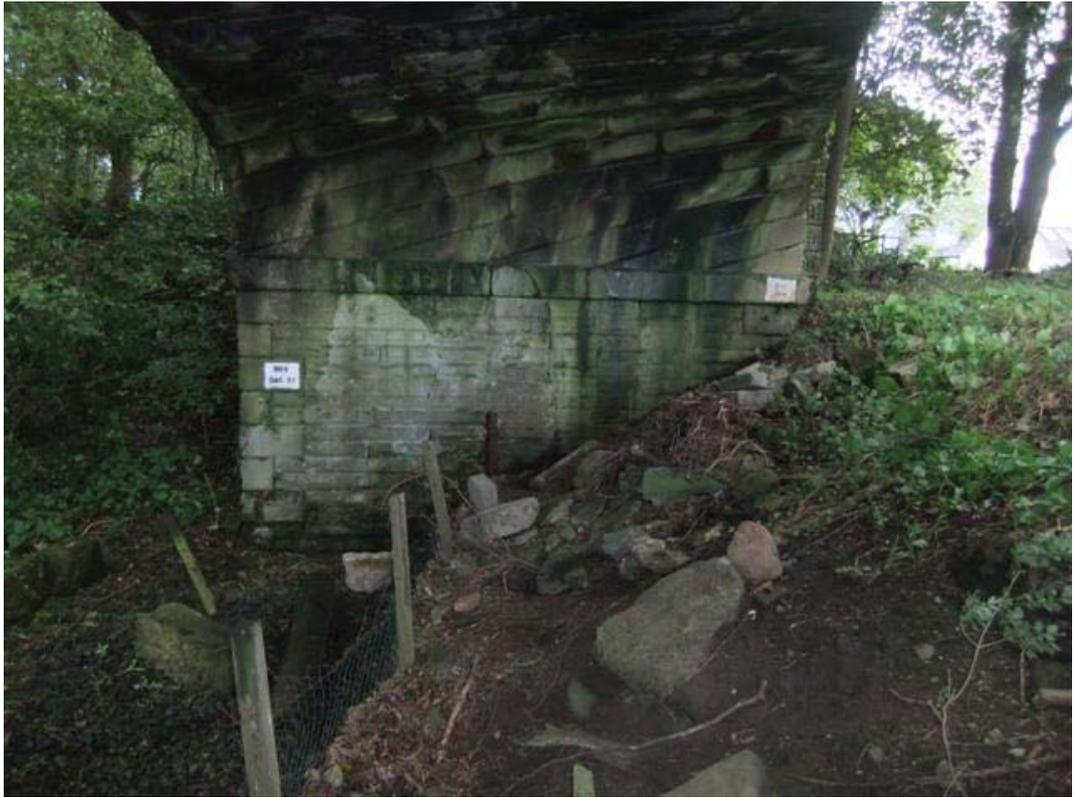
Both abutments appear to be in fair condition, the lower southern corners of the abutment faces are concealed by the embankment slope of the infilled south formation. The remaining exposed area of the east abutment face is subject to damp staining, originating from the water ingress from the arch barrel (Photograph 5). The east abutment face was found to be wet at time of inspection. The remaining exposed area of the west abutment is subject to algae staining and minor open joints throughout (Photograph 6).

Photo 5 – East Abutment

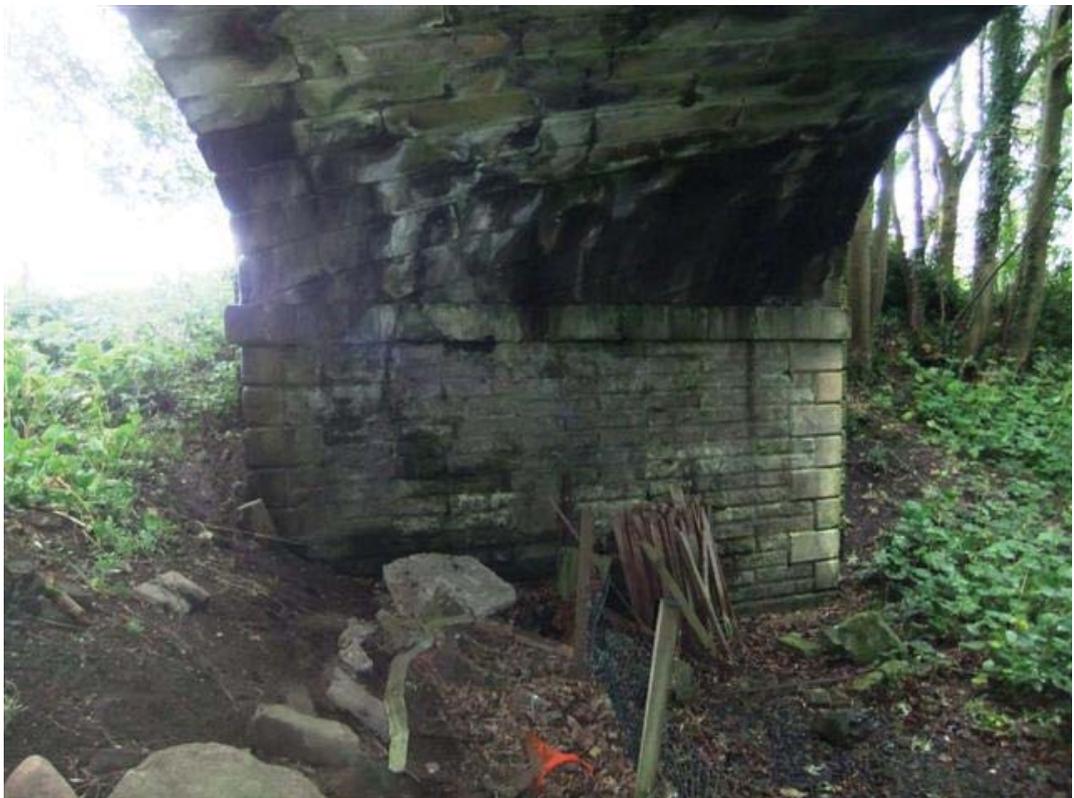
Photo 6 – West Abutment

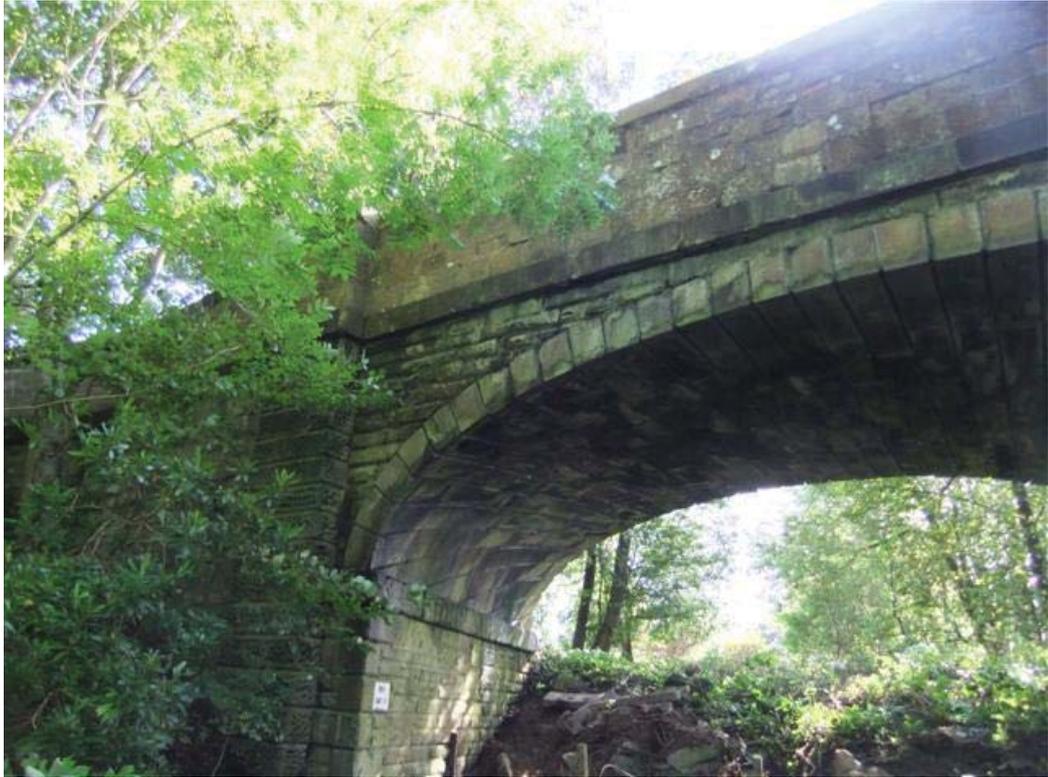
Both the north and south spandrel walls appear to be in fair condition, with minor spalling to the edges of the stringcourses (Photographs 7, 8, 11 and 12). There is a sapling growing from the south string course, towards the west pilaster (Photograph 12). No associated defects or signs of movement were noted during the inspection.

Photo 7 – North spandrel wall and pilaster (east)

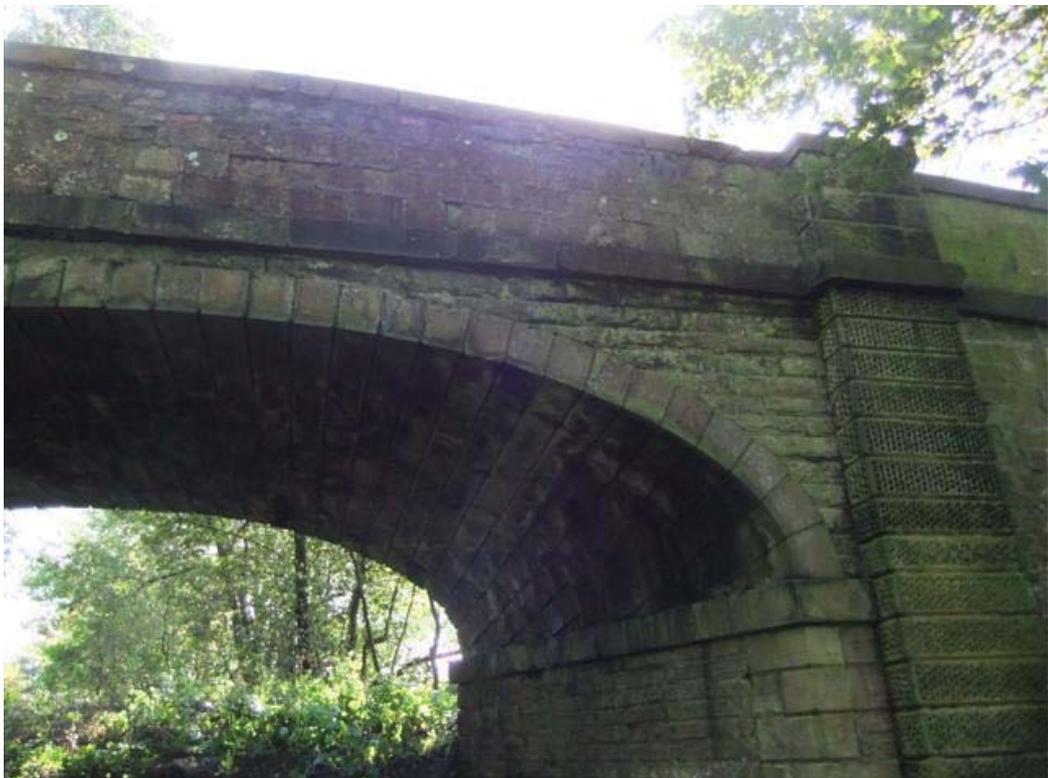
Photo 8 – North spandrel wall and pilaster (west)

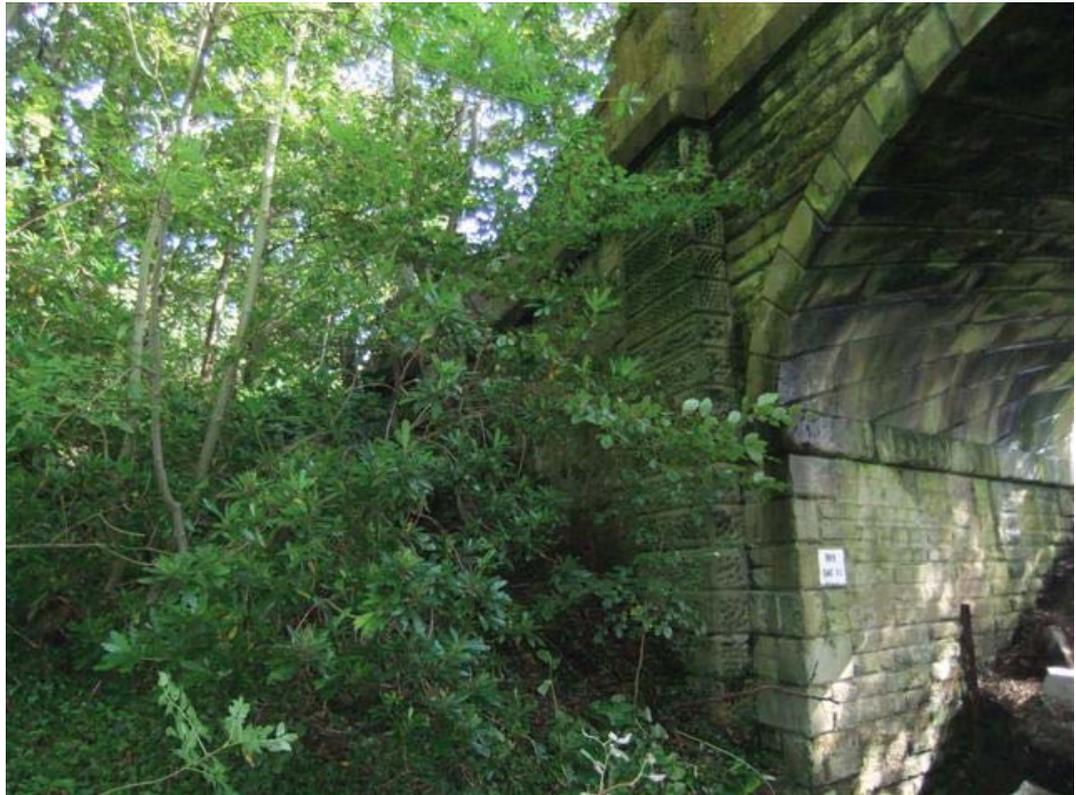
The north east wingwall appears to be in fair condition, the embankment in front of the north east wingwall is largely overgrown with vegetation. No associated defects or signs of movement were noted during the inspection (Photograph 9).

Photo 9 – North east wingwall

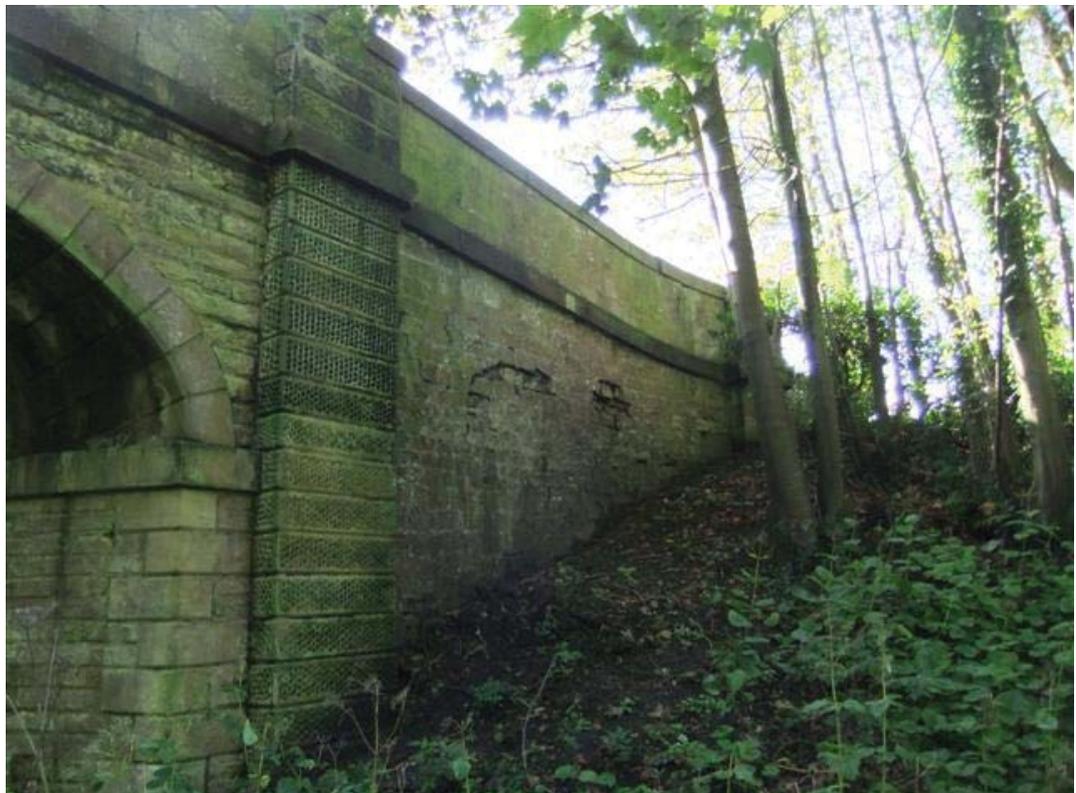
The north west wingwall is in fair condition with minor spalling and mortar loss throughout the lower areas. There are two areas of deep spalling to the wingwall, approximately 1000mm x 1000mm x 200mm deep and 1500mm x 1000mm x 150mm deep (Photograph 10).

Photo 10 – North west wingwall

Consideration should be given to brickwork patch repair works to the north west wingwall. These works are considered desirable rather than necessary as the current condition of the wingwall poses no immediate cause for concern. In general, the substructure does not give cause for concern and has sufficient capacity for BE4 loading by qualitative assessment. The condition of all substructure elements should continue to be monitored as part of future inspection works.

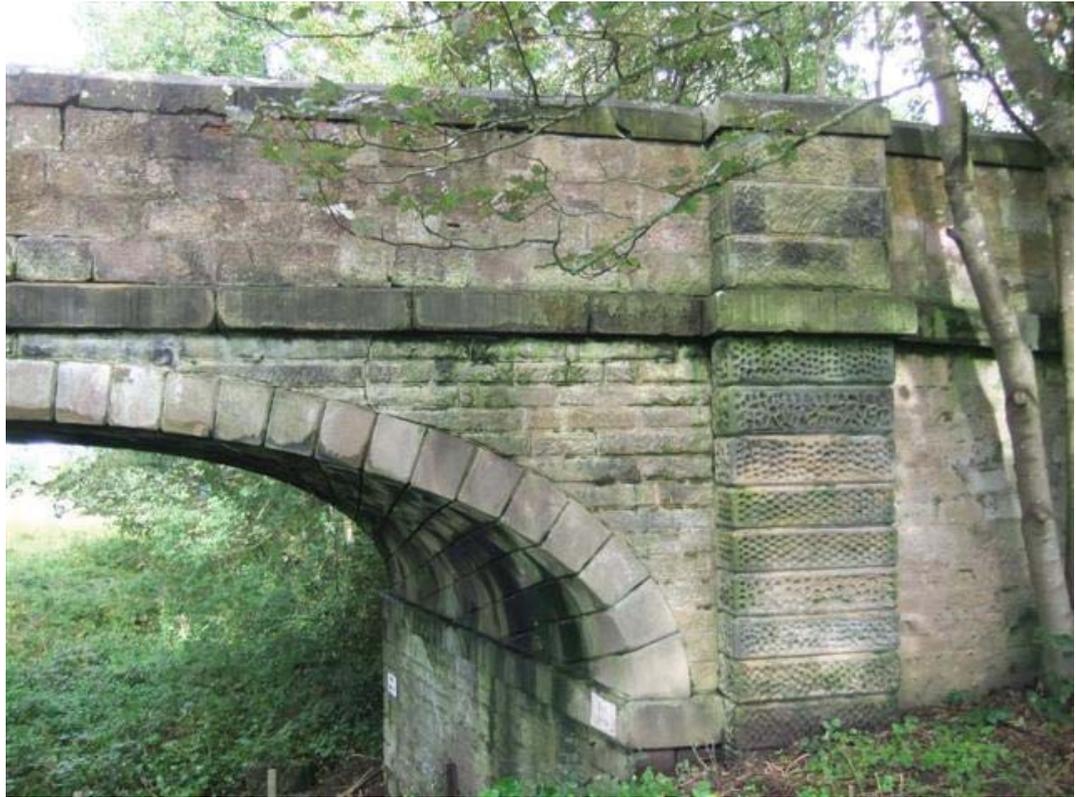
Photo 11 – South spandrel wall and pilaster (east)

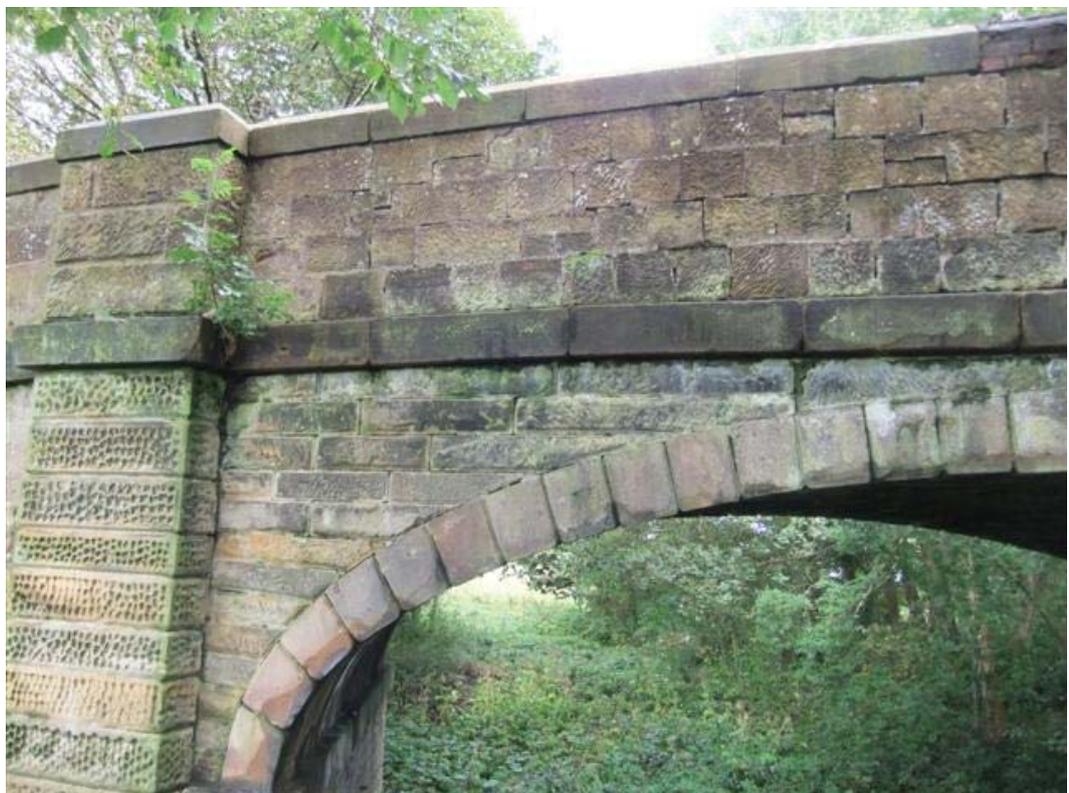
Photo 12 – South spandrel wall and pilaster (west)

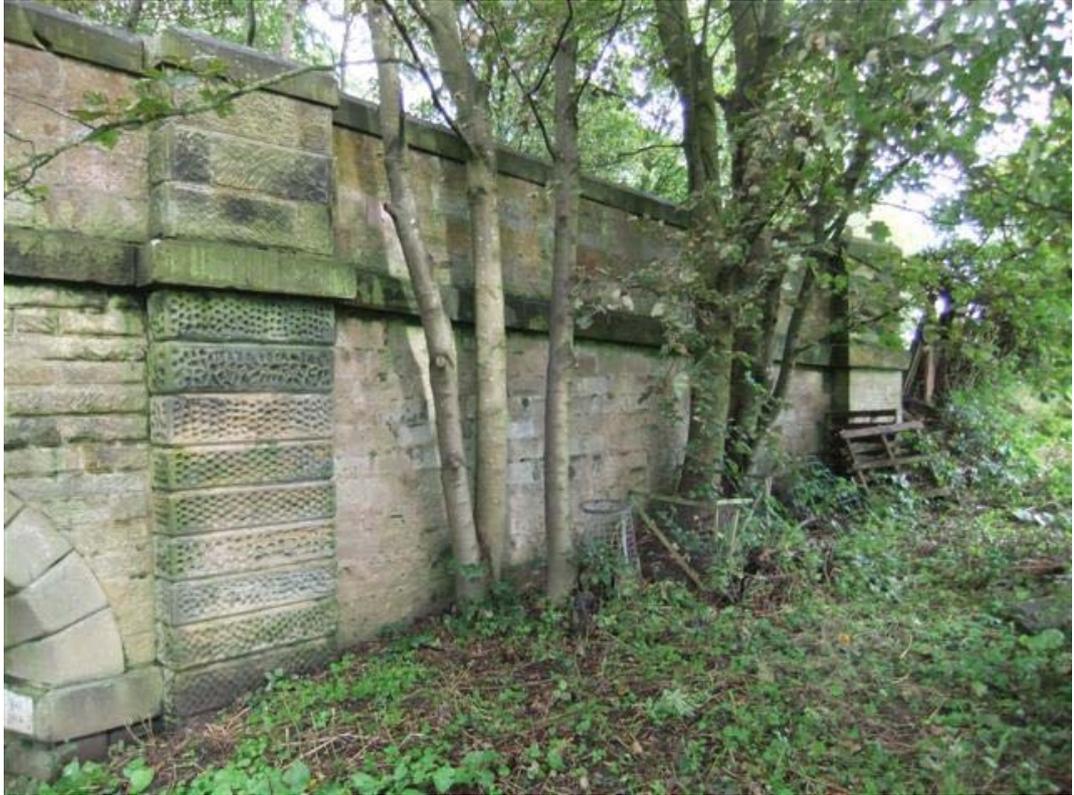
Both the south east and south west wing walls appear to be in good condition. There are a number of large trees growing close to the base of the south east wing wall. No associated defects or signs of movement were noted during the inspection (Photograph 13). There are localised areas of mortar loss to the lower areas of the south west wing wall, and minor spalling to the string course (Photograph 14).

Photo 13 – South east wingwall

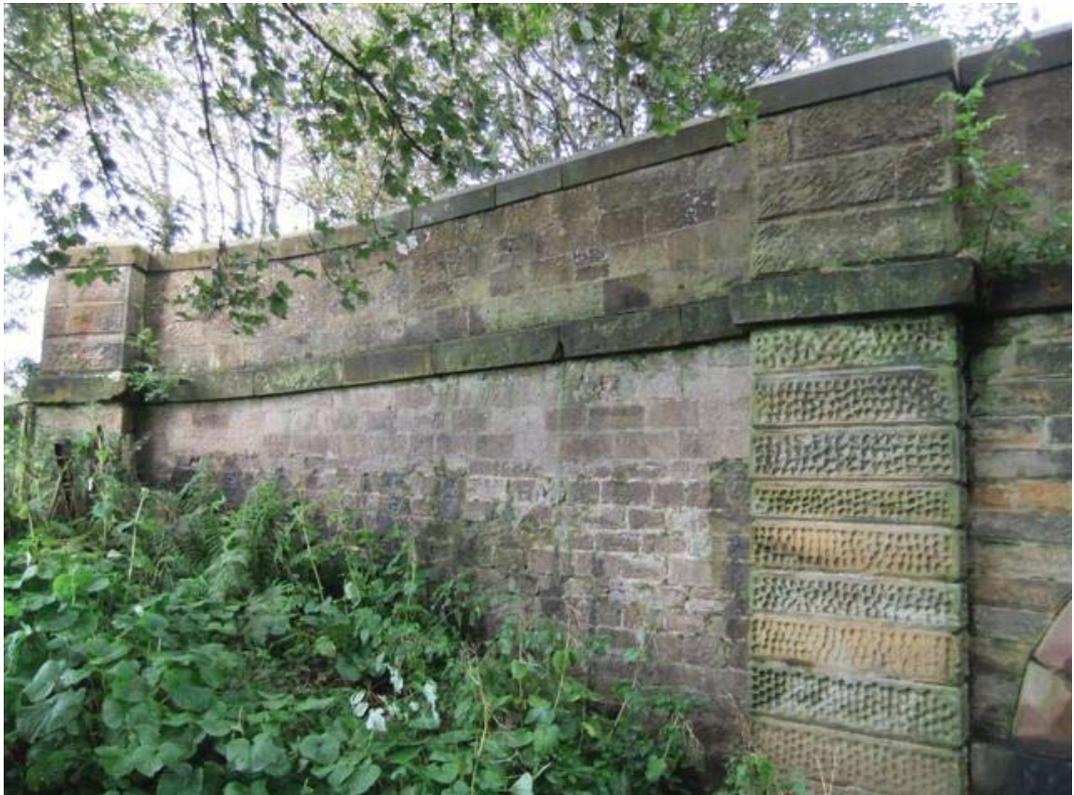
Photo 14 – South west wingwall

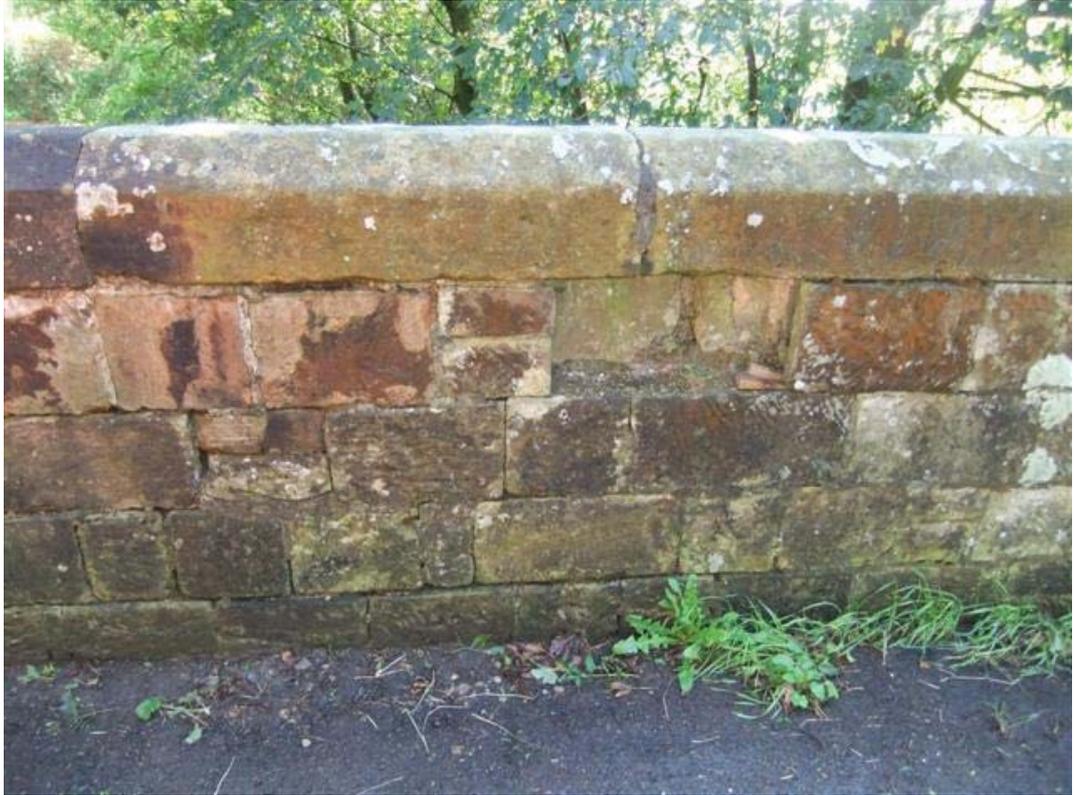
Evidence of vehicle impact damage was observed towards the midpan area of the southern parapet. Two blocks of the external course appear to be displaced out of plane. One block was noted as missing from the north elevation of the southern parapet (Photographs 15 and 16). The mortar within the affected area was found to be loose with the adjacent block work unsecured at the time of inspection.

Photo 15 – Vehicle impact to north elevation of south parapet

It is recommended that repair works are carried out throughout both parapets. Where possible the displaced blocks are to be realigned, with all areas of loose mortar being repointed securing all block work within the parapet. Damaged block work is to be replaced with brickwork repairs similar to those noted during the inspection. Existing brick repairs should be re-faced where the mortar is seen to have spalled away.

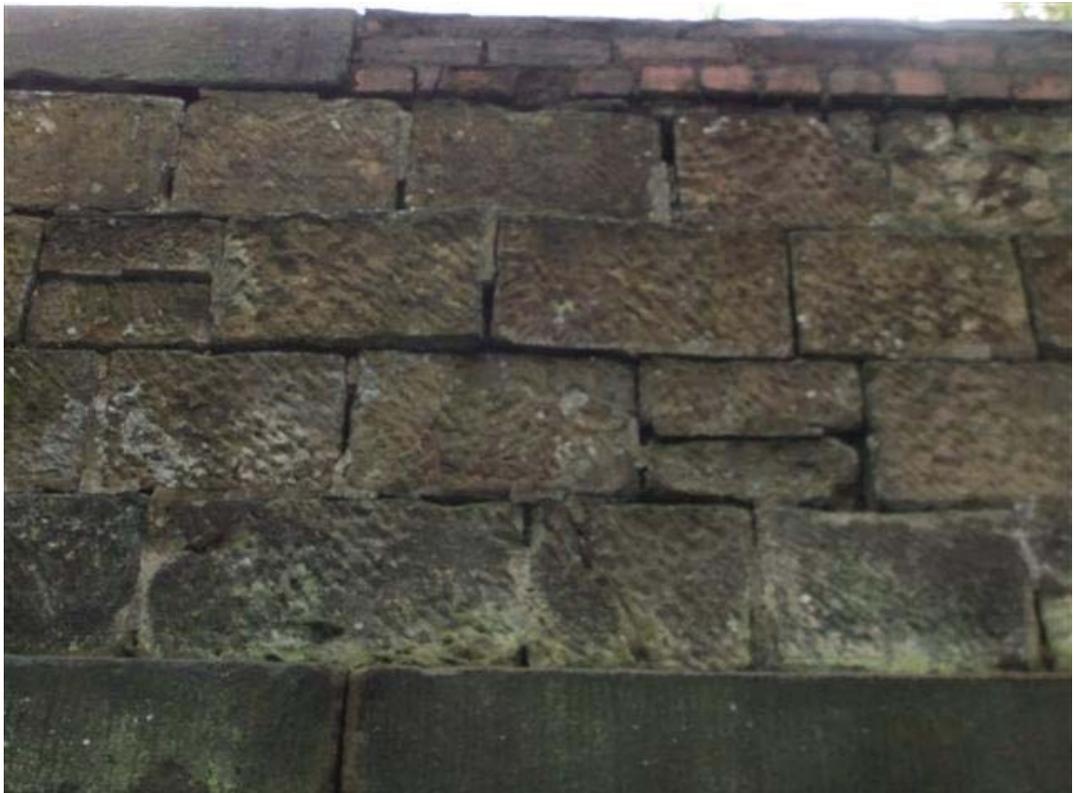
Photo 16 – Two blocks displaced out of plane with south elevation of south parapet due to vehicle impact
