**EAST AYRSHIRE COUNCIL
DEVELOPMENT AND PROPERTY SERVICES
ROADS DIVISION**

**ASSESSMENT REPORT
DISUSED RAIL BRIDGE NOS 1 & 97**

**Structure Ref B751/20
OS Ref. NS 400 396**

**VOLUME 1
December 2009**

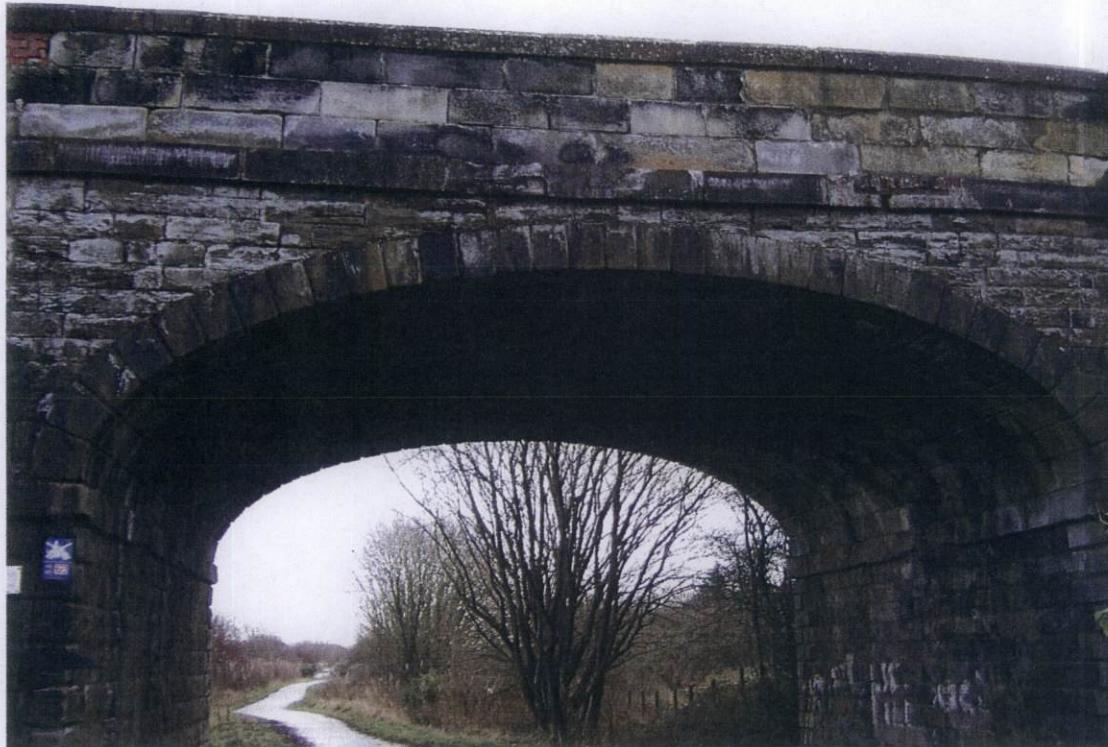
The masonry arch barrels were in good condition. Despite some evidence on the west spandrel, stringer course and parapet copes to suggest that Bridge 1 (the south span) barrel may have sagged, the arch profiles showed no signs of deviation when measured and compared with the geometry of bridge 97. The barrels were generally dry, with only some minor dampness on the barrel at the east side of bridge 1 barrel. The brickwork repairs at the South quarterpoint of bridge 1 were in good condition.

Photograph 5: South arch (bridge 1), west elevation.
Note no deviation in arch barrel profile despite visible 'sagging' of string course and parapet masonry courses.

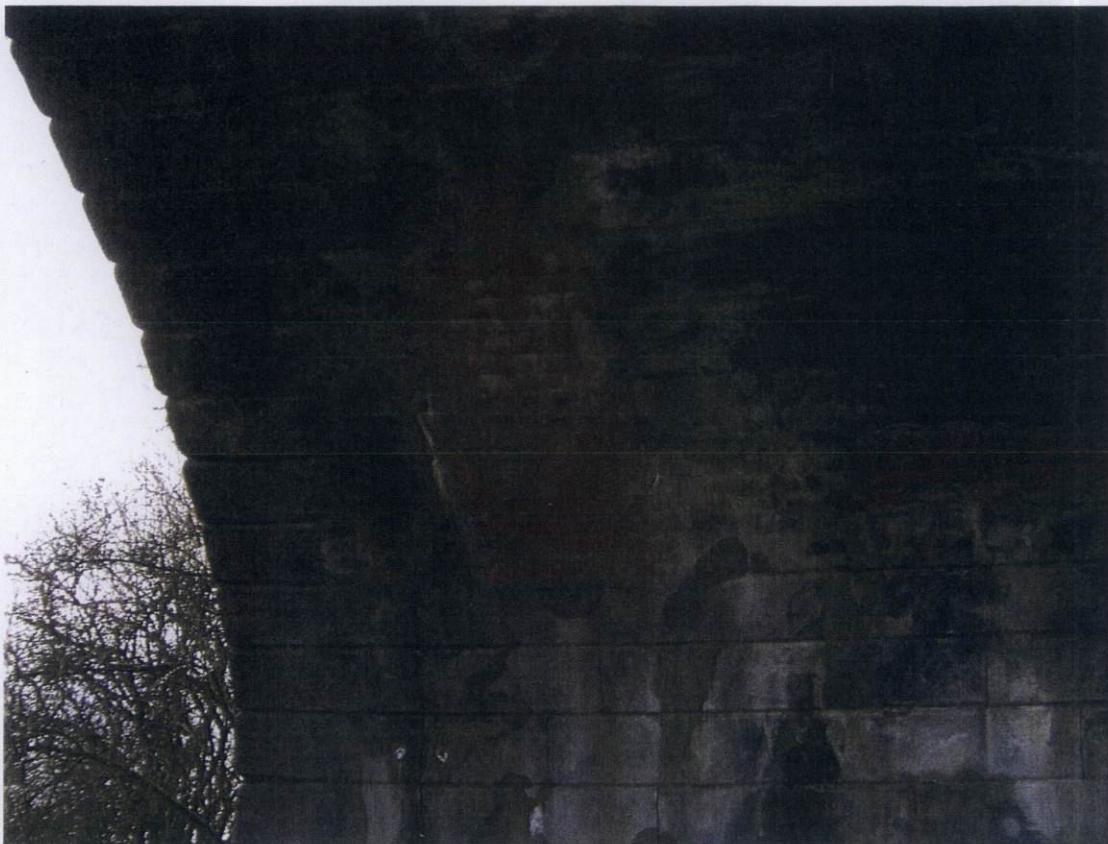
There was some minor weathering of the stonework noted particularly at the North springing of bridge 97, but is no cause for concern. (See Appendix B photographs 2,5 to 9,18)

Photograph 9: South arch, quarter point, south side. Repairs & crack.

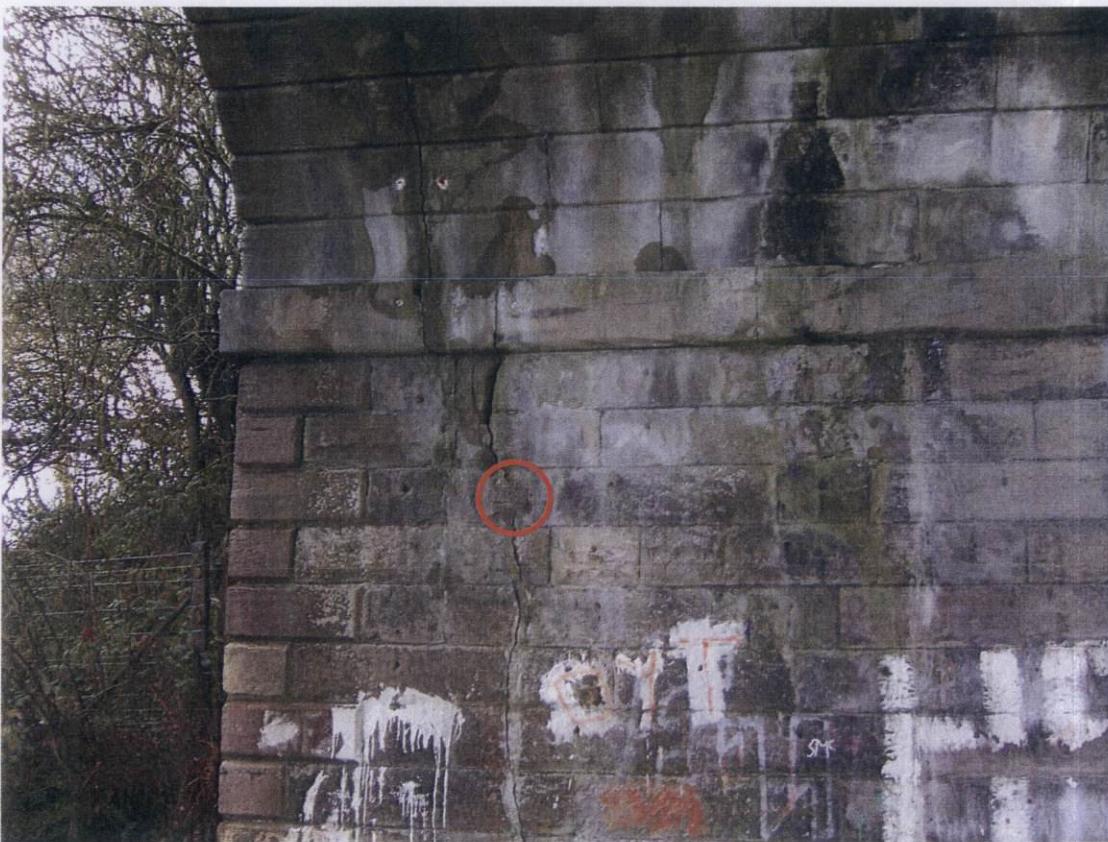
At the south East corner of bridge 1 and the Northwest corner of bridge 97, vertical cracks were observed running the full height of the abutments. Tell-tales marked 27/8/4 (suggesting a date of probably 2004) show no significant movement since installation. (See Appendix B photographs 10 to 12)

Photograph 10: South arch south abutment. Vertical crack. Tell-tale position circled.

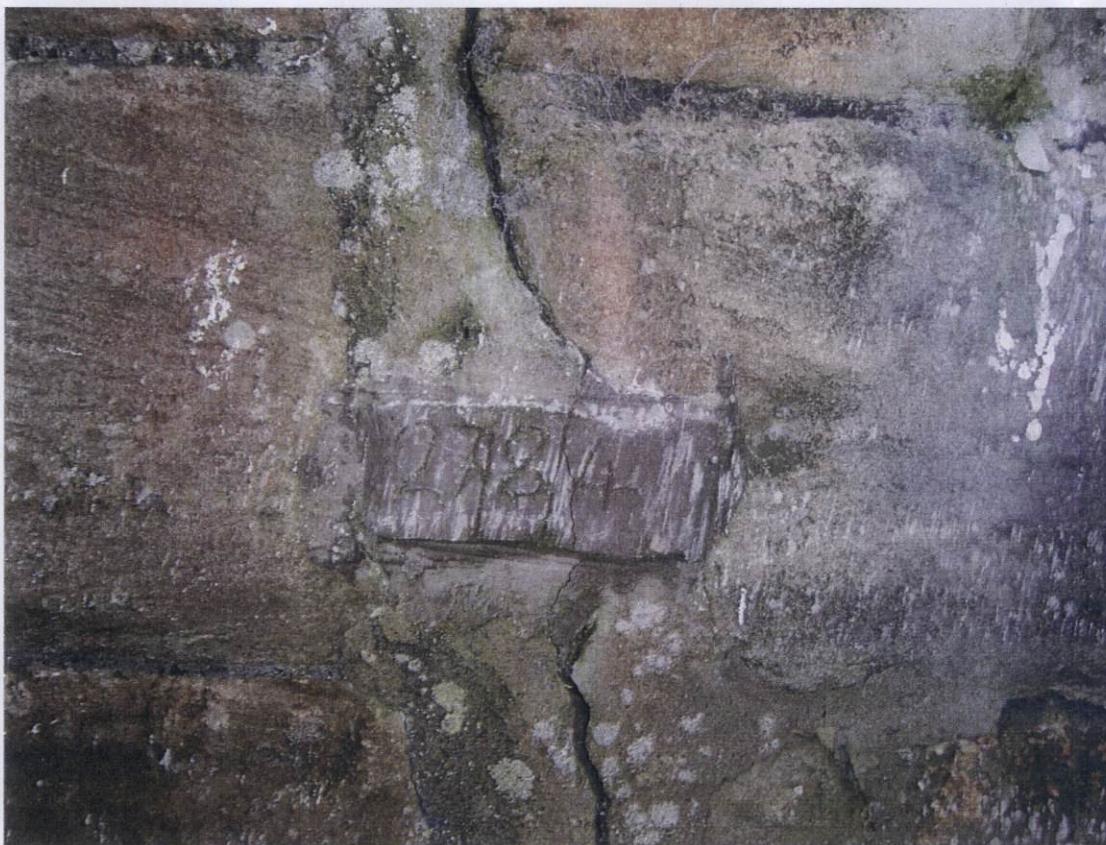
Photograph 11: Tell-tale, south arch, south abutment. Dated 27/8/4

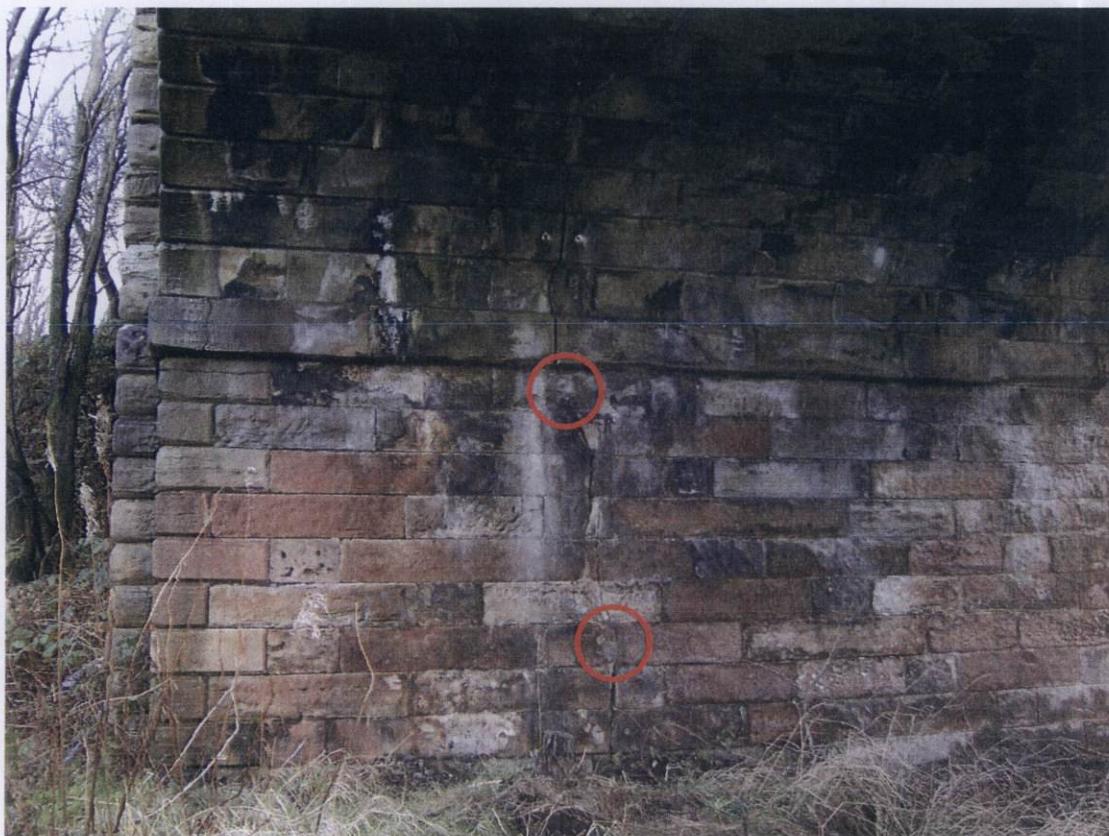
The foundations were not inspected directly. There were cracks found in the barrel and the abutments, however there was no discernible differential movement across the crack. Furthermore, the cracks did not get progressively wider further up the abutment as might be expected if the foundations had allowed the ends of the abutment to rotate outwards. On the above basis it is deemed unlikely that the foundations have moved. With the tell-tales indicating no recent movement, there is no cause for concern. (See Appendix B photograph 12)

Photograph 12: North arch, north abutment. Crack. Tell-tale positions circled.

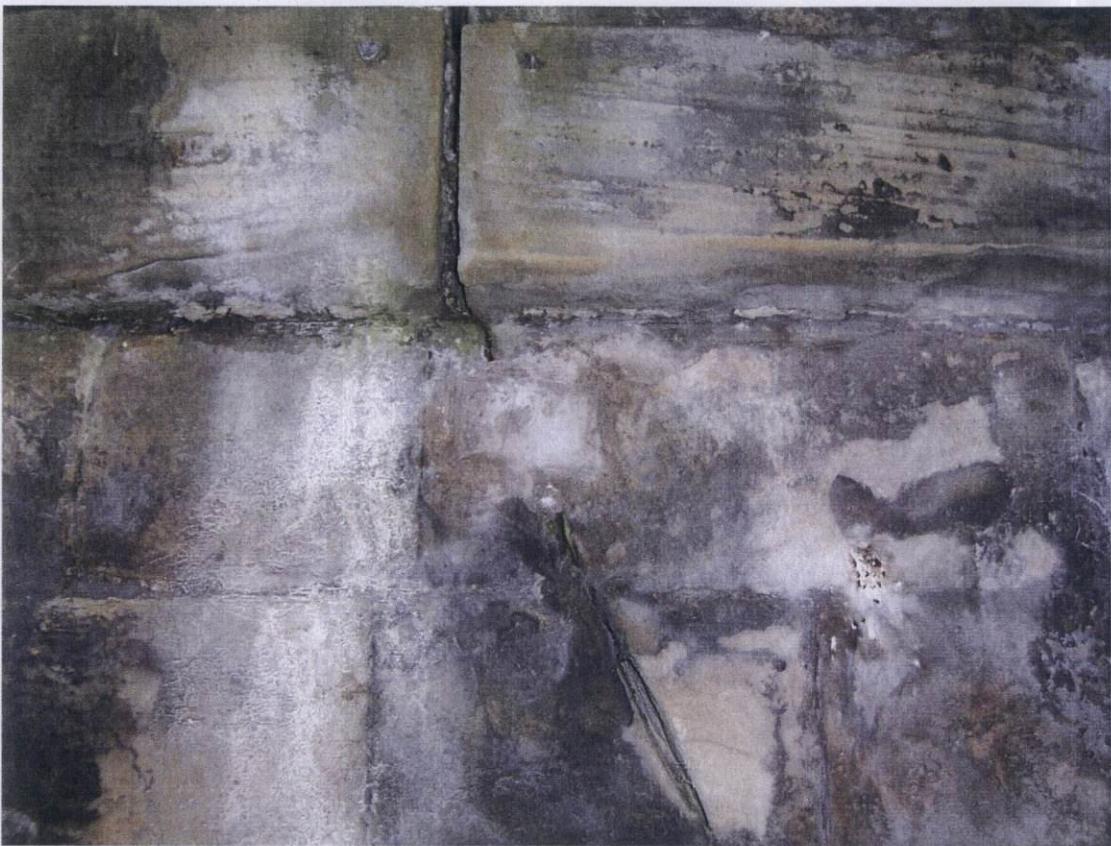
Photograph 13: North arch north abutment; tell-tale; upper. Dated 27/8/4

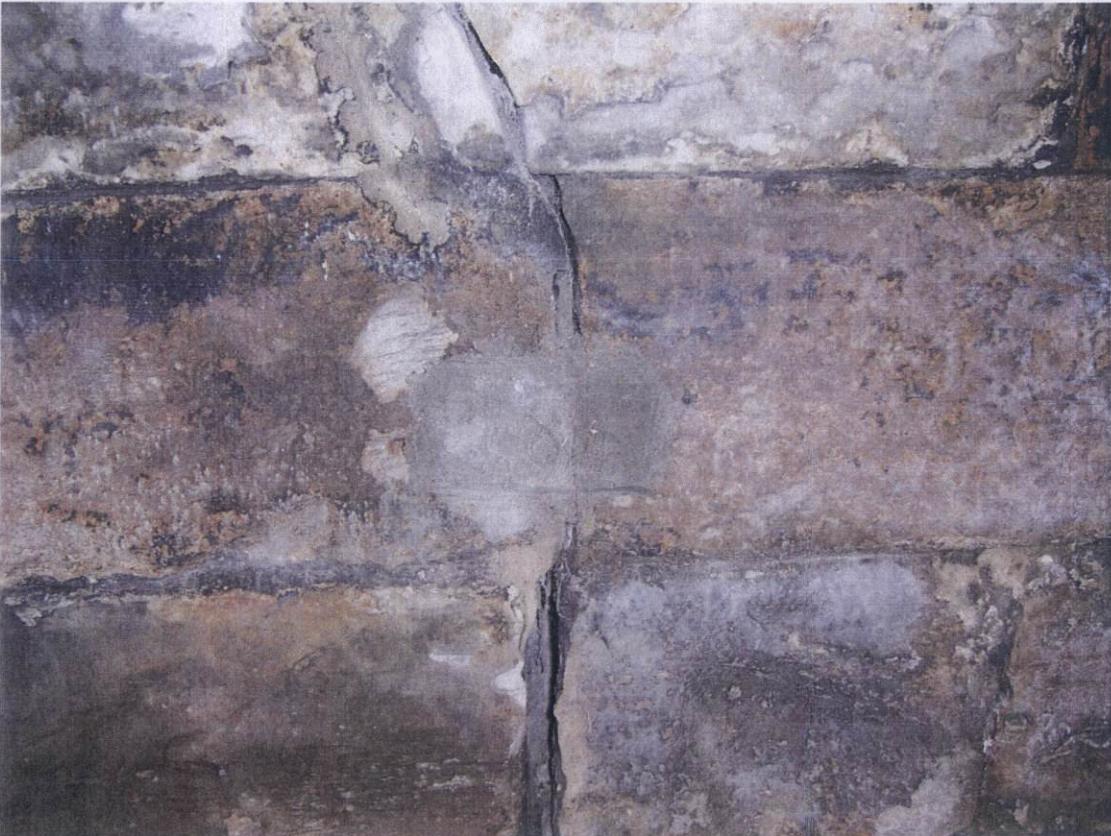
Photograph 14: North arch north abutment; tell-tale; lower. Dated 27/8/4

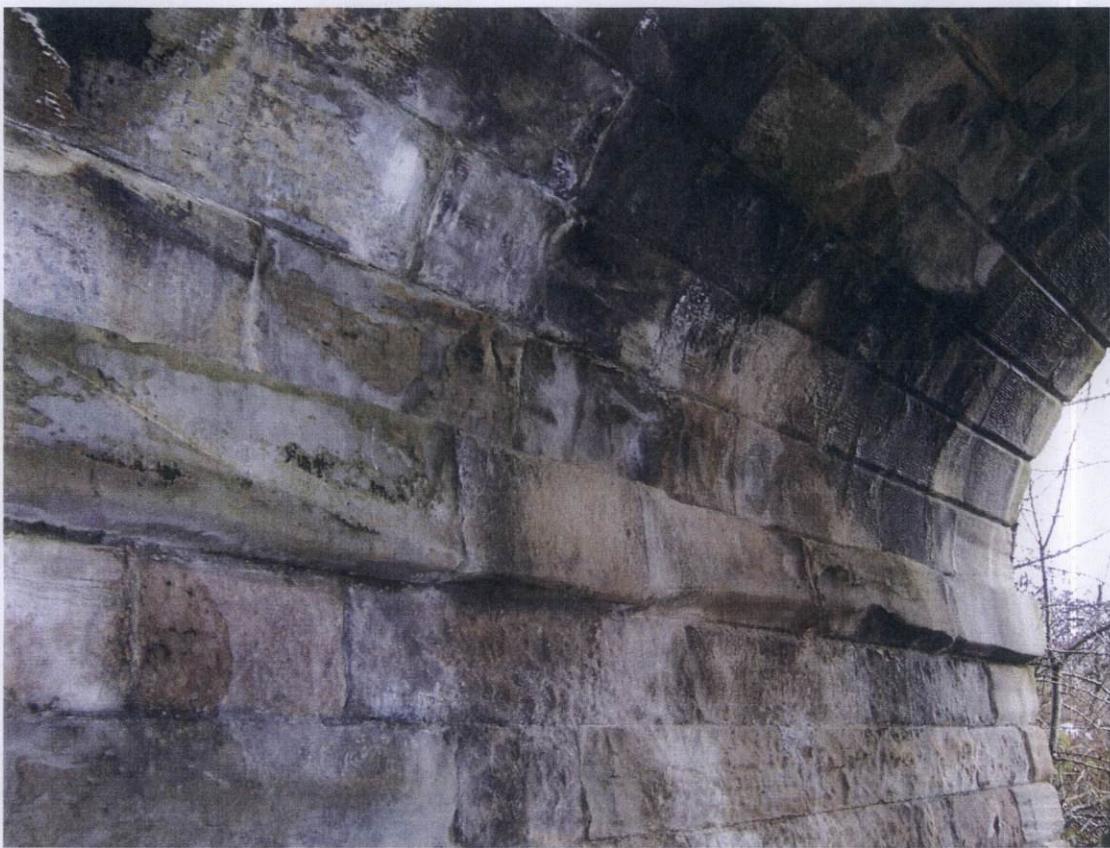
Photograph 15: North arch, north abutment. Weathering to stone.

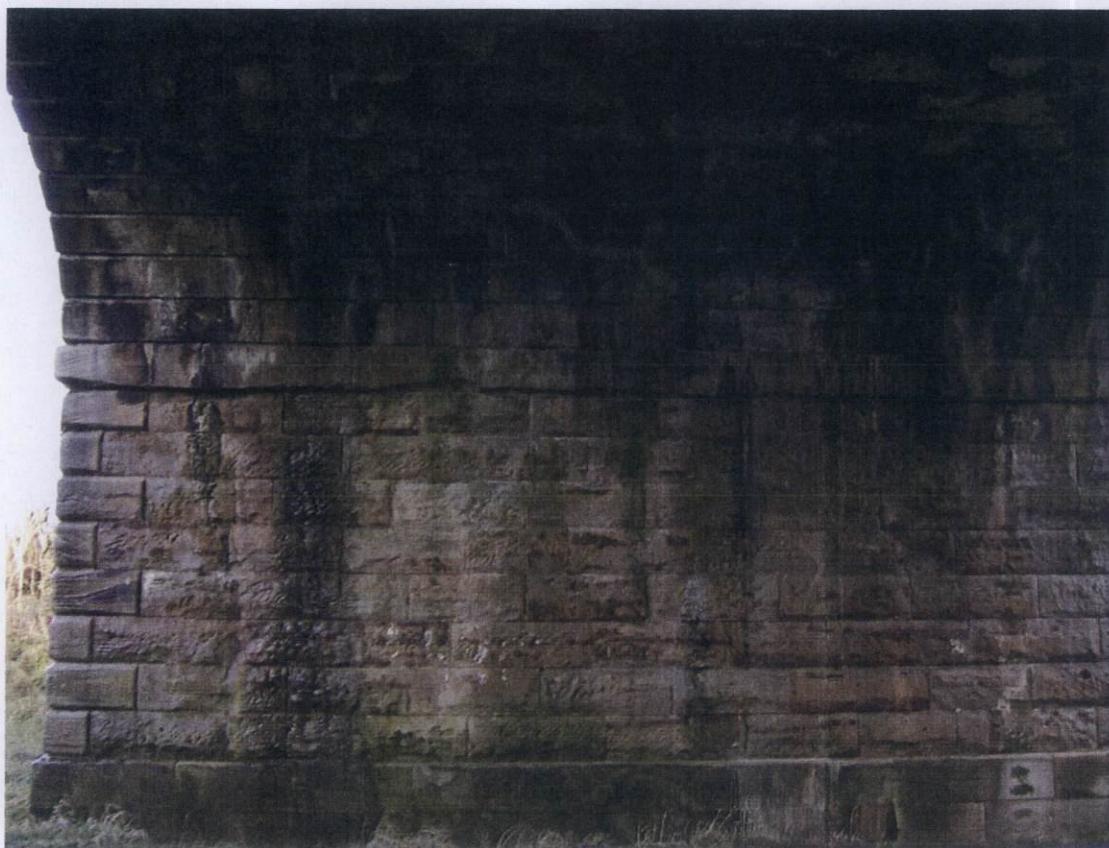
Photograph 17: South side of central pier. Damp staining.

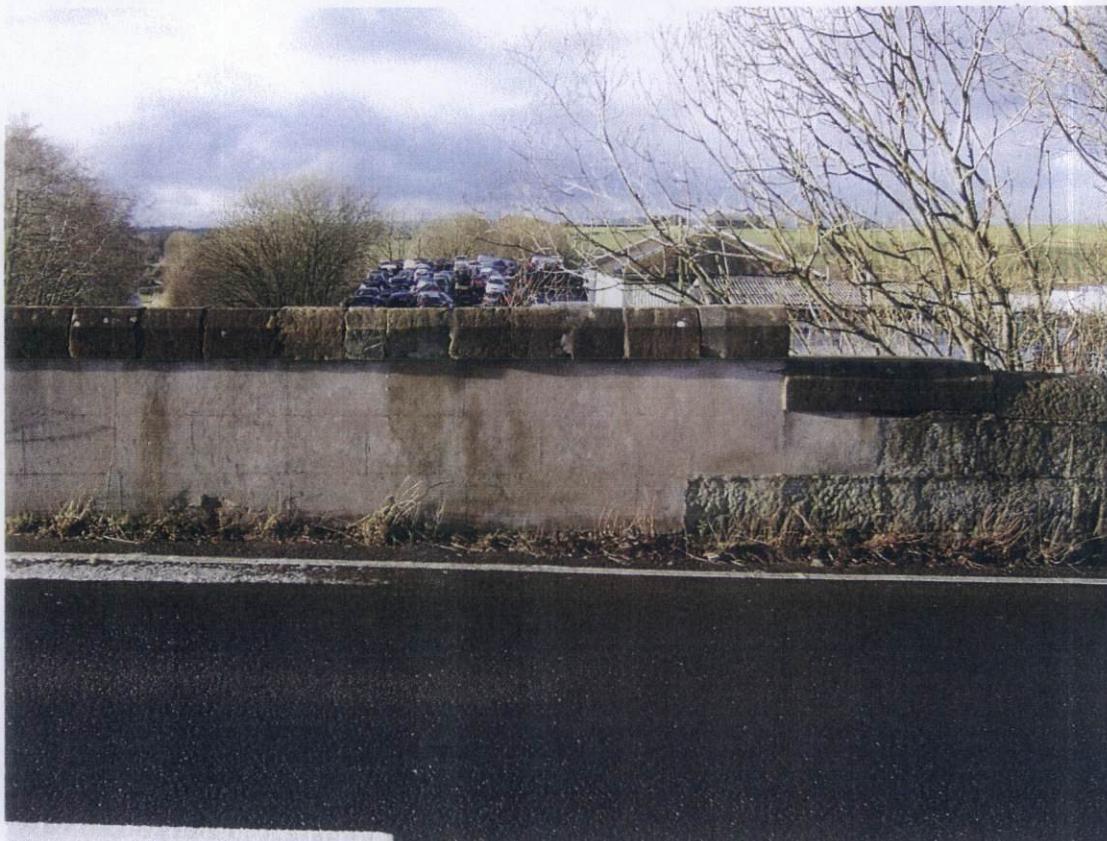
Photograph 23: NW parapet. End cope loose.

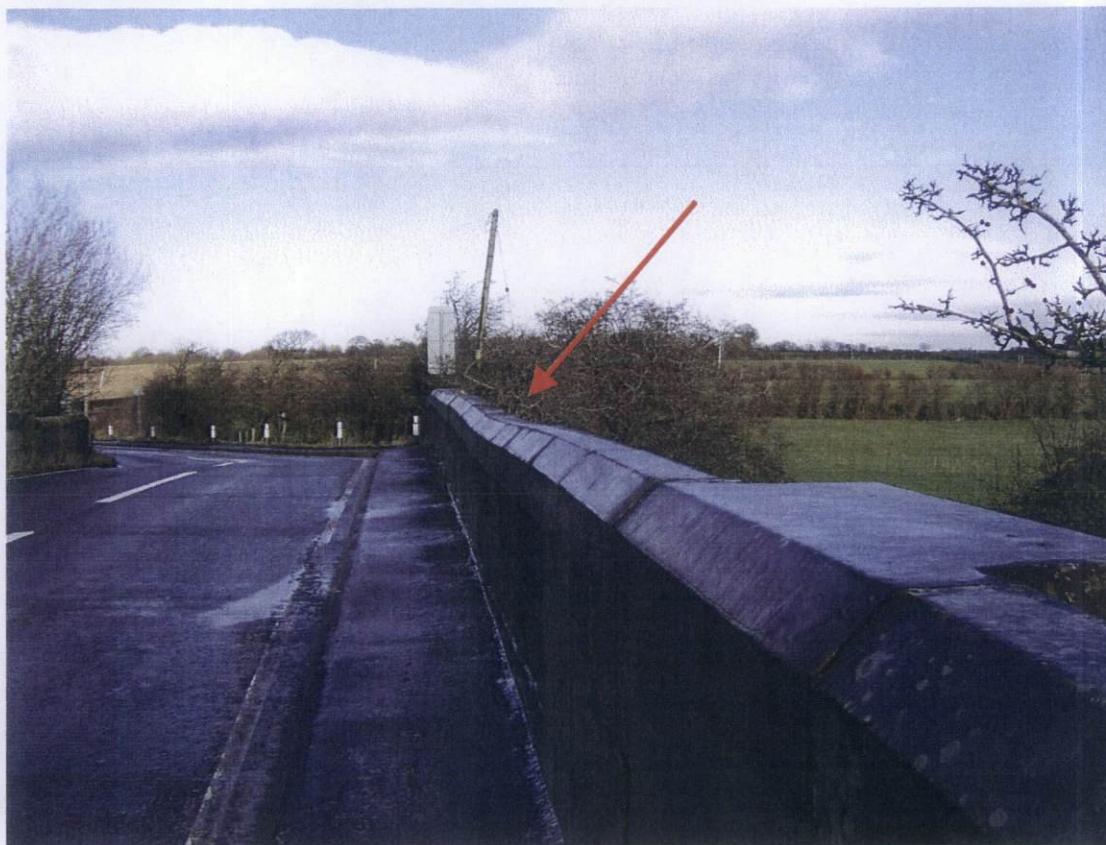
Photograph 27: East parapet. Note sag in line of copes

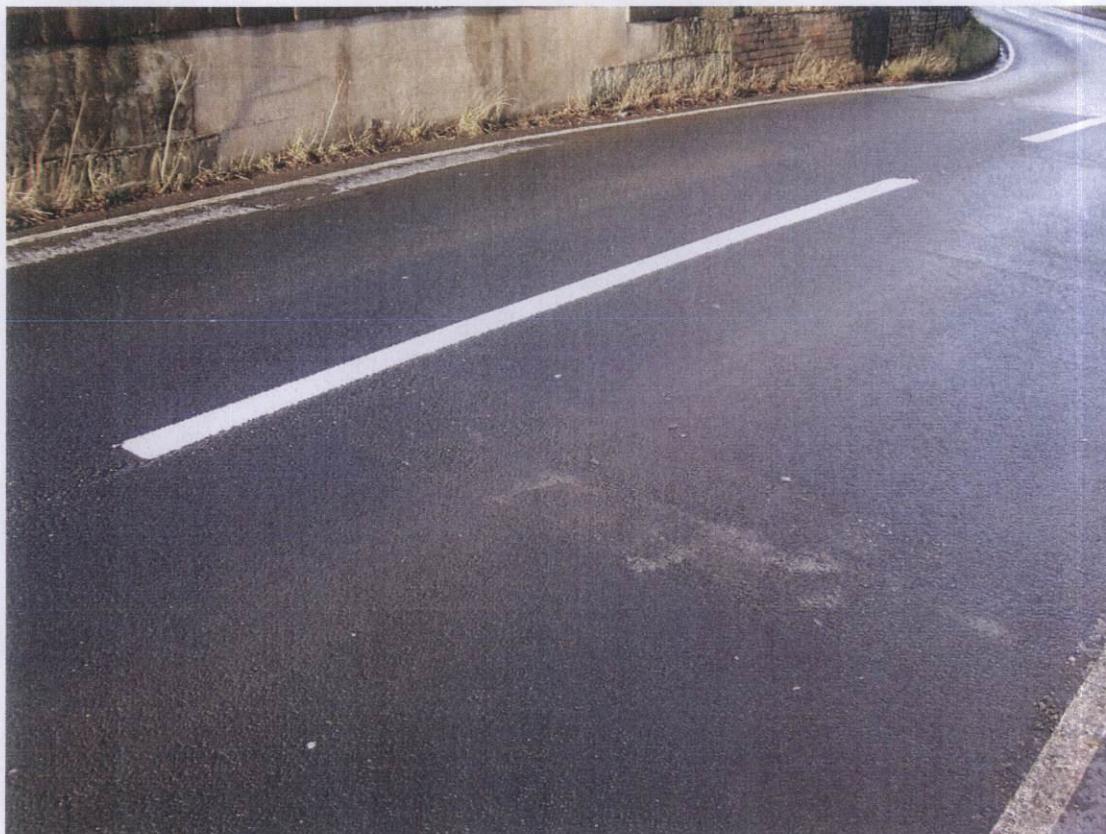
The carriageway wearing course was in good condition.

Photograph 28: Carriageway in good condition

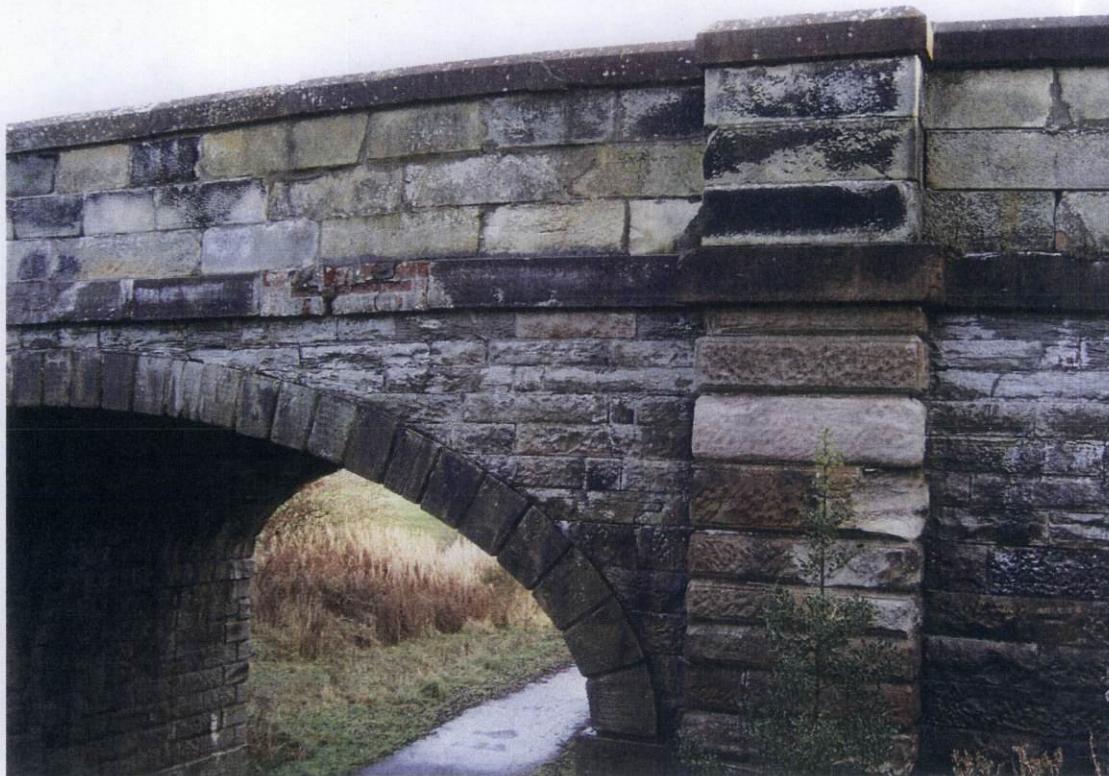
Photograph 29: Minor cracking to west spandrel wall near springing

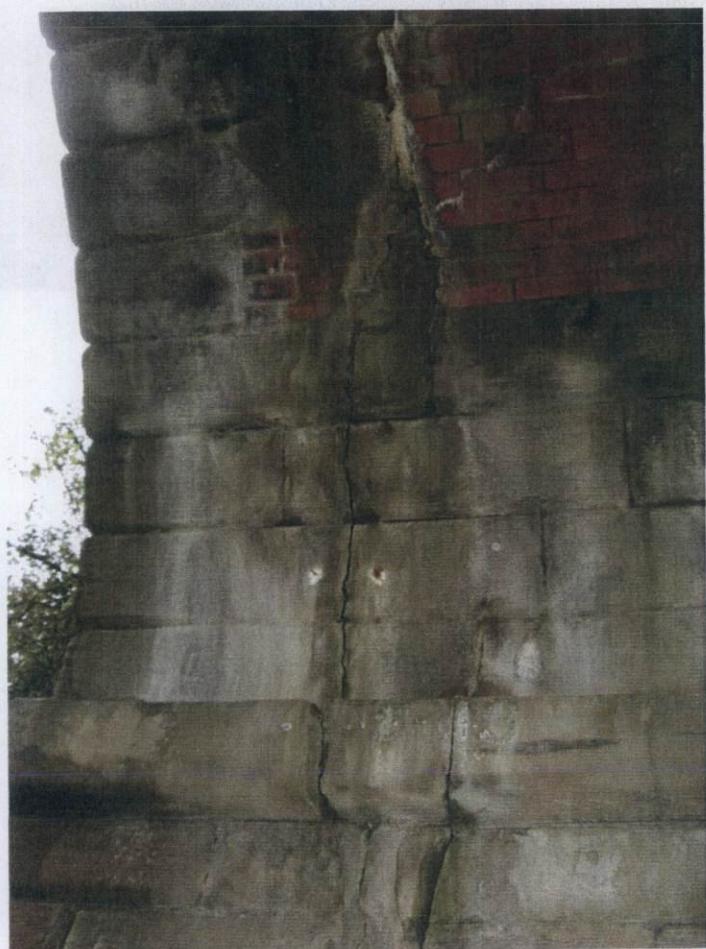
Plate 3

Bridge Ref 1
Crack Spanning between South Abutment and Quarter Point

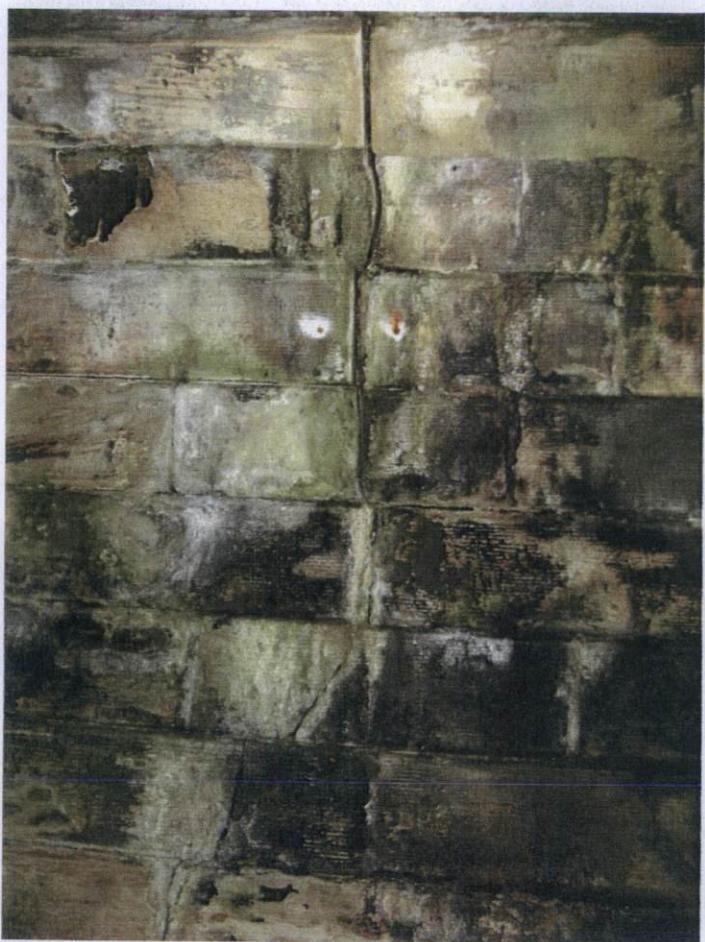
Plate 16

Bridge Ref 97
Crack Spanning between North Springing and Quarter Point
