**BE4 ASSESSMENT AND
INSPECTION REPORT**

**Balmacassie Bridge, Ellon,
Aberdeenshire**

BRIDGE REF: EBD/756

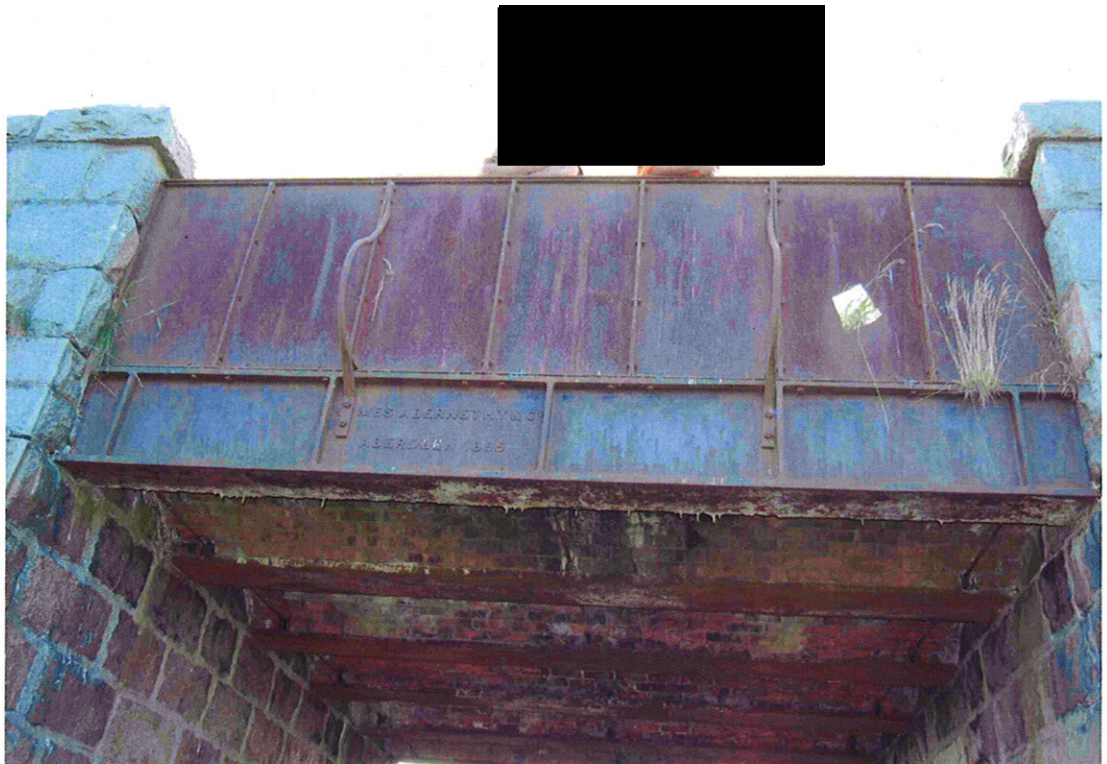
The bottom flanges of the edge girders have general light corrosion increasing to moderate corrosion on the inside edge and a degree of calcareous staining with small stalactites. There is no significant section loss. (Photos 2 and 3)

Photo 2 – East edge girder

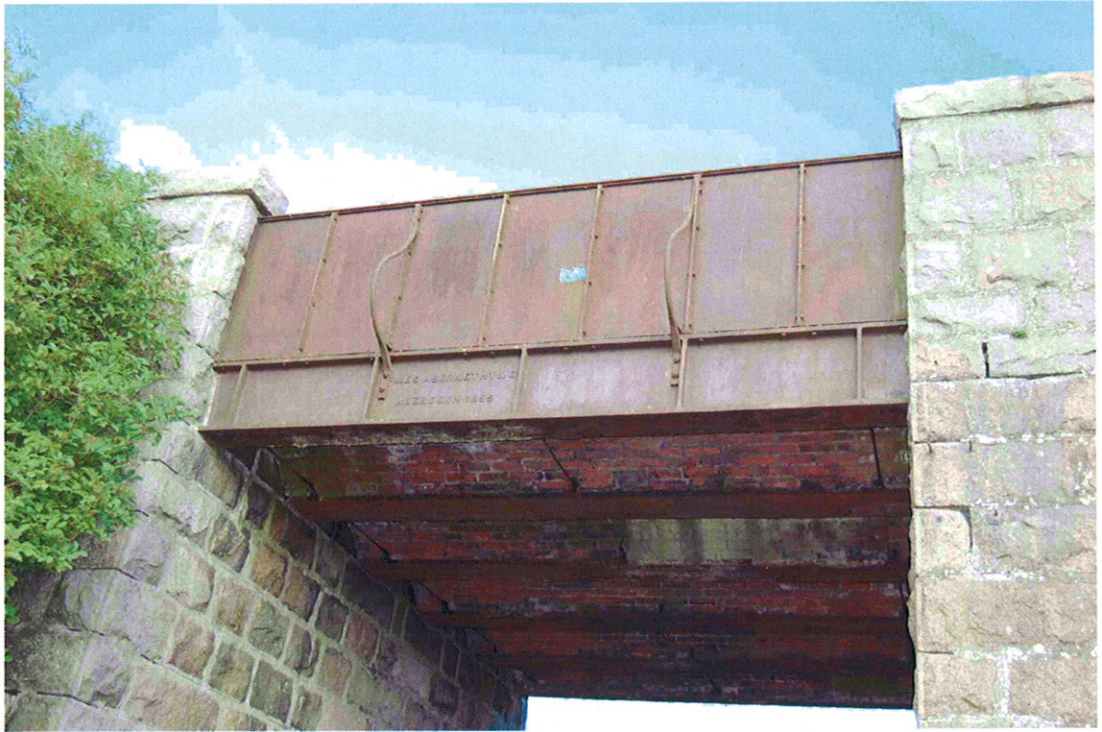
Photo 3 – West edge girder

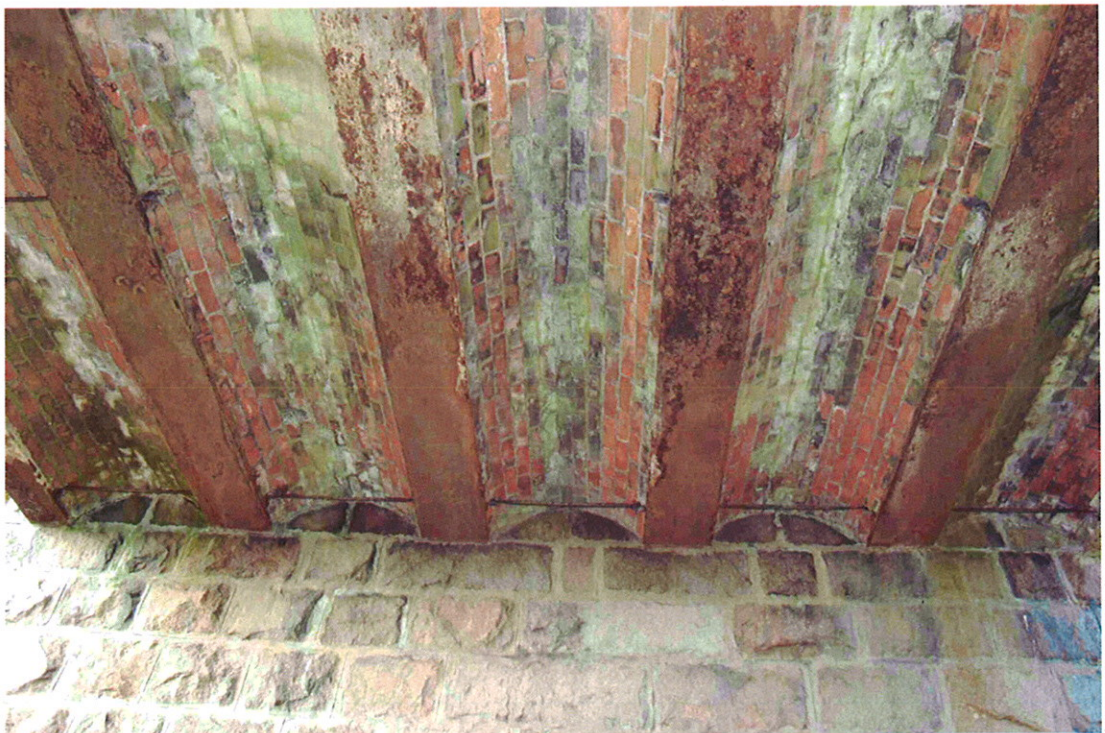
The second and third internal girders from the west edge have the most corrosion, with approximately 10% loss of section to the bottom flange. (Photo 4)

The tie bars are heavily corroded. (Photo 5) The mid-span bars have all corroded away. Those adjacent to the south abutment are severely corroded with little effective section remaining. Those near the north abutment have severe thinning at their contact with the brickwork. (Photo 4)

The tie bars are badly corroded and do not meet requirements.

Photo 4 – Internal cast iron girders and jack arches (Note missing tie-bars)

To permit continued normal traffic use, it is recommended that temporary barriers are installed to prevent loading of the edge bays until the tie bars can be replaced.

To achieve full 24 ton C&U capacity, it will be necessary to replace the tie bars with suitable tensioned bars between the bottom flanges of the girders in the outer bays.

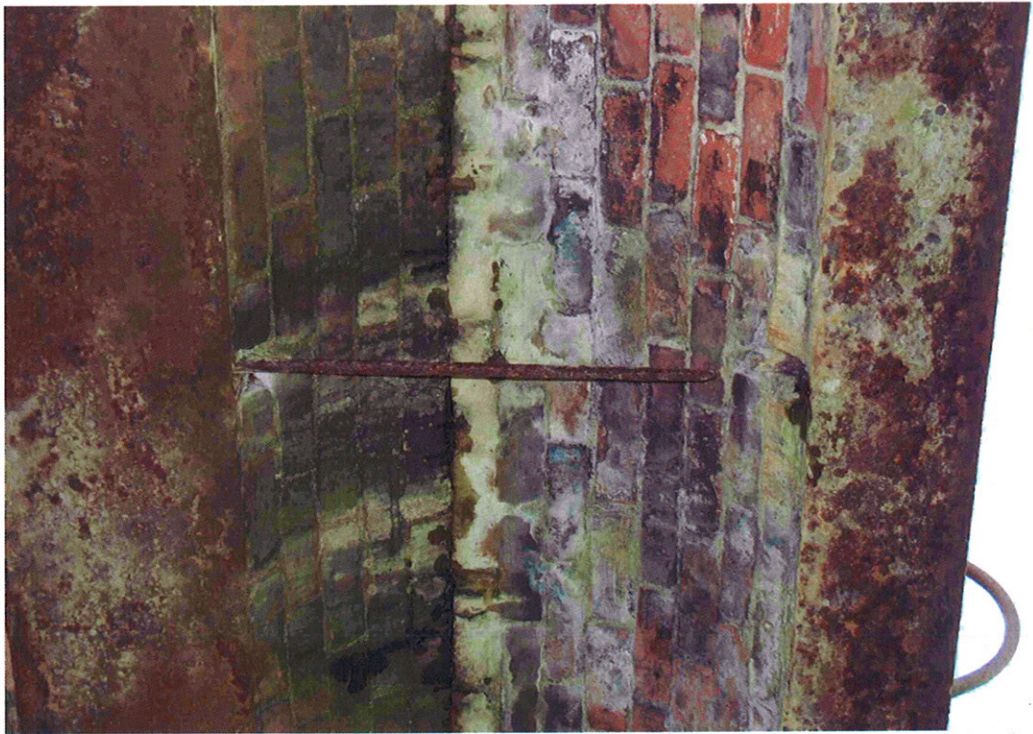
Girder capacity is satisfactory for full C&U loading, but the tie bars are badly corroded and in many cases completely lost. The bridge capacity would be satisfactory if the tie bars were replaced.

Photo 5 – Corroded tie bar by east edge girder

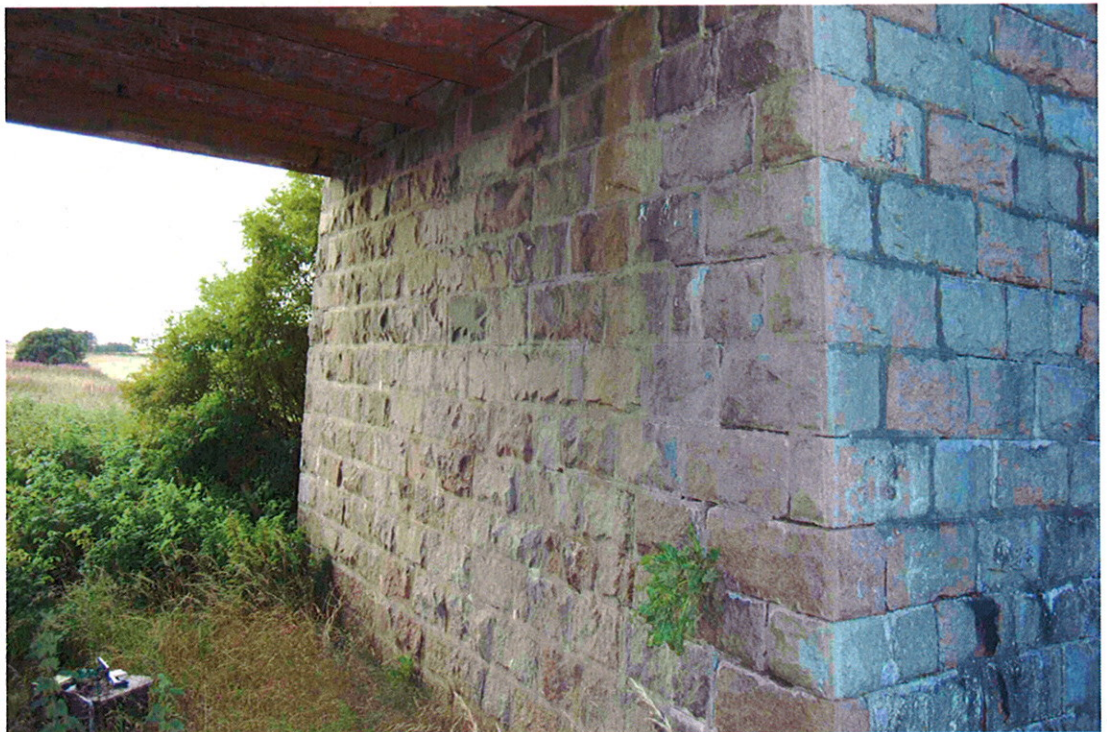
On the north abutment there is some deep mortar loss in the lower courses at the north east corner and one or two of the blocks may be loose.

Photo 6 – North abutment

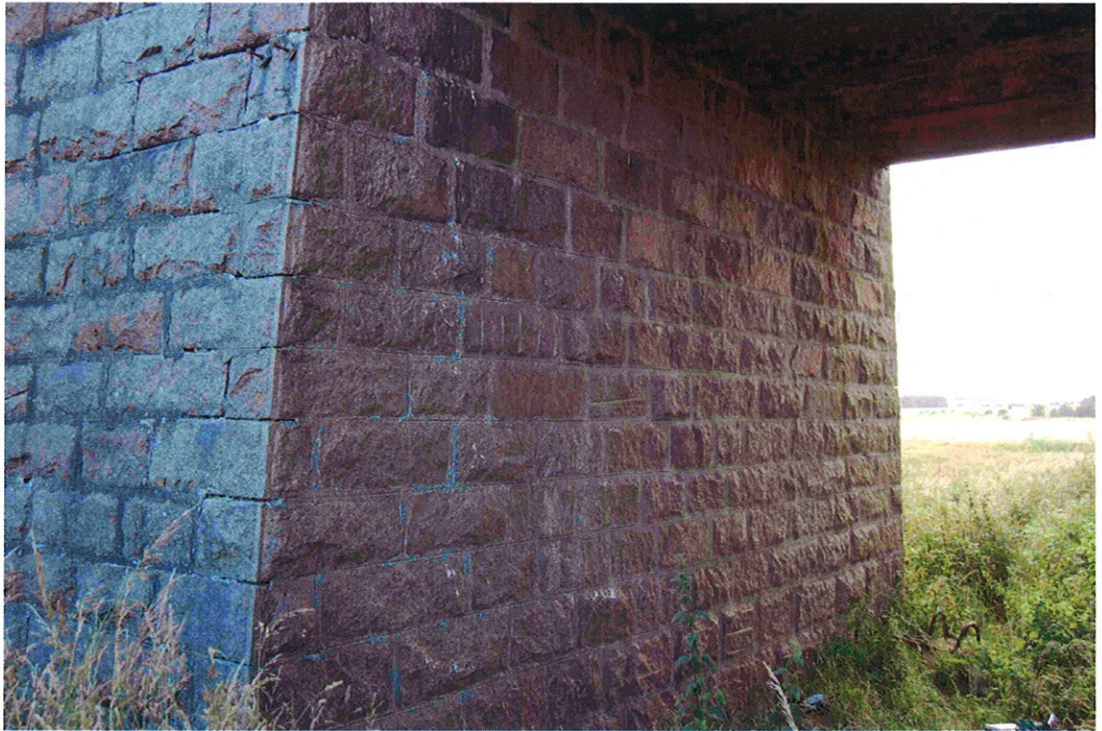
On the south abutment there is some minor cracking and mortar loss at the south west corner.

Photo 7 – South abutment

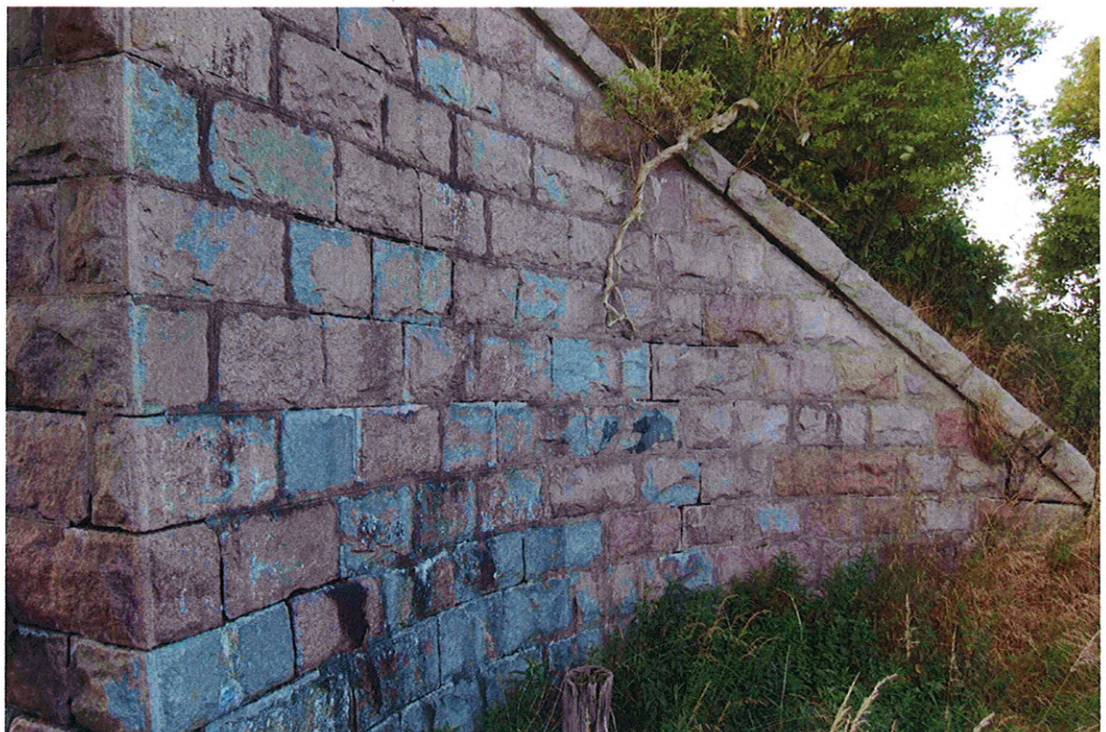
The north east wingwall displays minor mortar loss intermittently. The copings are intact. There is some dislocated masonry at the outer end of the wall. (Photo 8)

Photo 8 – North east wingwall

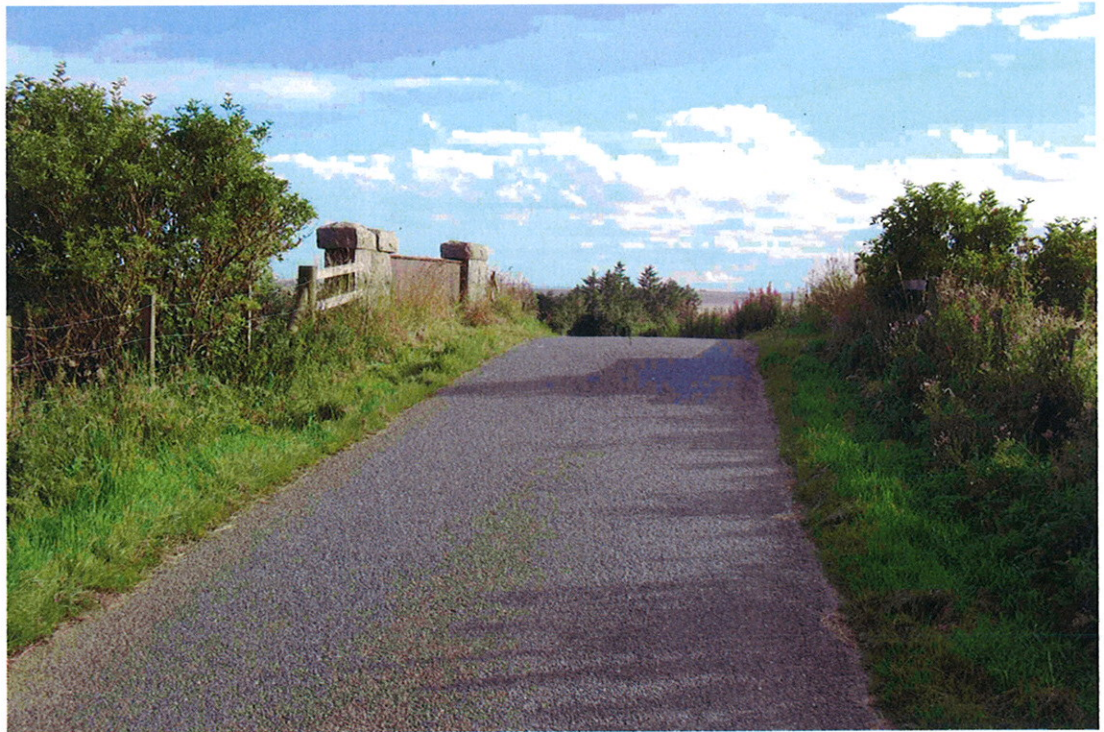
The road surface is in good condition with no observed defects. There is a pronounced vertical curve over the bridge.

Photo 9 – Road over the bridge looking south

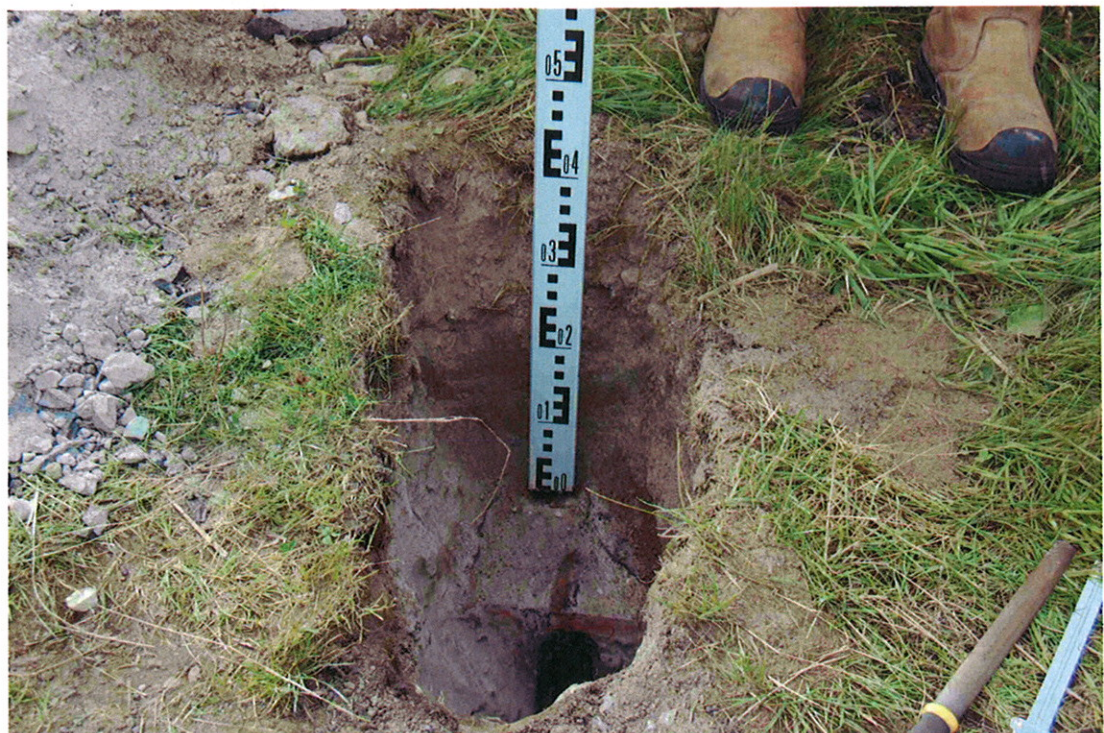
Structural Soils Ltd excavated a trial pit in the verge at the west side of the carriageway exposing the top flange of second longitudinal girder.

Photo 10 – Trial pit exposing top flange of CI girder and concrete infill
