RAIL PROPERTY LTD

ASSESSMENT AND INSPECTION REPORT

WHITCHURCH BRIDGE, BRISTOL

OVERBRIDGE REF: FNS-3/19m76ch

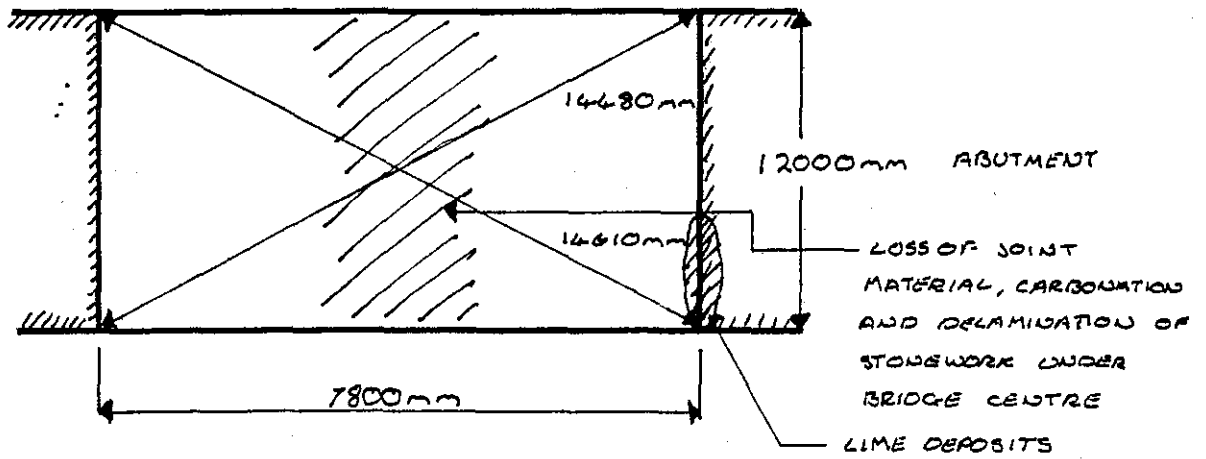
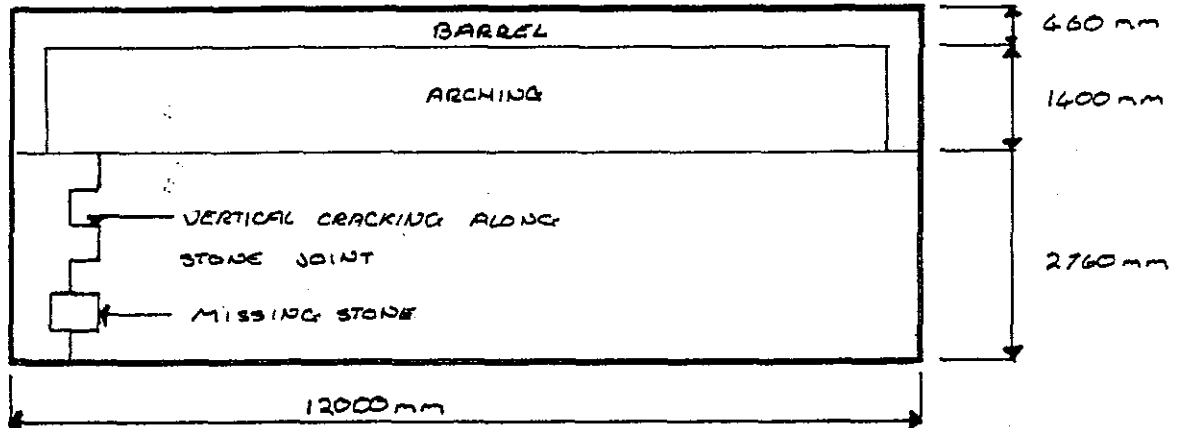
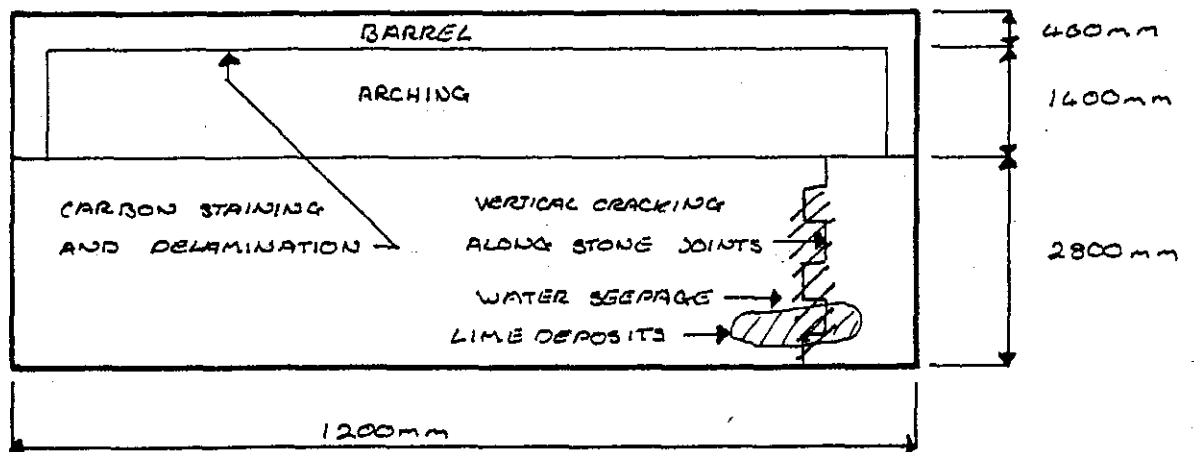
The abutment walls and wingwalls are formed by large coursed stonework and are generally in poor condition. There are areas of staining, water seepage and joint erosion. A large crack was observed at the east end of the south wall and lime deposit on the east end of the north wall with similar cracking and location as that found at the south wall. The remaining lower parts of the walls were not accessible for examination, as the whole disused line has been filled with earth.

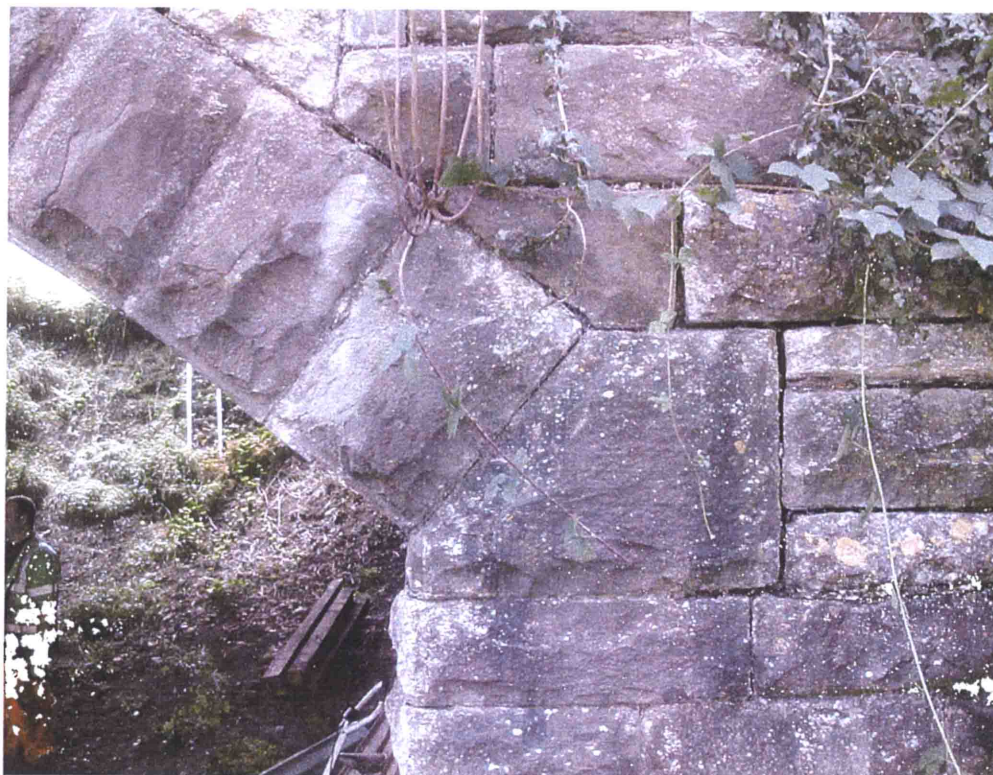
Photograph 4 View of northeast abutment showing mortar loss around the arch barrel and vegetation growth.

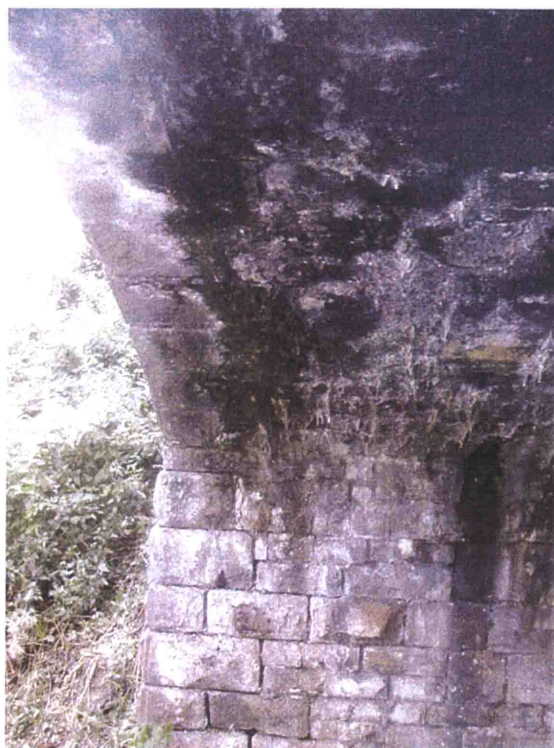
Photograph 9

View of west section of south abutment and arch ring showing extensive mortar loss and staining indicating water seepage at springing

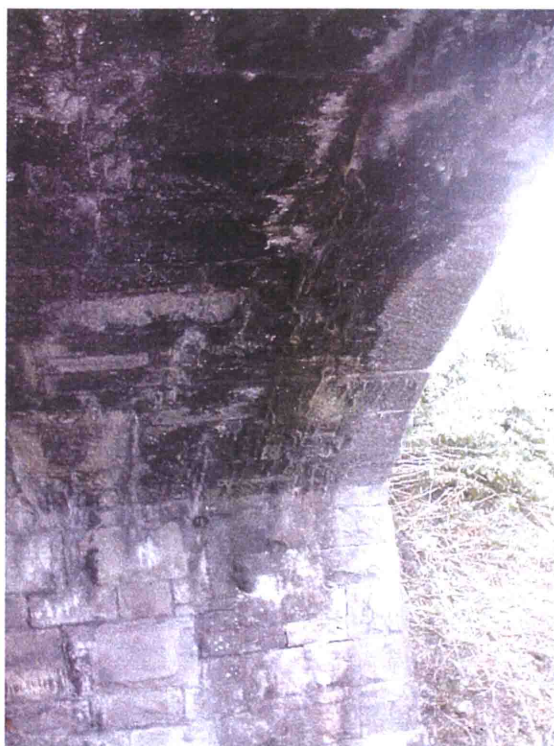
Photograph 10

View of west section of north abutment and arch ring showing extensive mortar loss and staining indicating water seepage at springing

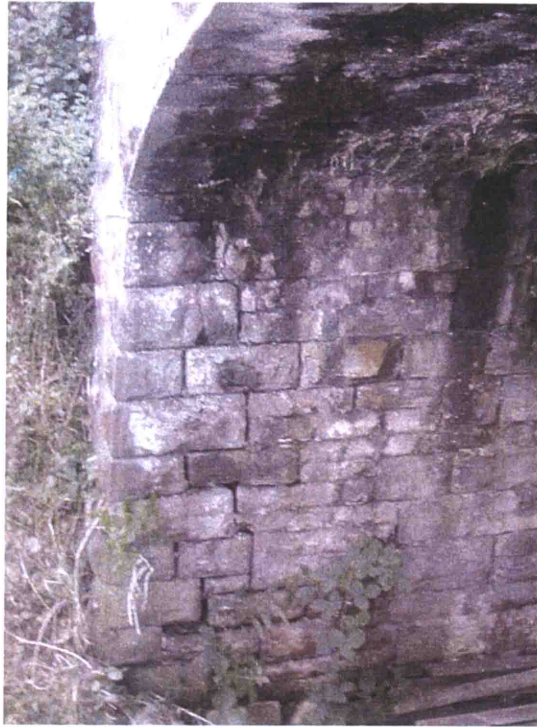
Photograph 11

View of west section of south abutment showing extensive mortar loss and staining indicating water seepage at springing

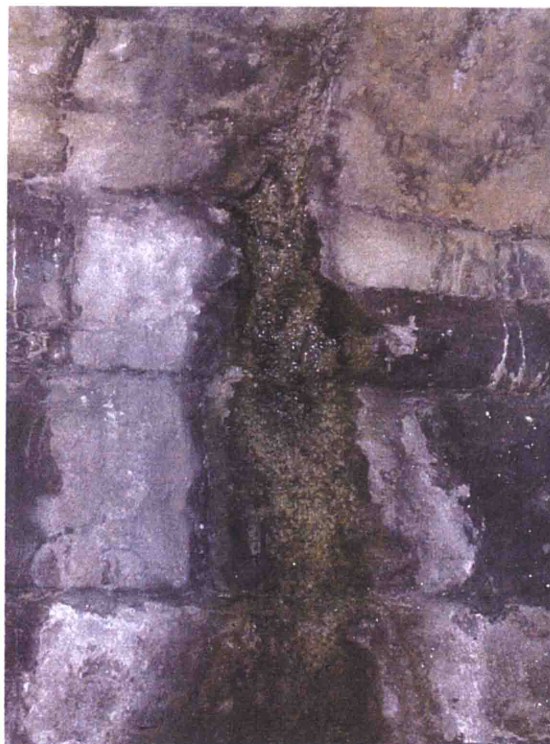
Photograph 12

View of springing level at the north abutment exhibiting evidence of water seepage.

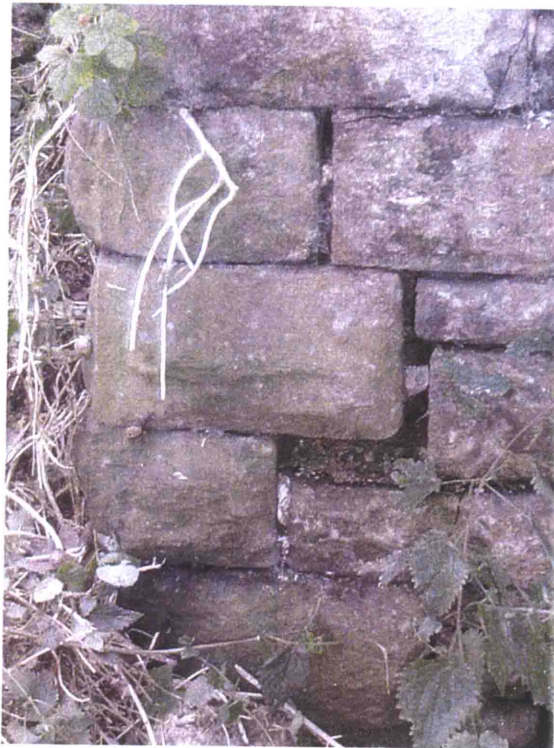
Photograph 13 Close up of west section of south abutment showing extent of mortar loss

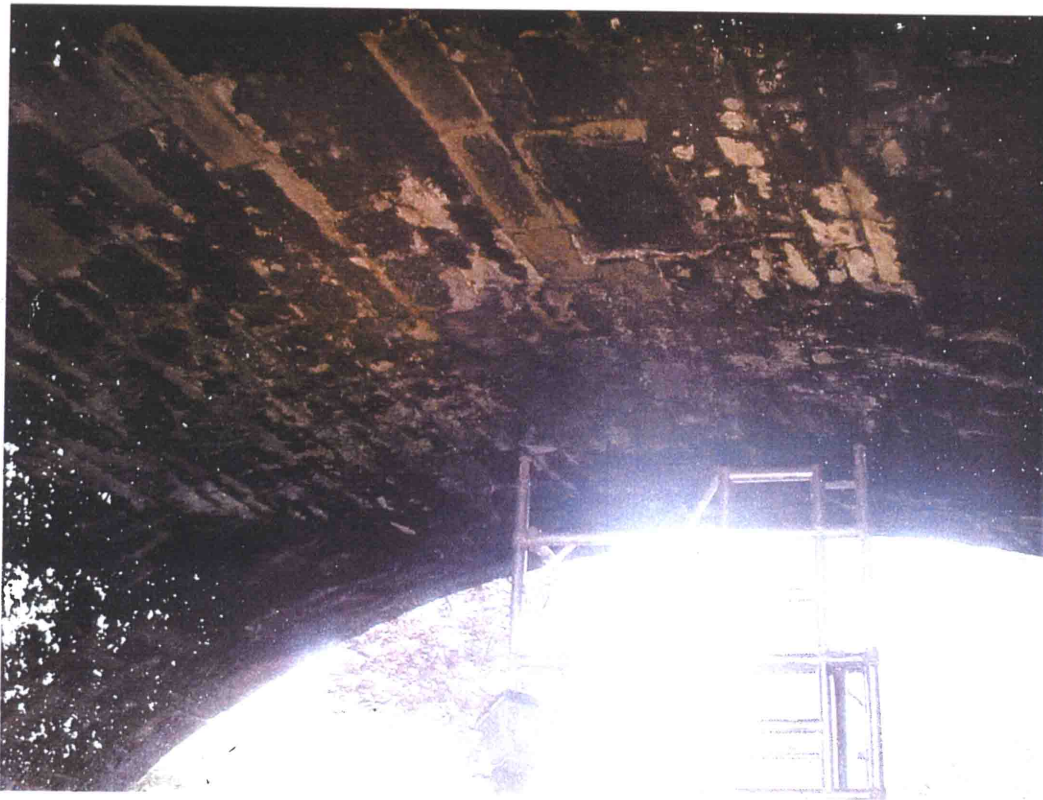
Photograph 14 View of east section of soffit of arch barrel exhibiting widespread mortar loss and staining due to extensive water seepage

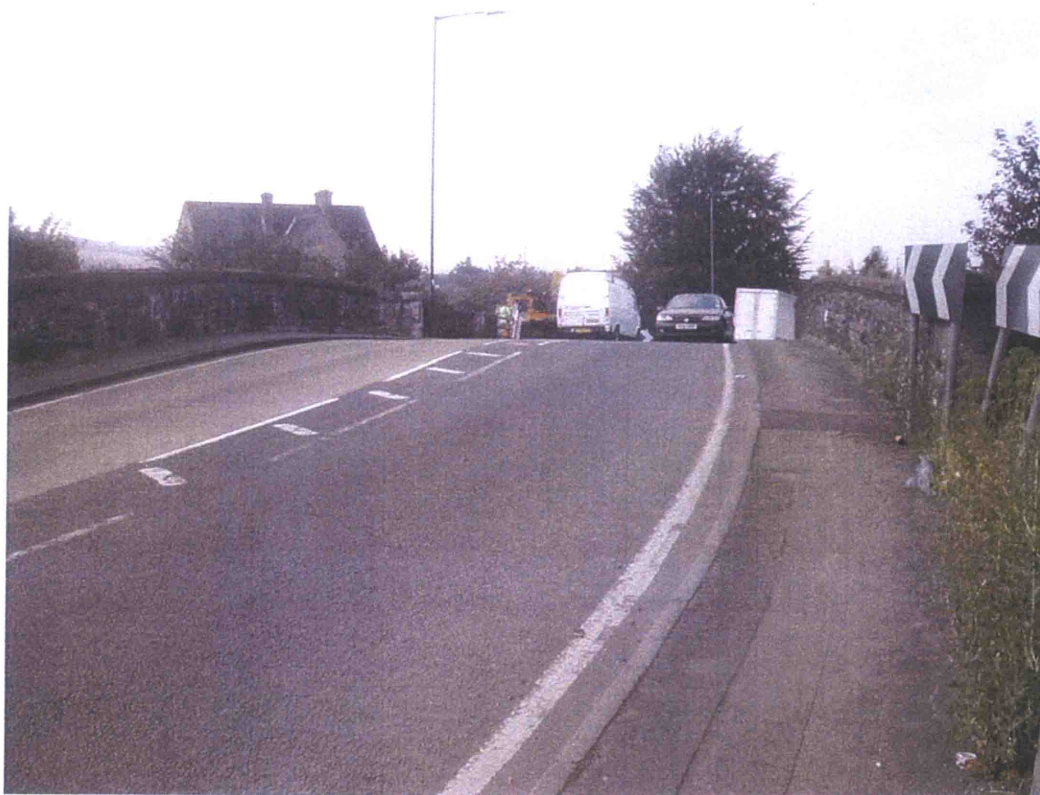
Photograph 17 General view of carriageway (shows likelihood of axle lift off)
