Major Works Programme 2009 - 2012

BE4 ASSESSMENT & INSPECTION REPORT

**Stubbs Road, Walden Stubbs,
North Yorkshire**

BRIDGE REF: HBR3/123

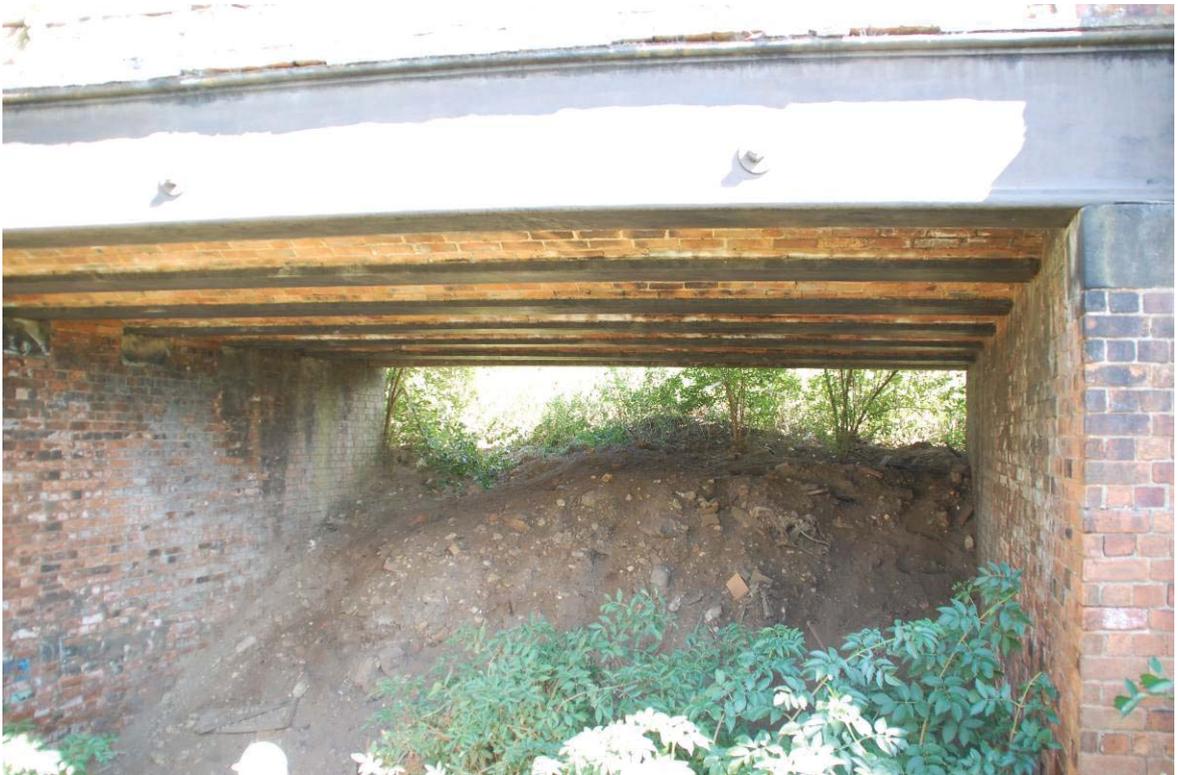
Photo 1 – West Elevation

The west parapet has a stepped fracture to the inside face. The outside face has loose and missing brickwork above the top flange of the edge girder. The outside face also has minor vegetation growth. The parapet is generally in fair condition with all coping intact.

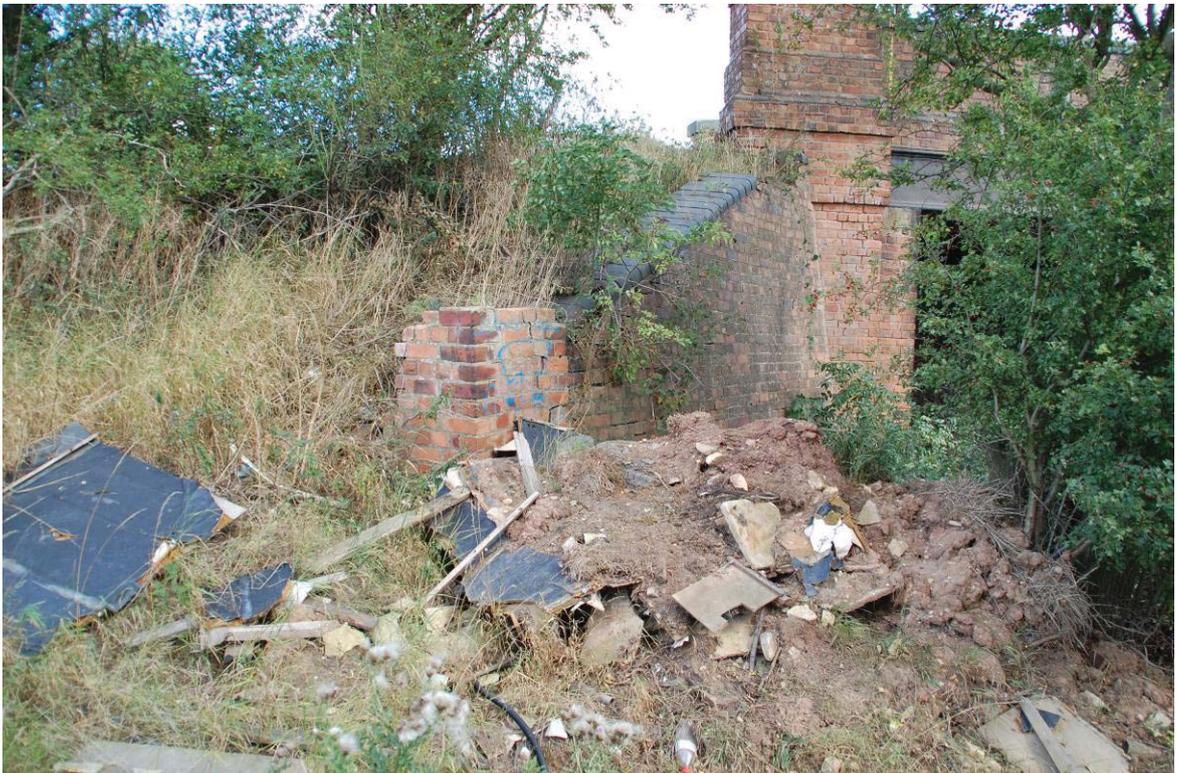
Photo 2 – North West wingwall / newel

The north west wingwall newel is in poor condition with fractures noted and a missing capping stone. The wingwall adjacent to the newel has loose bricks and missing mortar.

The above problems are sufficiently remote from the road that they will not affect the load carrying capacity of the wall.

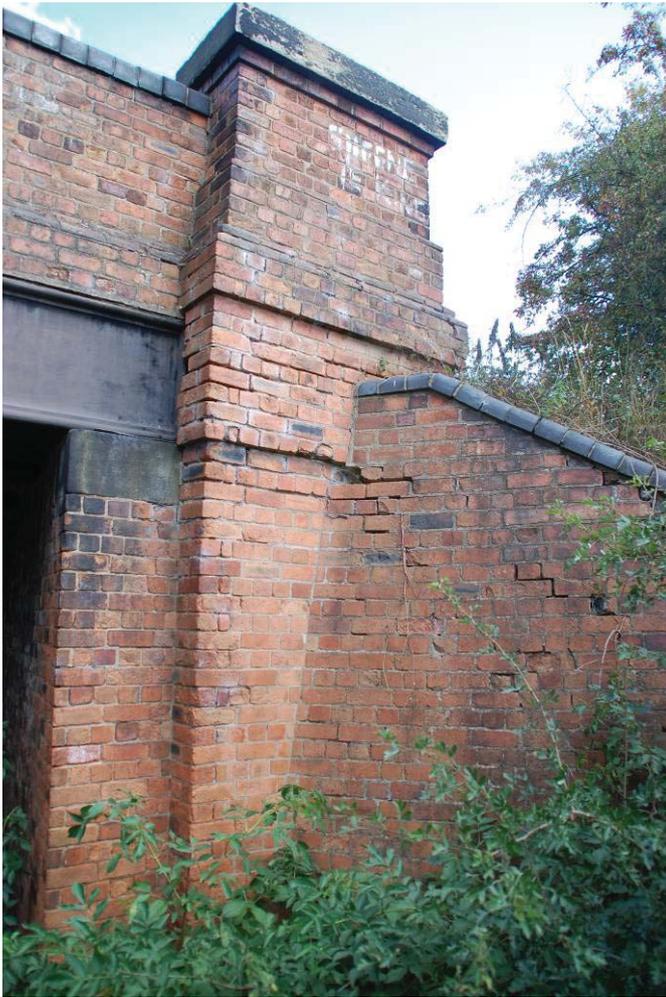
Photo 3 – South West wingwall / pilaster

The south west newel is in equally poor condition. There are areas of minor spalling and deep open joints to the adjacent wingwall.

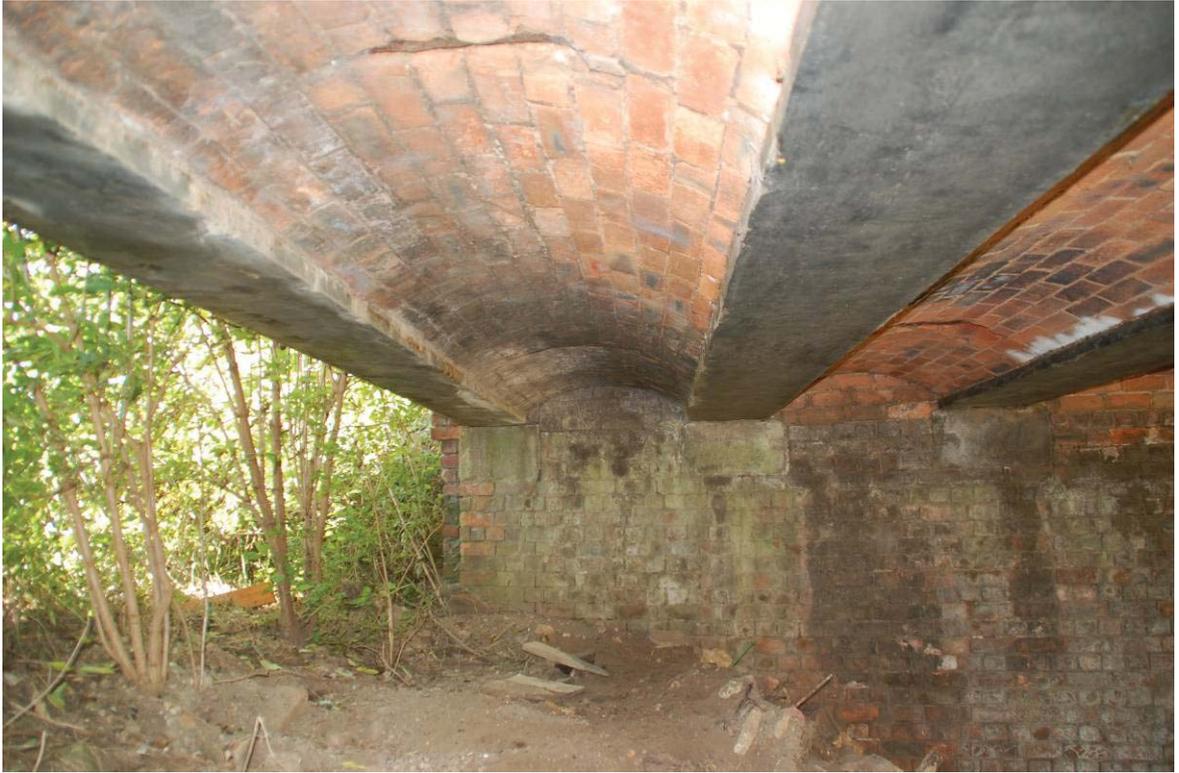
Photo 5 – East side jack arch

The inner jack arches are in good condition with localised mortar loss, calcite staining and spalling, mainly located around the tie bars. The outer jack arches are in equally good condition with only minor defects.

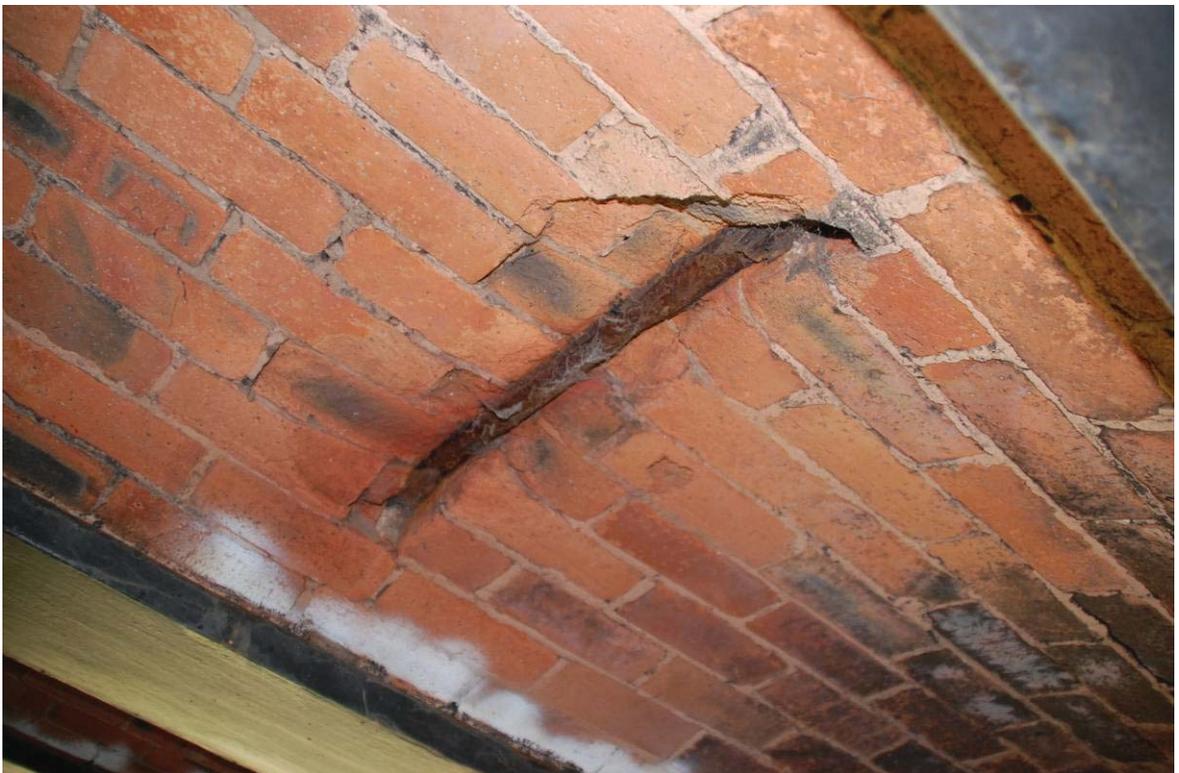
Photo 6 – Tie bar through jack arch

The three tie bars present through the lower section of each girder are 25mm (1") in diameter. Heavy corrosion was noted with an estimated 30-50% loss of section.

The jack arches fail according to the advice of the Bridgeguard Current Information Sheet No. 22 with regards to the strength of the ties in the edge bays. The current tie arrangements provide approximately 50% of the required 260mm²/m specific area. Approximately 50% of the original 1" diameter has been lost to corrosion.

The empirical assessment of the jack arches shows them to be non-compliant with the requirements stated by the Bridgeguard Current Information Sheet No. 22. The specific area of the ties falls well short of the recommendation. While recognising that the empirical assessment is written for the higher BD21 loading and there is no BE4 loading applied on the edge jack arches, in view of the extent of the deficiency it is considered prudent to add additional tie straps.

The additional ties, proposed as part of the jack arch strengthening should ensure the stability of the edge girders; however their condition should continue to be monitored as part of all future inspection works. Reduced tie provision does not currently appear to pose a danger to traffic.

Install additional ties straps in outer bays to meet specific area requirements in order to ensure stability of the edge girders and edge jack arches.

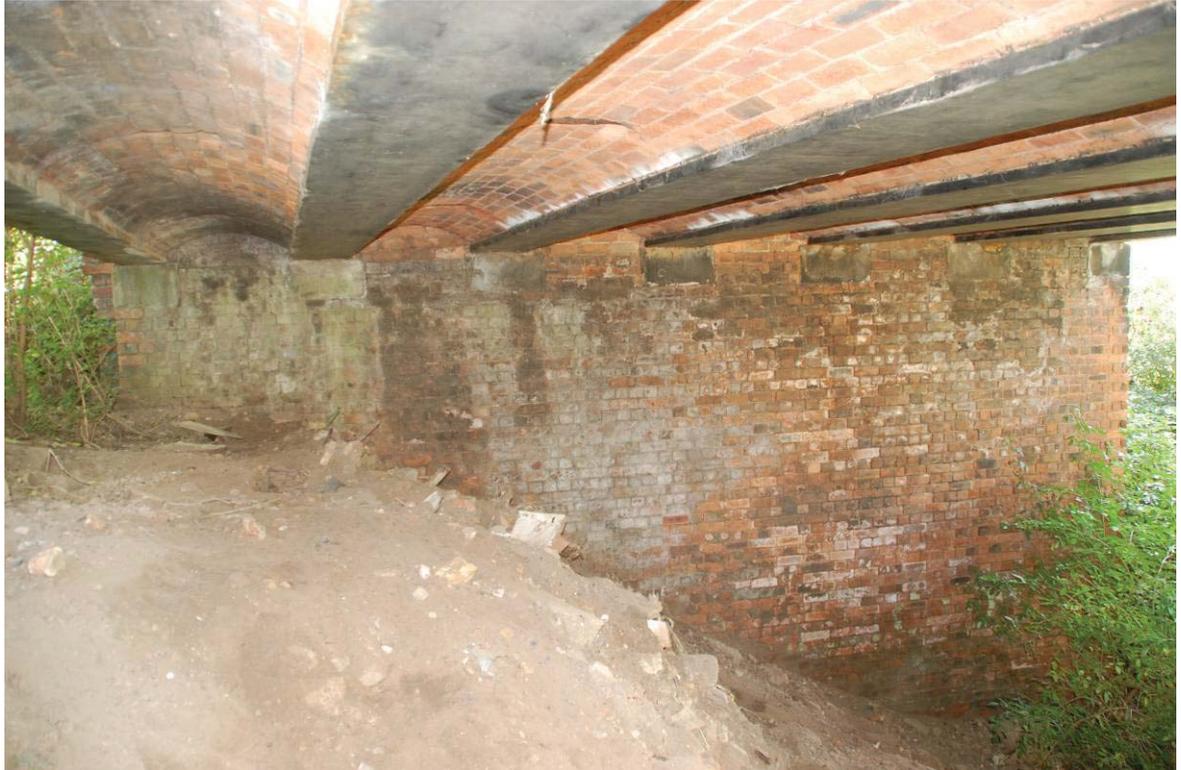
Photo 7– North side abutment

The abutments are partially infilled with only the central and western side visible for inspection. Brickwork is in good condition with some calcite staining

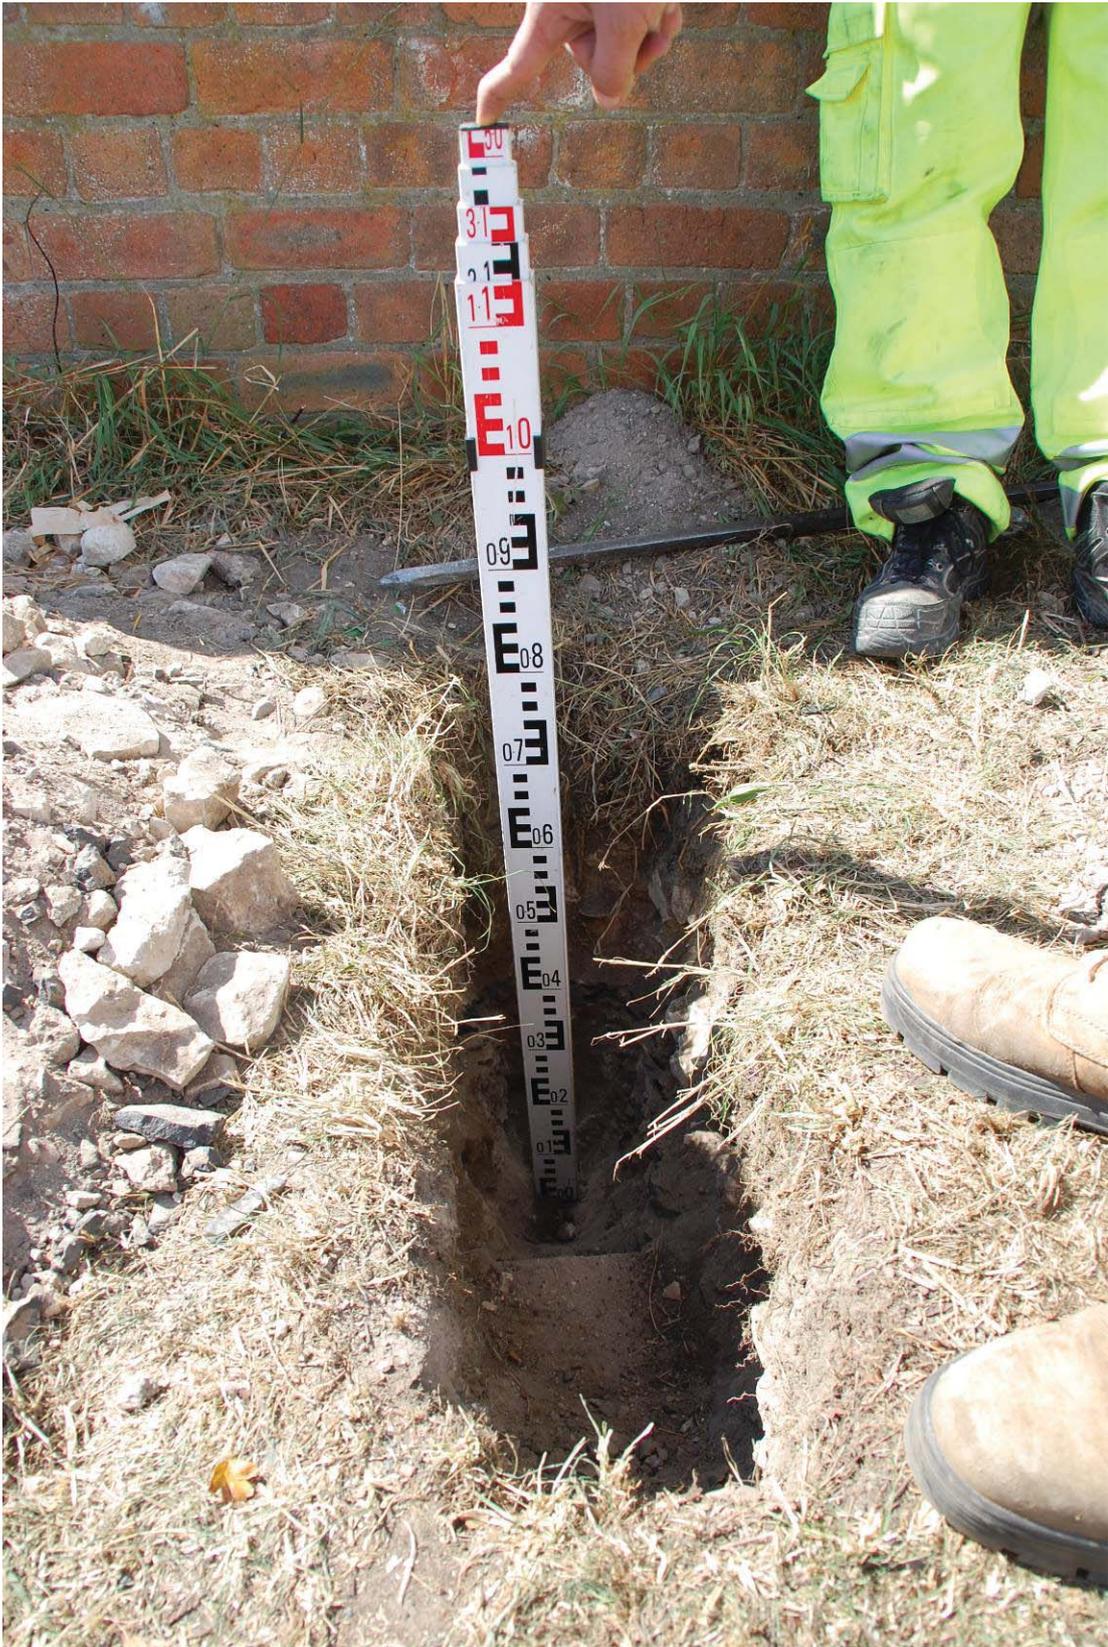
Photo 9– Trial pit

The trial pit exposed a dense concrete backing above the jack arch which encases the internal girders up to a depth which is 95mm below the top flange. The upper 95mm of the internal girders web and the top flange are both embedded within compacted, friable clay material which lies on top of the concrete backing (Refer to Logging data for Trial Pit in Appendix C).
