Southill Road Railway Bridge

No. HIB27

Assessment Report

ASSESSMENT OF BRB BRIDGES IN BEDFORDSHIRE
SOUTHILL ROAD RAILWAY BRIDGE (HIB27)
AMENDED ASSESSMENT

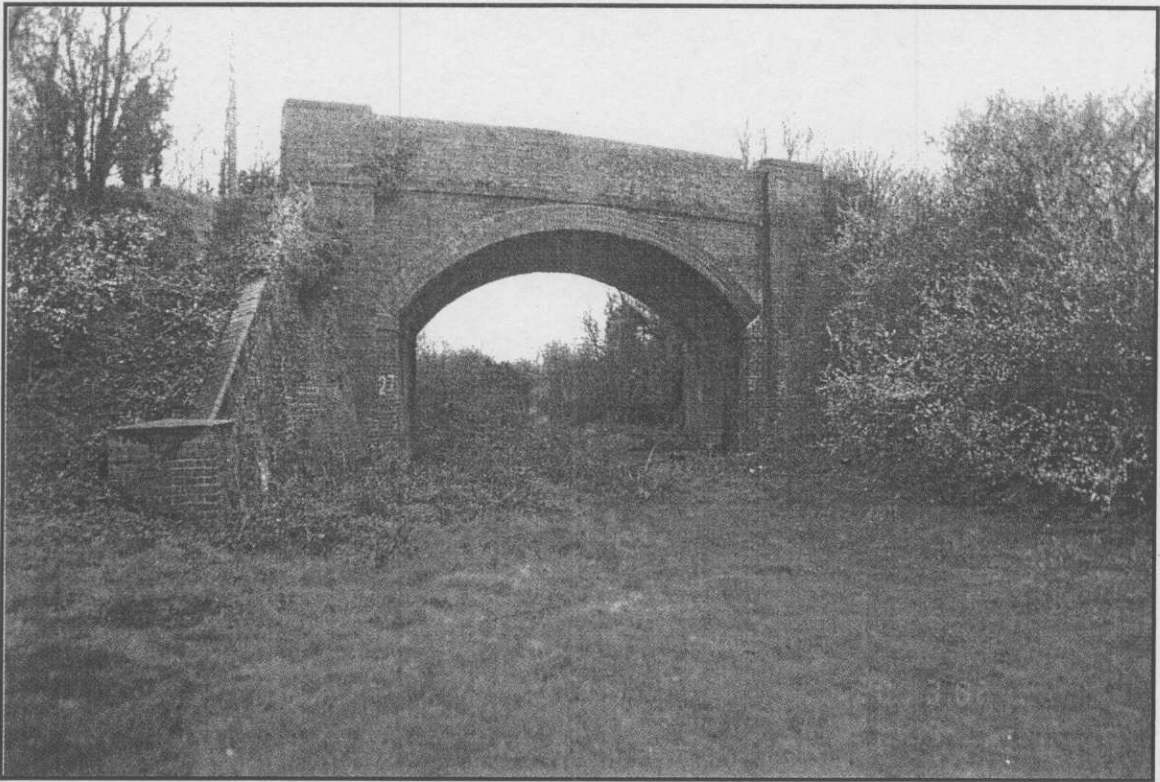
2.24.3 The east parapet has much spalling and poor joints, with much ivy growth in the joints. The north pilaster has a vertical crack 1mm wide and there are missing copings adjacent to the wall. The south end has some bulging with the spandrel wall below and there is vegetation growth at the south pilaster. There is a diagonal crack 1mm wide to the road face adjacent to the south pilaster (see plates 1, 19-21, 25, 27, 28 and 30).

Plate 1
East elevation

4.24.1 Remove ivy roots from the parapet brickwork, repoint joints, and replace spalled and displaced/missing bricks and copings to prevent further deterioration and restore parapet strength.

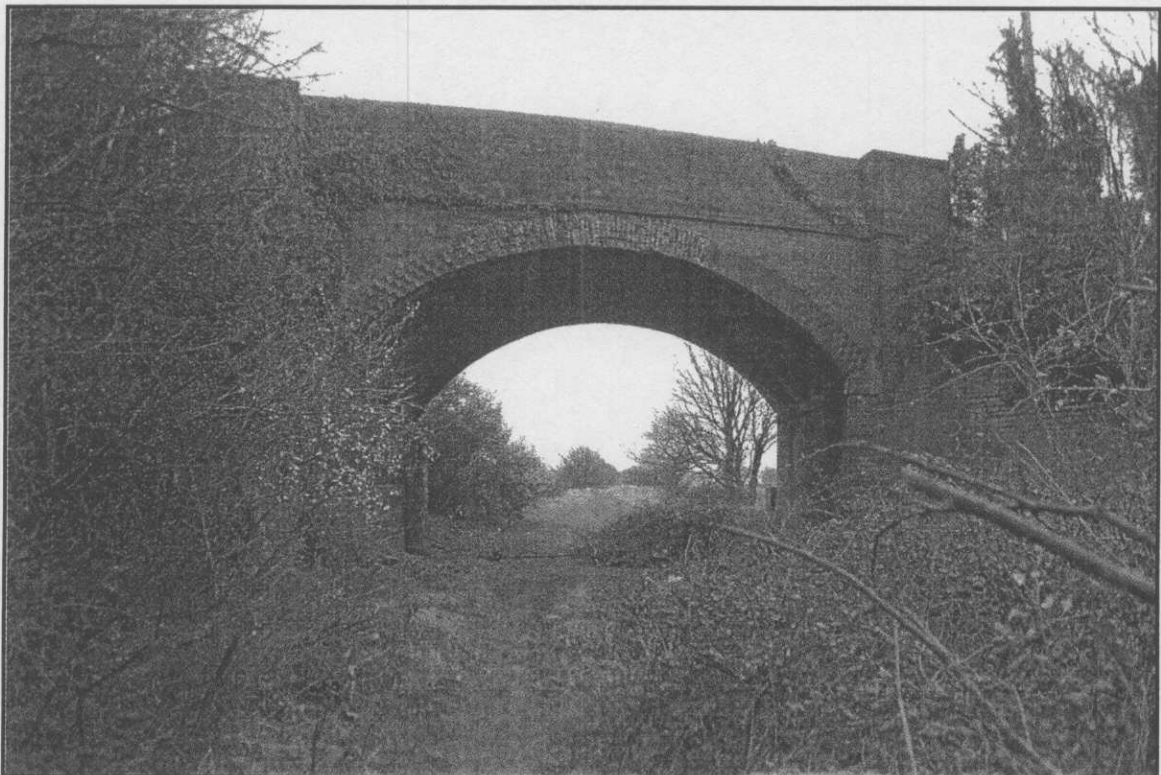
2.24.2 The west parapet has some spalled bricks and poor joints and has ivy growth to the ends. The north pilaster brickwork has cracking and is dislodged 20mm (see plates 2, 13 and 27-29)

Plate 2
West elevation

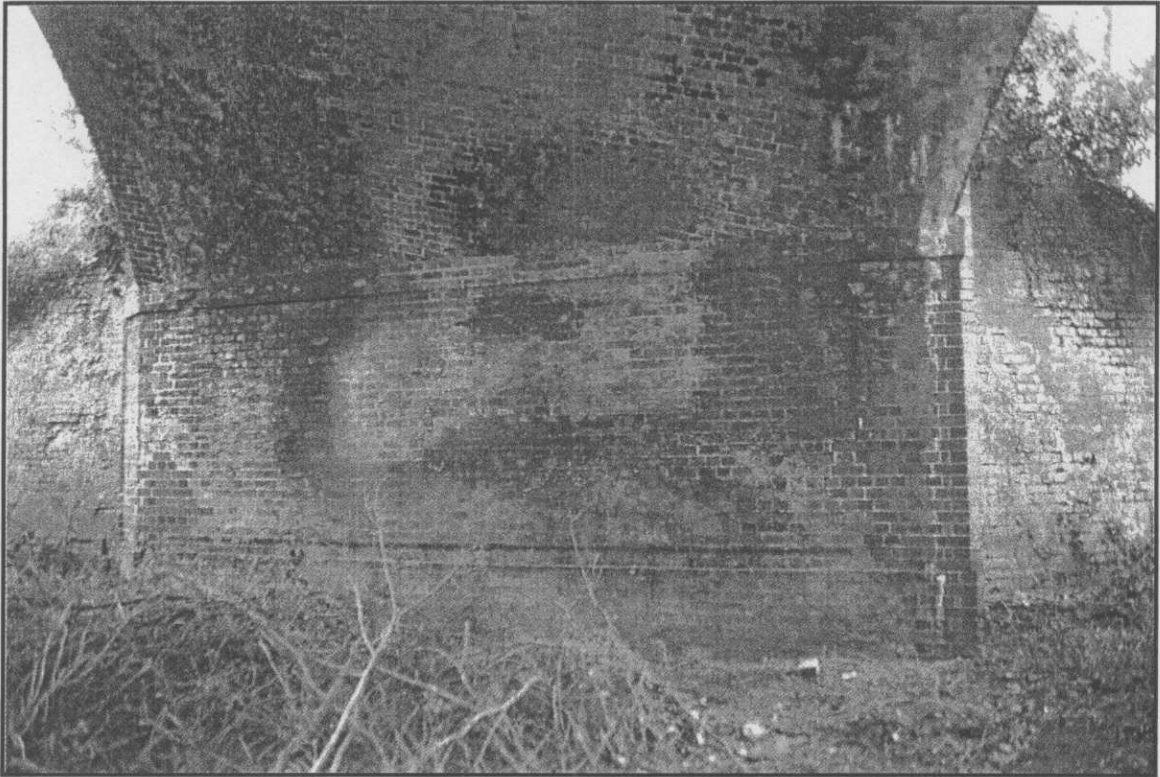
2.02.2 The invert has some debris present, including the missing copings from the parapet, and there is evidence of fires adjacent to the abutments (see plates 1-5).

2.05.2 The south abutment has a vertical hairline crack 0.85m from the east end for much of the height. There is a diagonal hairline crack from the stringcourse 0.6m from the east end running down to the abutment end at half height then horizontally into the east face and pilaster 1-2mm wide. There is a large area of hollow sounding brickwork west of centre, which may be fire damage. There is some spalled and hollow sounding brickwork to the east end base. The west face has a horizontal crack 1mm at the base plinth and a horizontal hairline crack at the springing, both extending into the pilaster. The pilaster has a further horizontal crack 1-2mm wide towards the top (see plates 3 and 4).

Plate 3
South abutment

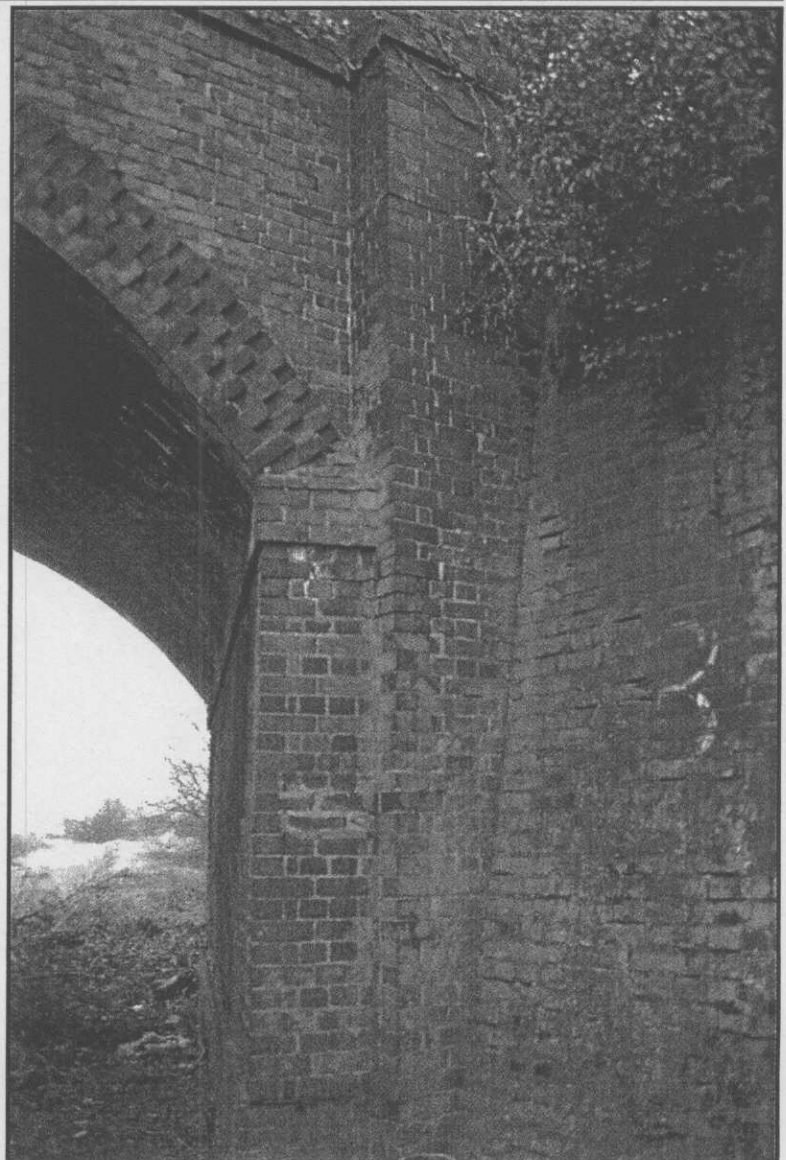
Plate 4
South abutment west end

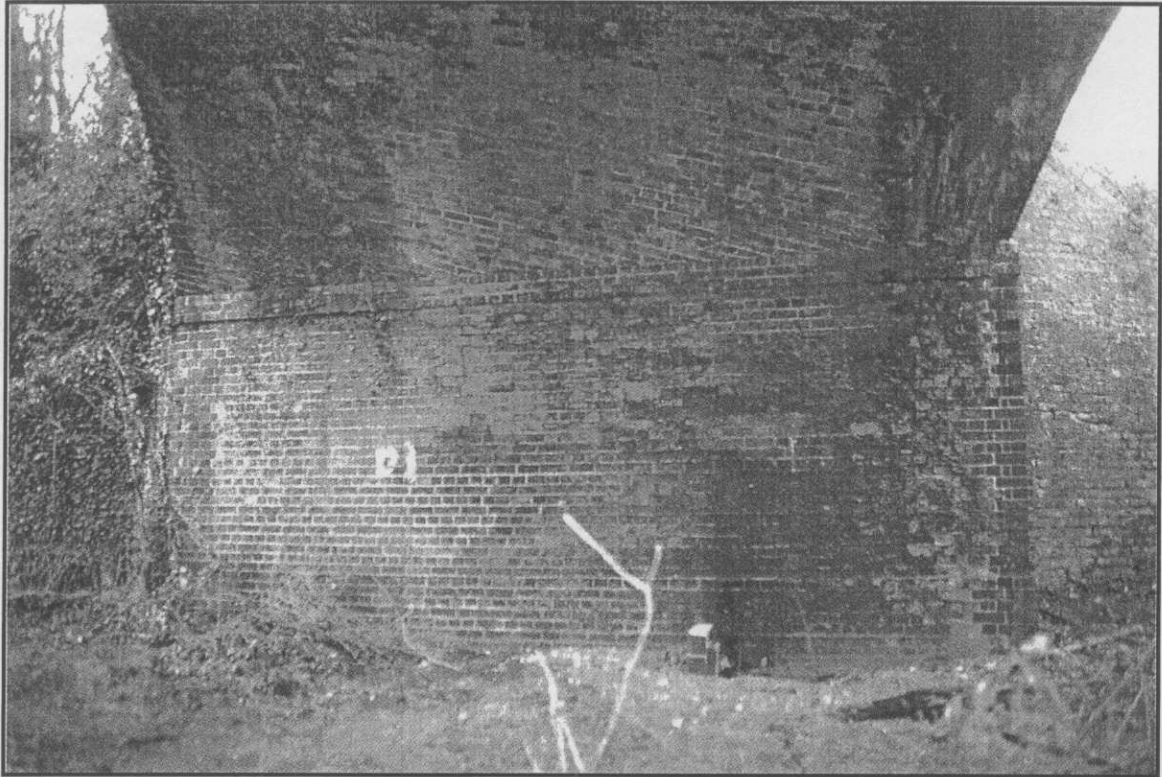
2.05.3 The north abutment has a vertical hairline crack west of centre for the full height extending into the arch. There is a vertical crack towards the west end at half height which extends horizontally to the west end just above the base plinth at 1mm wide. The west end has some ivy growth. The east end has two vertical hairline cracks over the centre, one running horizontally at half height into the east face and pilaster, joining a vertical hairline crack. The east end brickwork is spalled and hollow sounding and has seepage deposits. The east face has a horizontal crack 1-2mm wide at springing level running through the pilaster and vertically up the wingwall joint. The west pilaster is overgrown with ivy (see plates 5 and 6).

Plate 5
North abutment

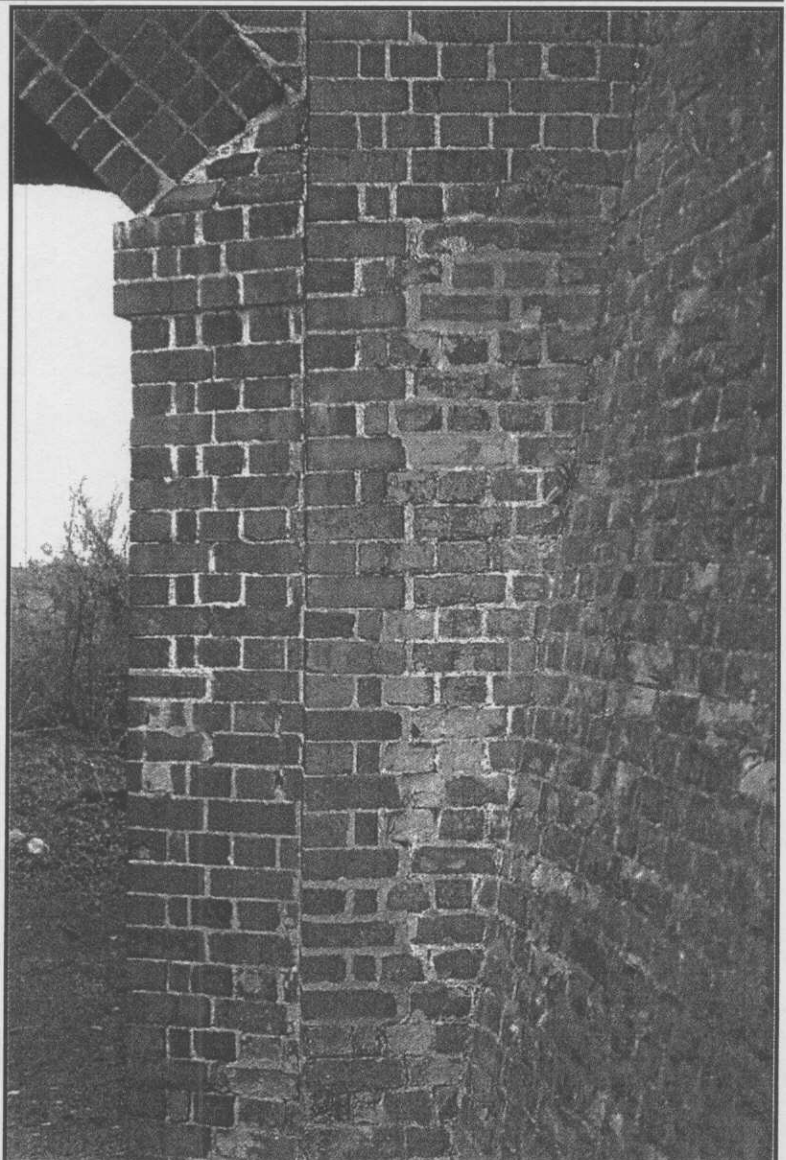
Plate 6
North abutment east end

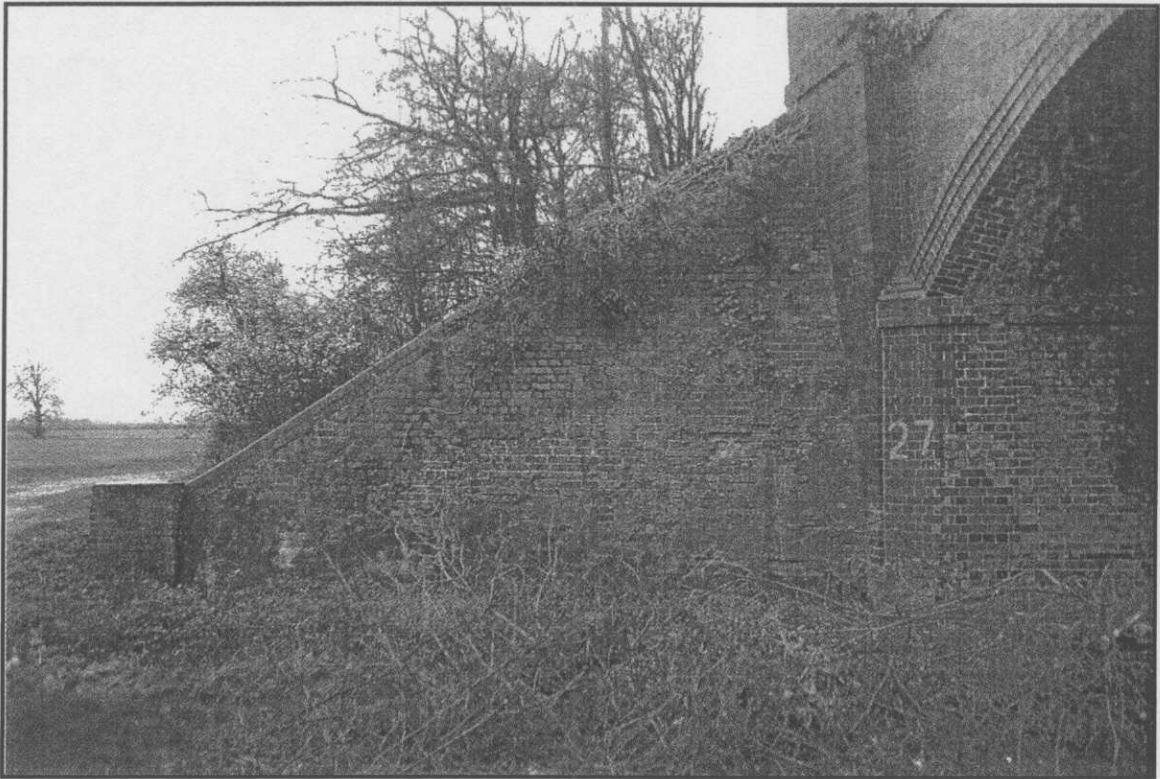
2.06.2 The southeast wingwall/pilaster joint is cracked at the top 1mm wide. The top of the wall has much ivy growth. The centre has an area of surface spalling and hollow sounding brickwork, some spalling up to 100mm deep and a slight bulge. The base adjacent to the abutment has spalling up to 100mm deep (see plate 7)

- 3.03 The spalled brickwork and poor joints in the wingwalls would appear to be due to weathering and ivy growth, which should be repaired to prevent further deterioration.

Plate 7
Southeast wingwall

4.06.1 Remove vegetation, replace spalled/hollow brickwork and repoint to prevent further deterioration.

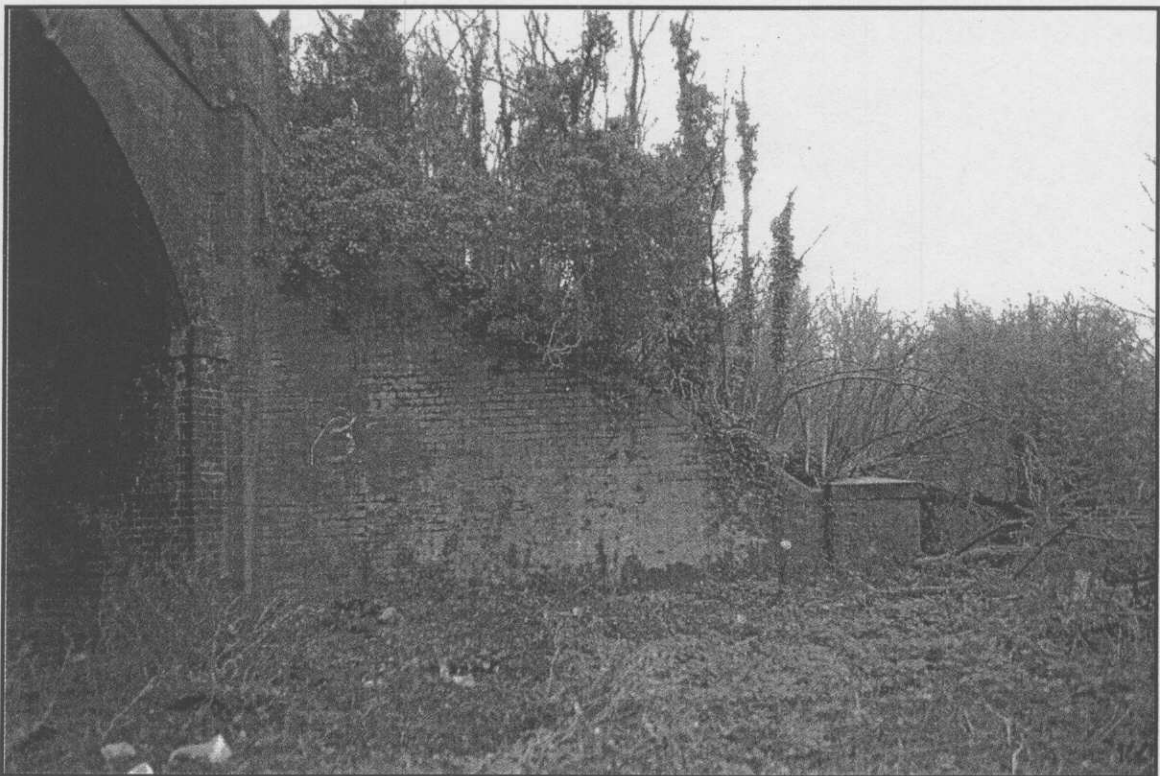
2.06.3 The southwest wingwall has a diagonal hairline crack emanating from the abutment joint at springing level running down towards the base. There is a horizontal crack at half height 2mm wide from the centre to the copings. The central area is bulging and hollow sounding (see plate 8).

Plate 8
Southwest wingwall

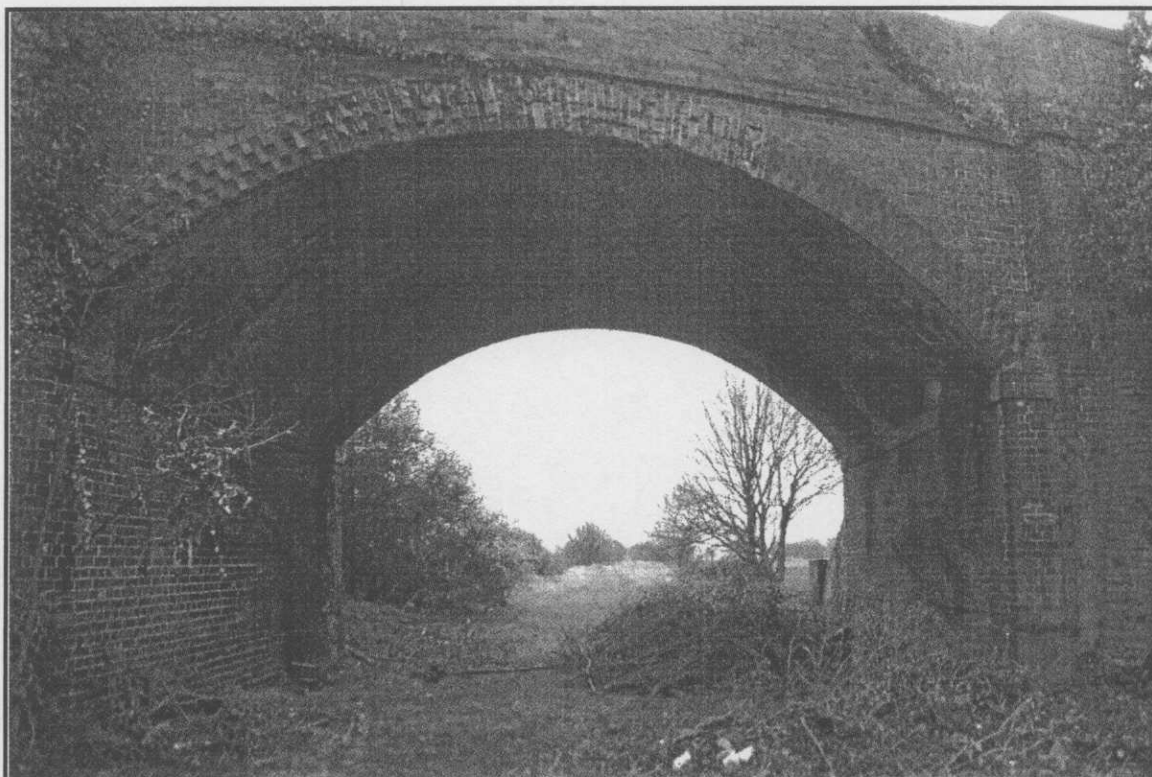
2.16.2 The arch west face original brickwork over the crown between the blue brick facing is all hollow sounding, cracked, spalled and loose. The face north of the crown is bulging 10mm. There is a crack around the barrel running from the south abutment at hairline wide, over the south $\frac{1}{4}$ point at 5mm wide, over the crown at hairline wide, over the north $\frac{1}{4}$ point at 3-4mm wide and finishing near the north abutment at hairline wide (see plates 11-16).

Plate 11
Elevation through arch from the west side

4.16.2 Replace brickwork to arch faces to prevent further deterioration.

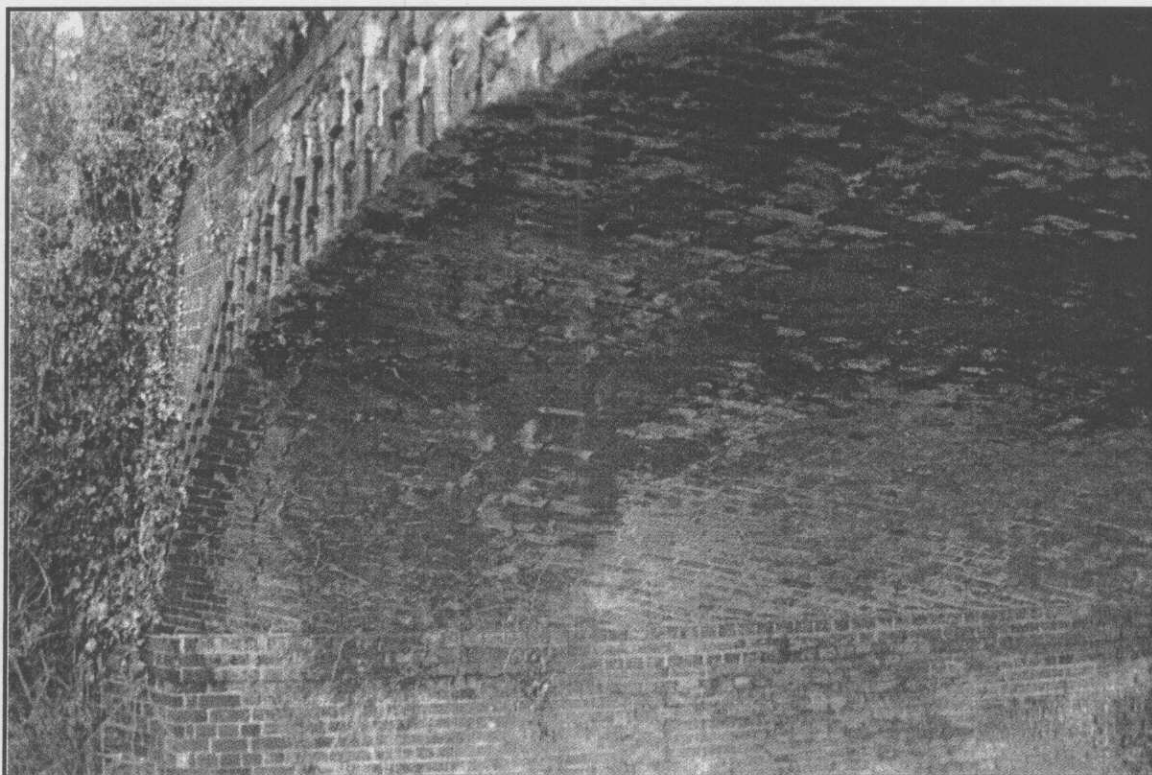
2.16.3 The arch intrados has a longitudinal crack 200mm from the west face, hairline at the north abutment, 3-4mm at the north $\frac{1}{4}$ point, 10mm at the south $\frac{1}{4}$ point and hairline at the south abutment. There is a crack running parallel 400mm from the face hairline at the crown, 2-3mm over the north $\frac{1}{4}$ point then running diagonally to the north abutment at hairline wide and a short crack 400mm from the face 1-2mm wide towards the south abutment. The west end over the crown has spalled bricks and the brickwork to the south side is hollow sounding. The northwest corner of the intrados has ivy roots in the joints. The west end has seepage deposits to both sides. There is a longitudinal crack at the centre 2-3mm wide running from the north abutment to south of the crown and a longitudinal hairline/0.5mm wide crack 0.6m west of centre from near the north abutment to near the crown. There is an area of eroded joints 20mm deep at the centre towards the north abutment. There is a longitudinal crack 240mm from the east face, hairline wide at the north abutment, 2-3mm at the north $\frac{1}{4}$ point, 3-4mm at the crown, 2-3mm at the south $\frac{1}{4}$ point then 440mm from the face running to the south abutment 2-3mm wide. The east end has seepage deposits to both sides and there is an area of spalled and hollow sounding brickwork at the south abutment (see plates 12, 14, 16-18, 20, 22 and 26).

2.17.2 The west spandrel/arch barrel joint is cracked from the south abutment at hairline wide, over the south $\frac{1}{4}$ point at 5mm wide, over the crown at hairline wide and at the north $\frac{1}{4}$ point 3-4mm wide, extending towards the north abutment at hairline wide. At the north $\frac{1}{4}$ point there is a horizontal crack 1-2mm wide running from the arch barrel/spandrel joint to the pilaster. The south side has a vertical crack south of the $\frac{1}{4}$ point from the arch barrel at hairline wide to the parapet stringcourse 2-3mm wide. There is a vertical hairline crack at the south pilaster joint from the parapet stringcourse to half height and continuing horizontally into the pilaster. The north end of the spandrel has ivy growth (see plates 12-15).

Plate 12
Arch and north abutment west end

4.16.1 Remove ivy roots from the west end of the arch intrados and repoint joints to prevent further deterioration.

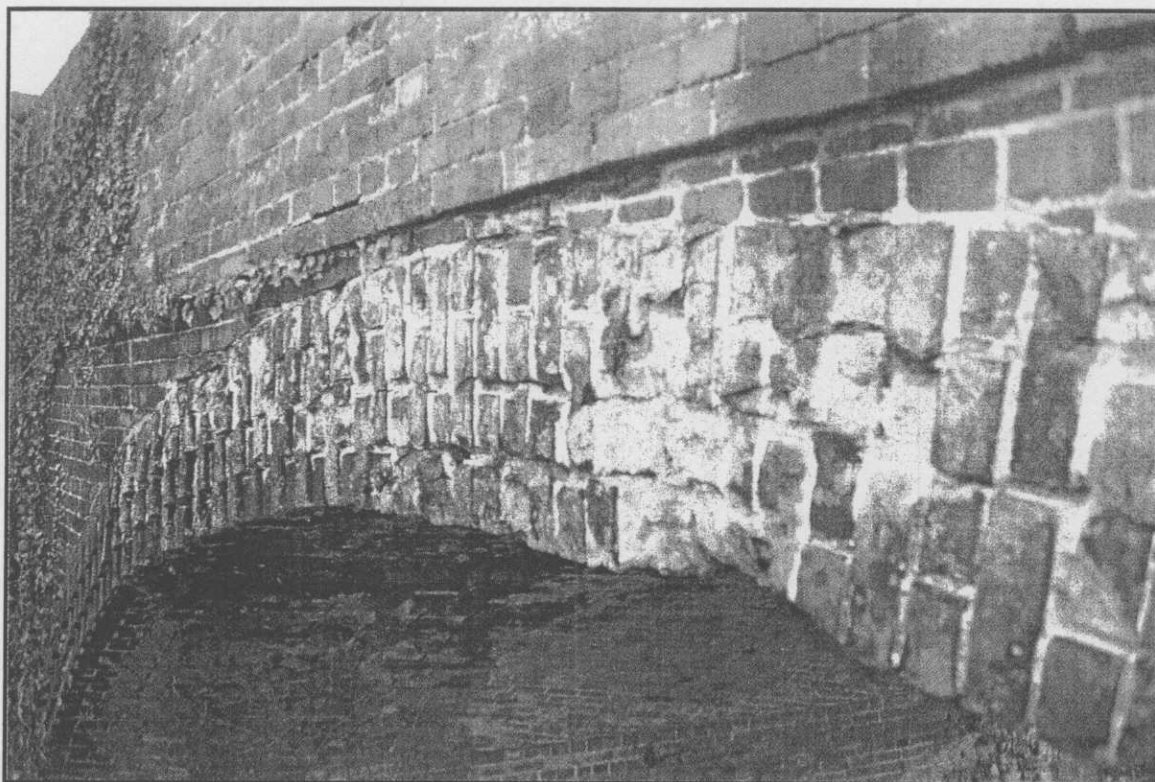
Plate 13
Arch west face north side

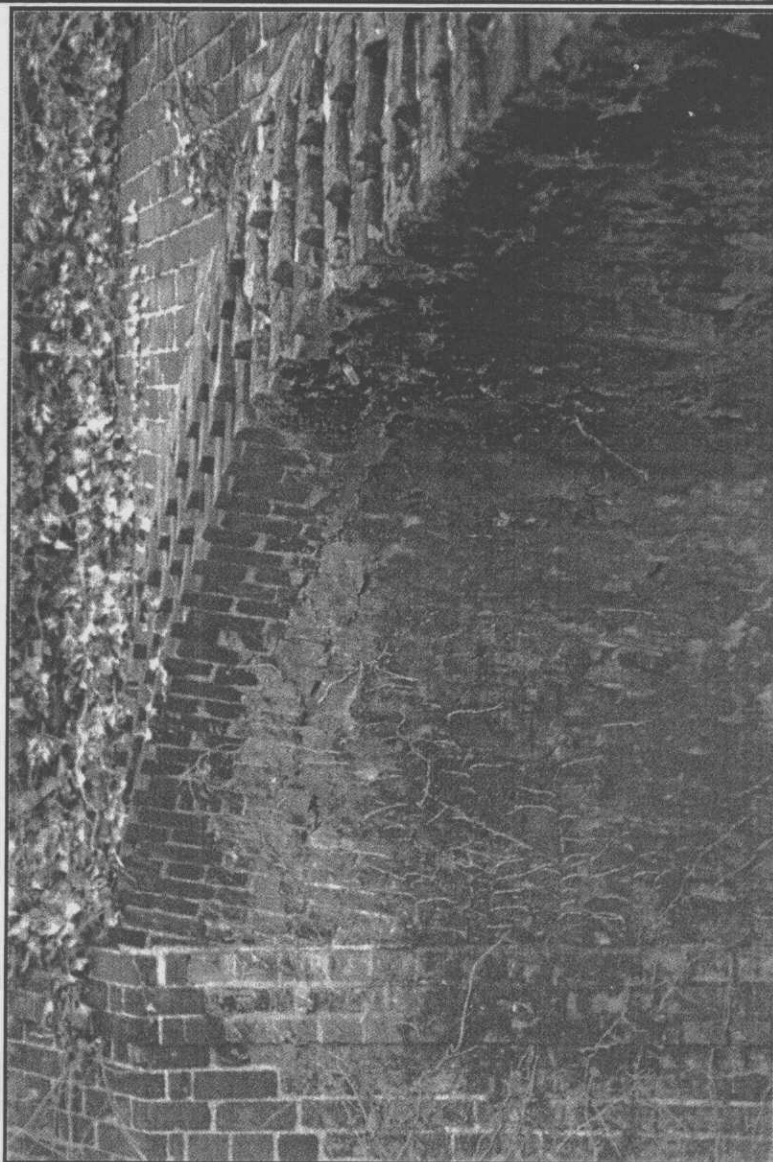
Plate 14
Arch west end over north
abutment

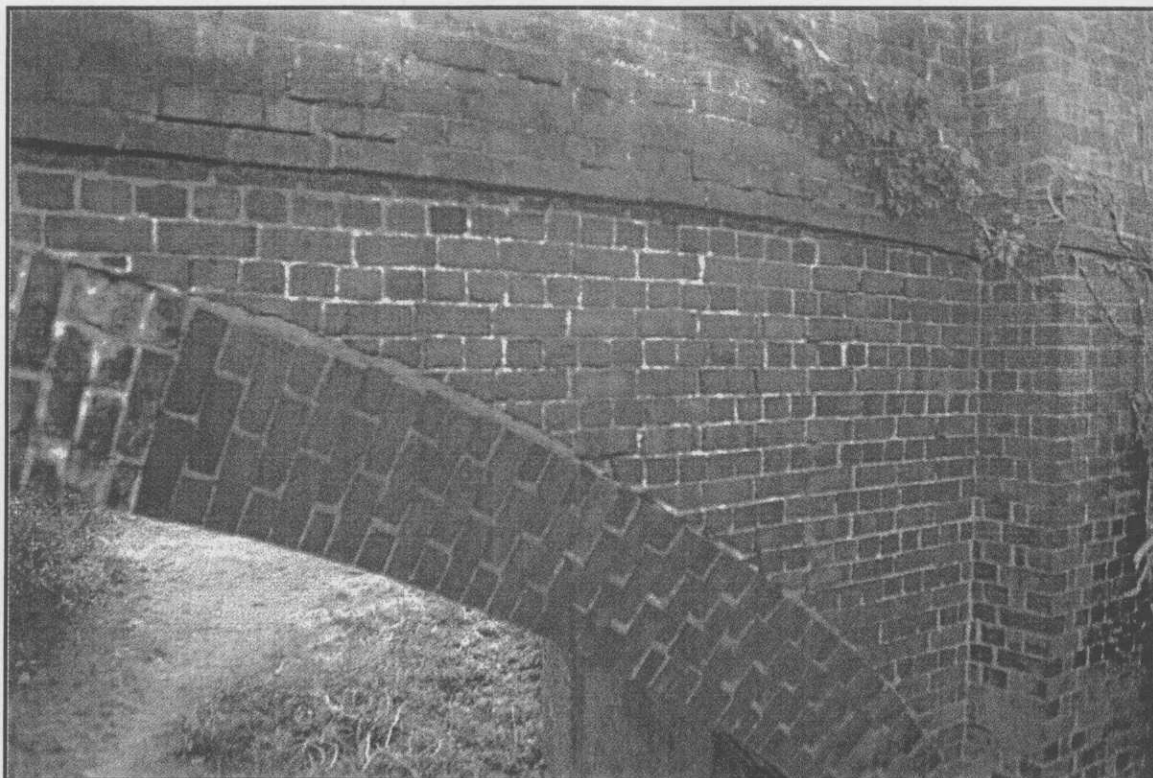
Plate 15
Arch west face and spandrel
south side

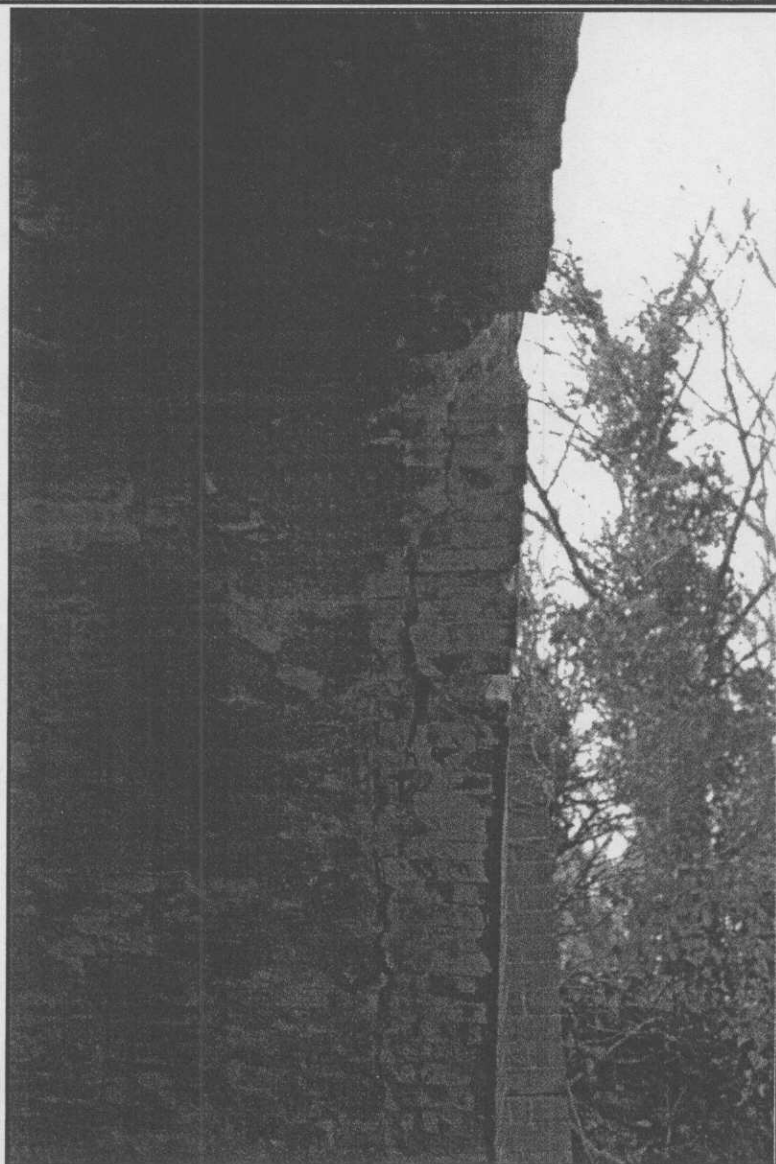
Plate 16
Arch west end over south
abutment

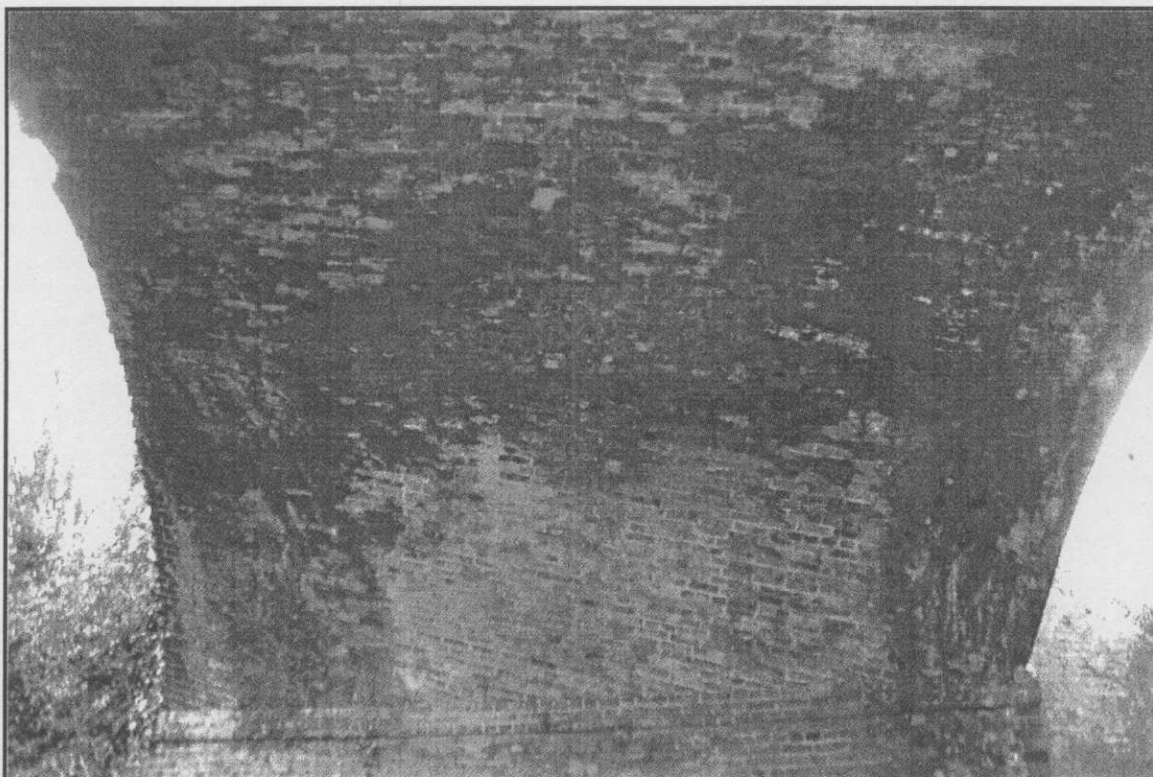
Plate 17
Arch north side

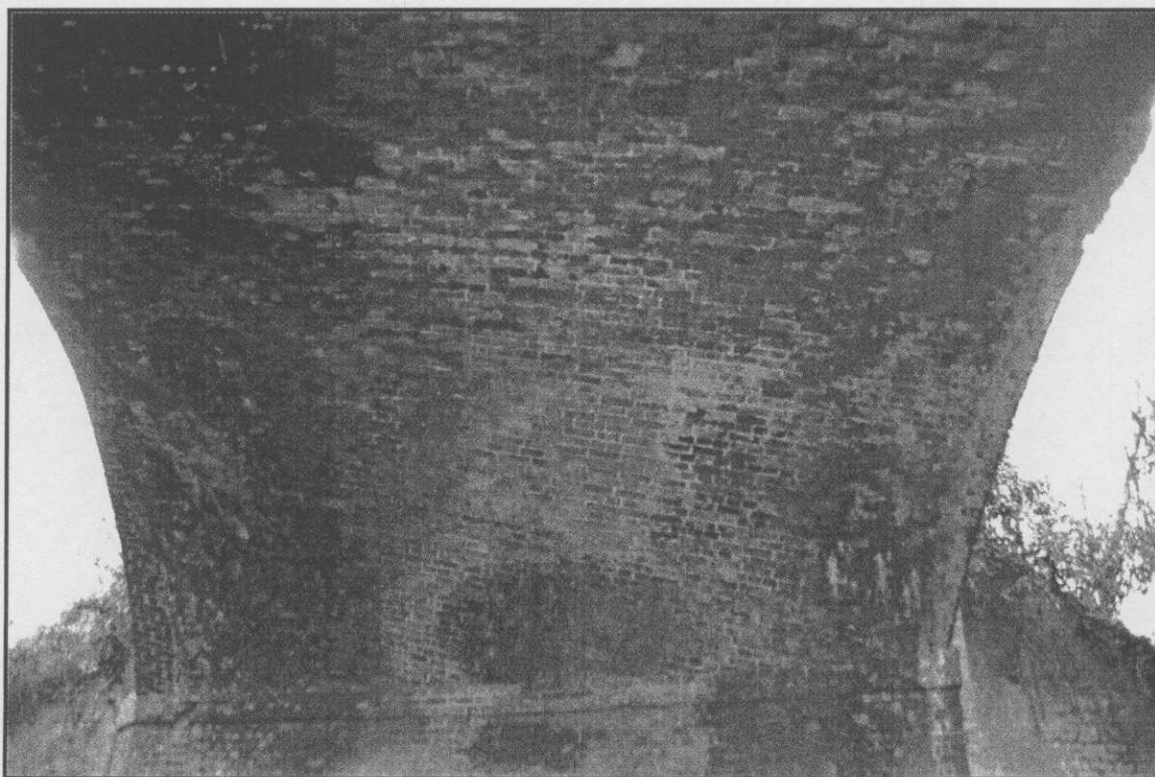
Plate 18
Arch south side

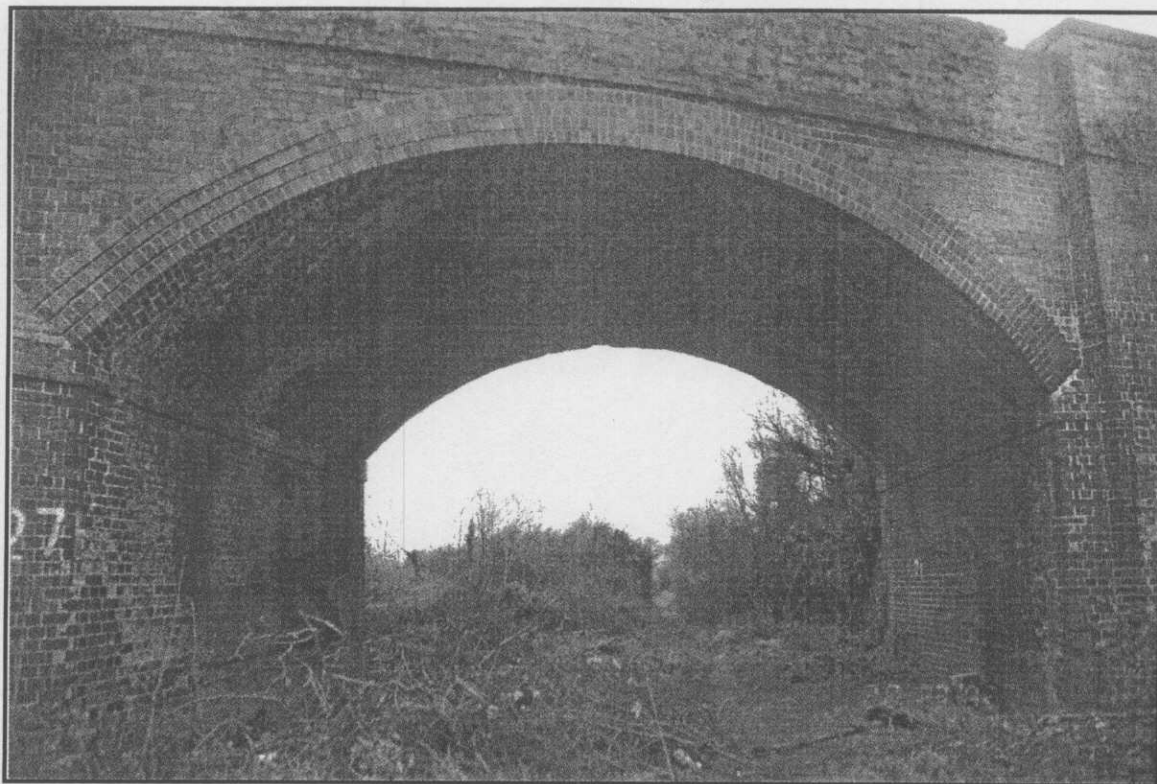
2.16.4 The arch east face has a crack around the barrel running from the north abutment to the north $\frac{1}{4}$ point 1mm wide and from the south abutment to the south $\frac{1}{4}$ point 1mm wide. There is some bulging with the spandrel wall over the south $\frac{1}{4}$ point (see plates 19-26).

2.17.3 The east spandrel has a crack around the barrel running from the north abutment to the north $\frac{1}{4}$ point 1mm wide. The barrel/spandrel joint is cracked from the south abutment to the south $\frac{1}{4}$ point 1mm wide then vertically up through the spandrel. The south side has a horizontal crack 1mm wide at half height and a vertical crack 4-5mm wide at the south end. The south side is bulging. The north side has some bulging and an area of eroded joints 20mm deep (see plates 19-26).

Plate 19
Elevation through arch from
the east side

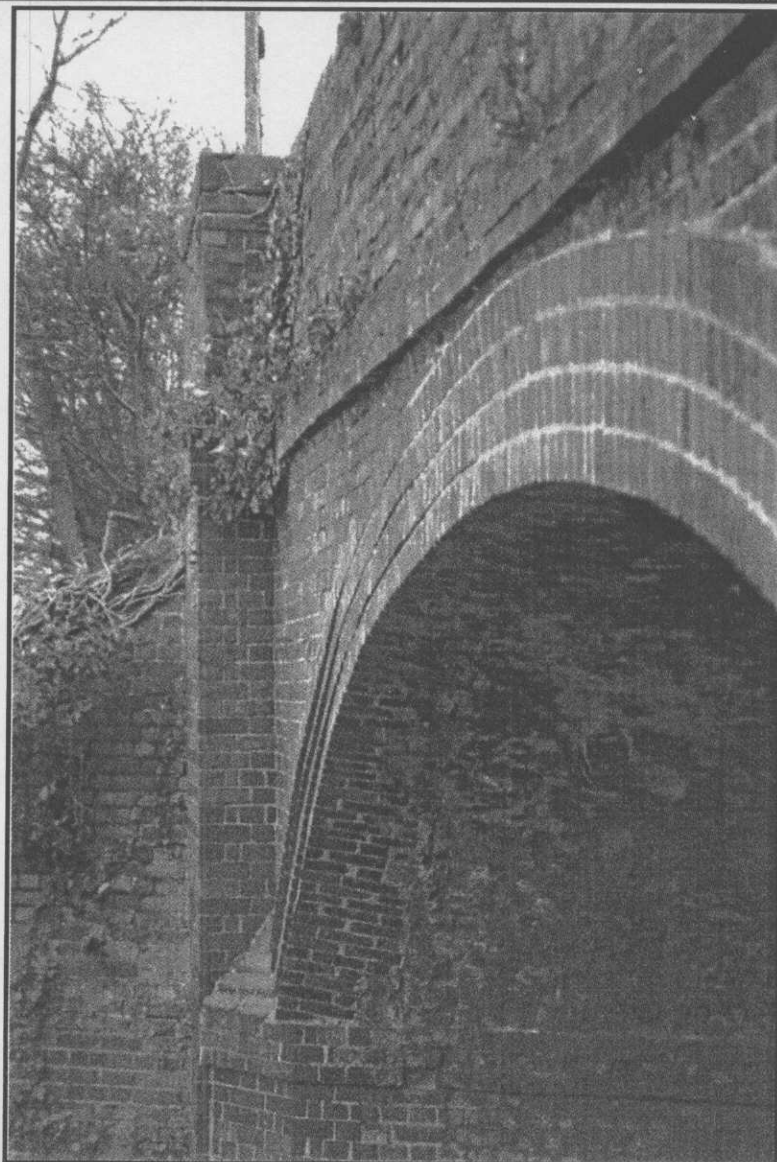
Plate 20
Arch east face and spandrel
south side

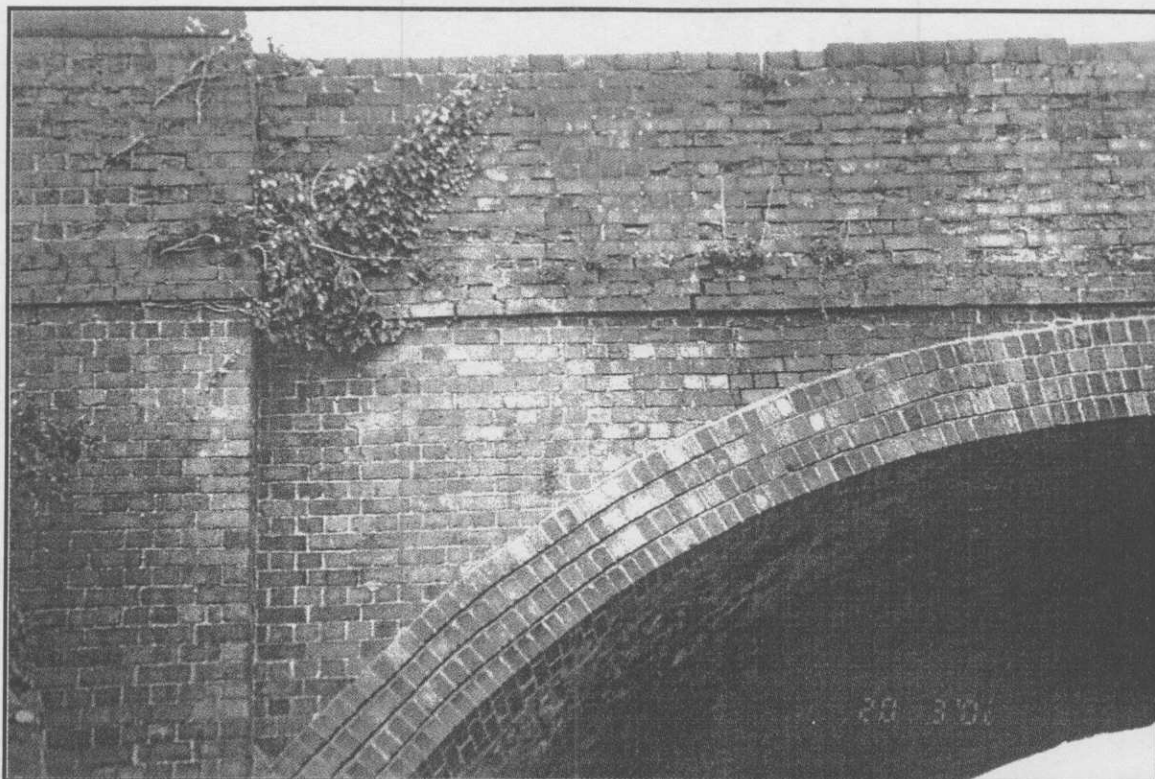
Plate 21

Arch east face, spandrel and
parapet south side

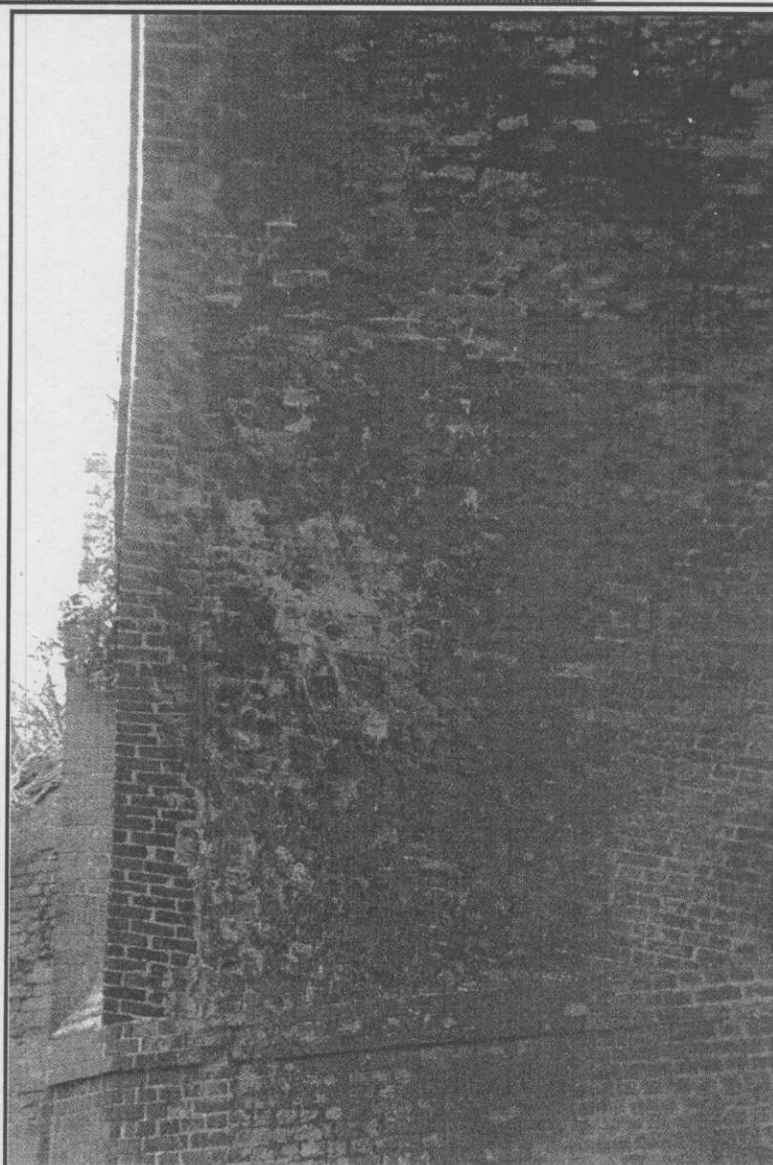
Plate 22

Arch and south abutment
east end

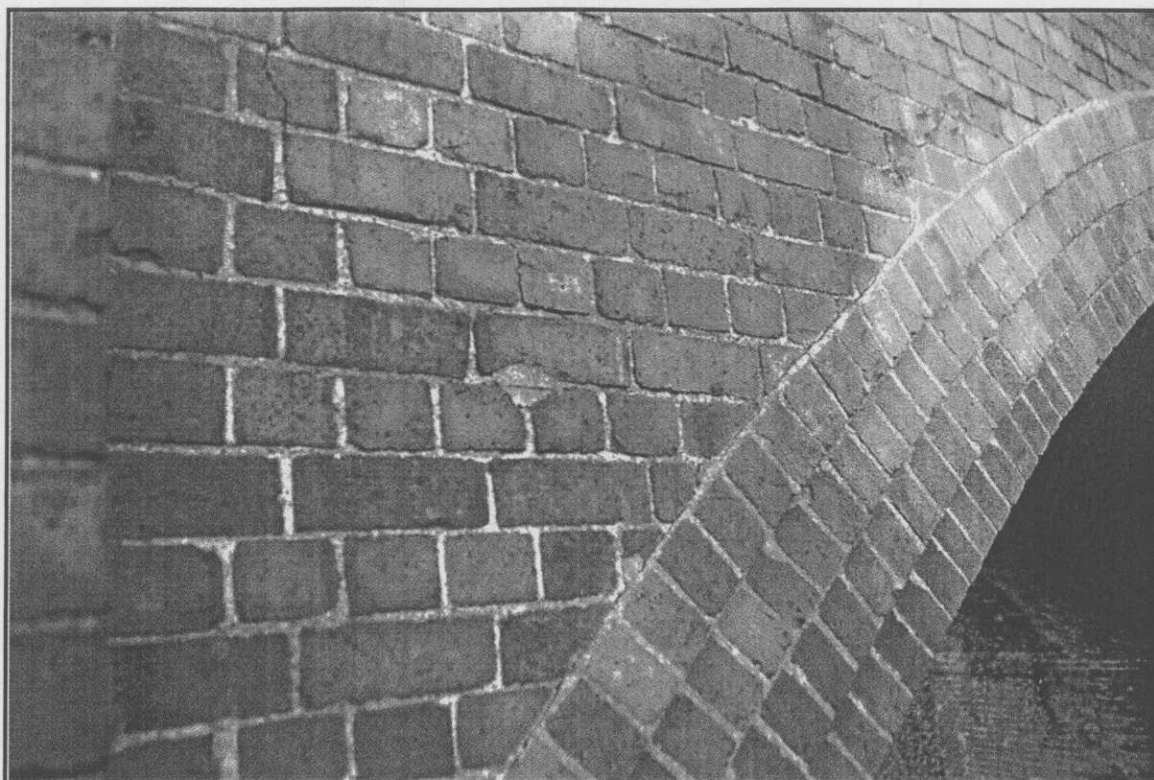
Plate 23
Arch east face and spandrel
south side

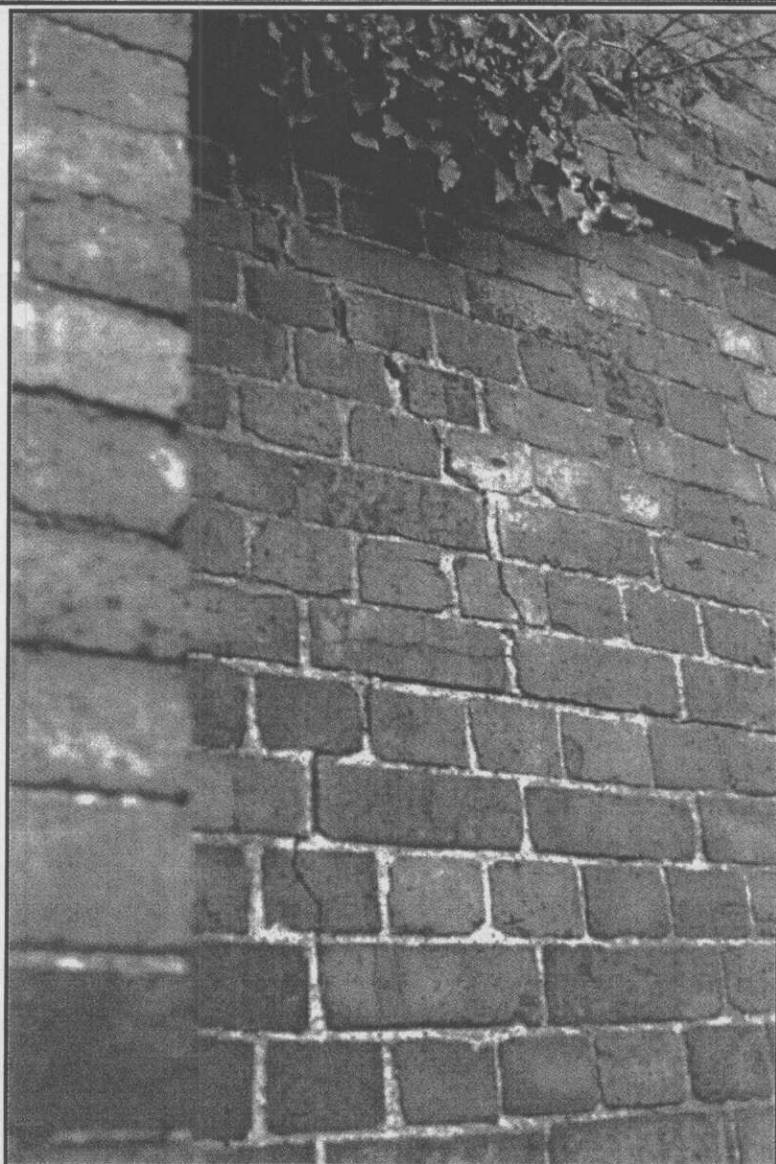
- 3.06 The cracking and bulging to the east spandrel indicates movement has taken place. The longitudinal cracking at the arch ends indicates both spandrels are moving, taking the arch ends with them. The spandrels require strengthening, possibly with reinforced concrete backing, to prevent further movement and damage to the structure.

Plate 24
East spandrel south end
