Southill Road Railway Bridge

No. HIB27

Assessment Report

ASSESSMENT OF BRB BRIDGES IN BEDFORDSHIRE
SOUTHILL ROAD RAILWAY BRIDGE (HIB27)
AMENDED ASSESSMENT

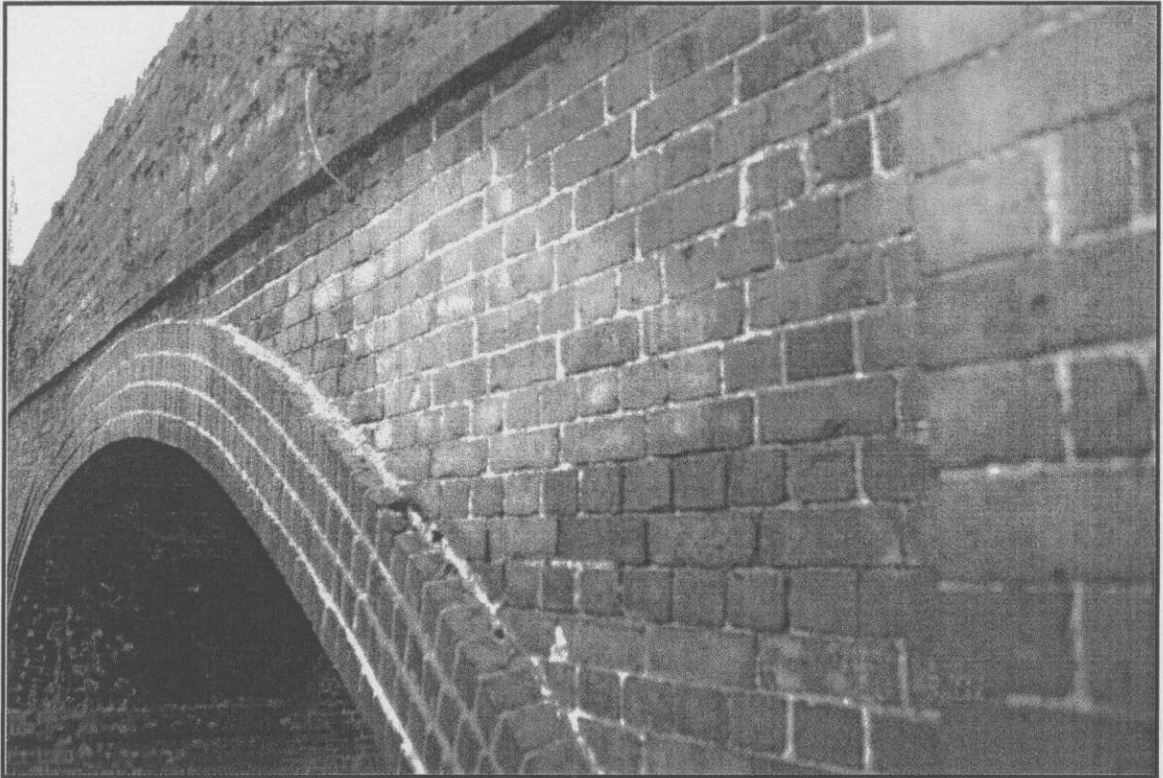
2.16.4 The arch east face has a crack around the barrel running from the north abutment to the north $\frac{1}{4}$ point 1mm wide and from the south abutment to the south $\frac{1}{4}$ point 1mm wide. There is some bulging with the spandrel wall over the south $\frac{1}{4}$ point (see plates 19-26).

2.17.3 The east spandrel has a crack around the barrel running from the north abutment to the north $\frac{1}{4}$ point 1mm wide. The barrel/spandrel joint is cracked from the south abutment to the south $\frac{1}{4}$ point 1mm wide then vertically up through the spandrel. The south side has a horizontal crack 1mm wide at half height and a vertical crack 4-5mm wide at the south end. The south side is bulging. The north side has some bulging and an area of eroded joints 20mm deep (see plates 19-26).

2.24.3 The east parapet has much spalling and poor joints, with much ivy growth in the joints. The north pilaster has a vertical crack 1mm wide and there are missing copings adjacent to the wall. The south end has some bulging with the spandrel wall below and there is vegetation growth at the south pilaster. There is a diagonal crack 1mm wide to the road face adjacent to the south pilaster (see plates 1, 19-21, 25, 27, 28 and 30).

Plate 25
Arch east face and spandrel
north side.

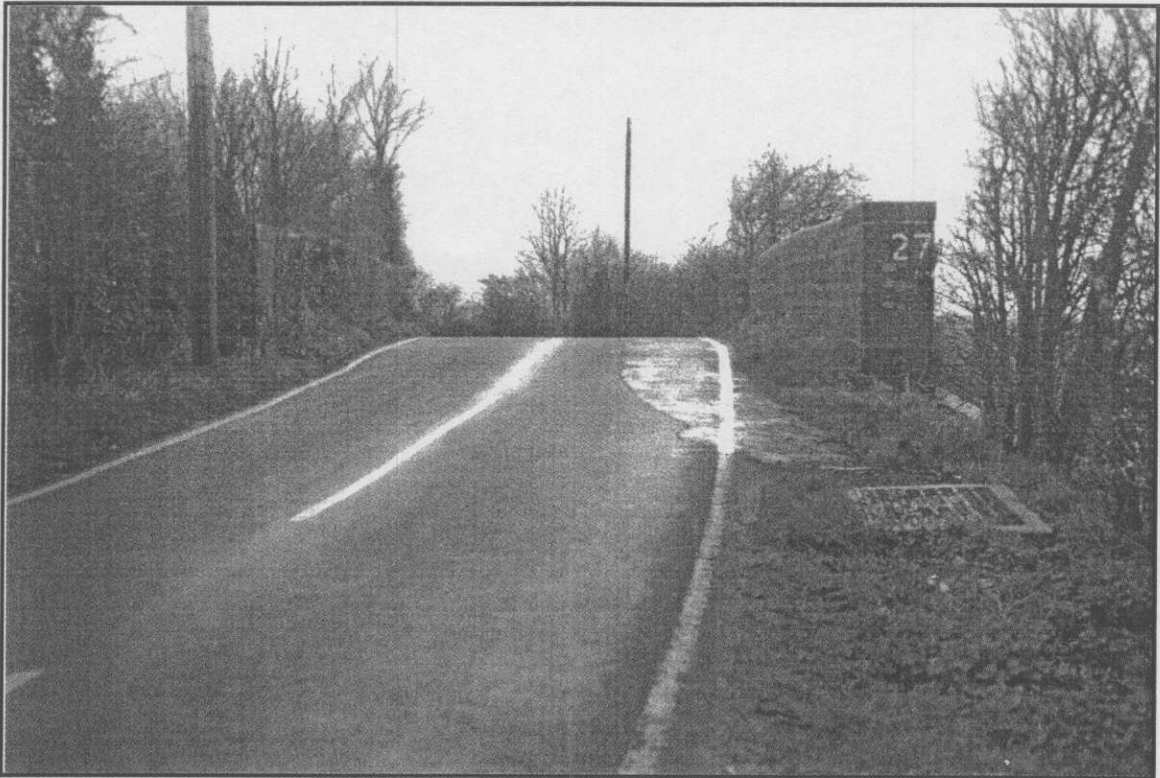
2.21.2 The carriageway has a wide trench reinstatement over the east side. There is minor cracking across the west side of the carriageway at the south end. The west carriageway edge has slight settlement up to 10mm at both ends of the parapet (see plates 27 and 28).

2.24.2 The west parapet has some spalled bricks and poor joints and has ivy growth to the ends. The north pilaster brickwork has cracking and is dislodged 20mm (see plates 2, 13 and 27-29)

Plate 27
Carriageway elevation from the south

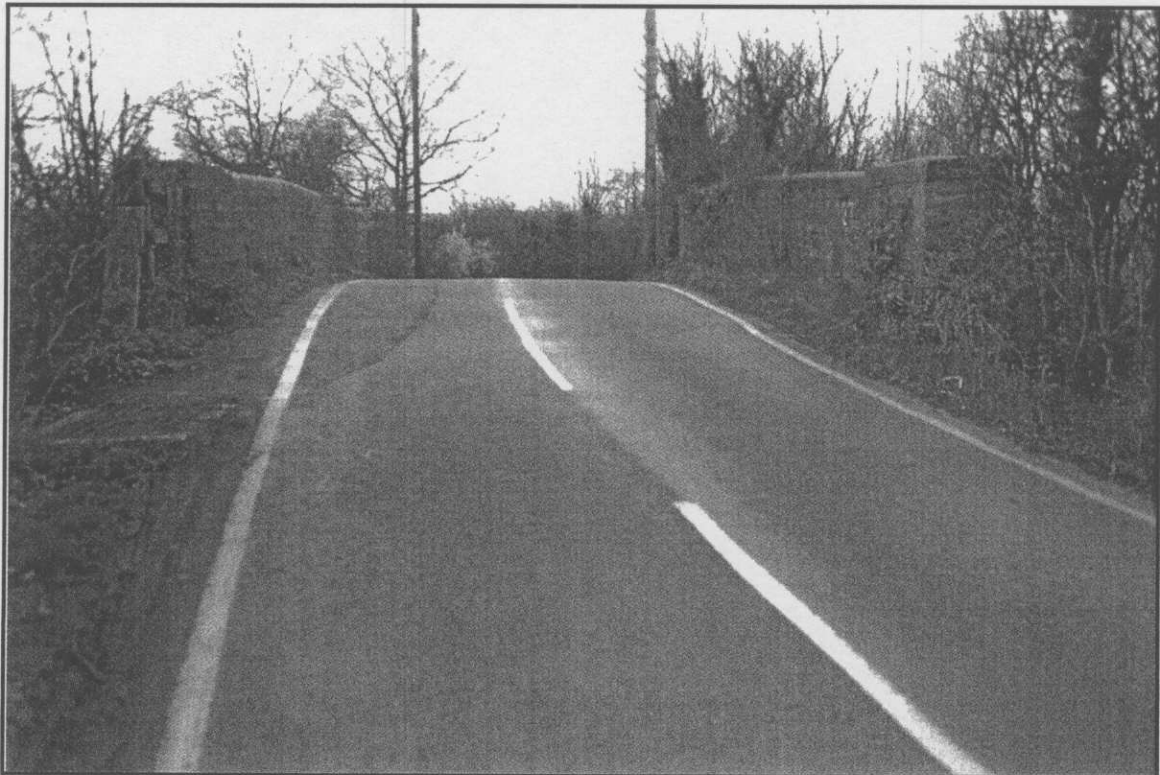
Plate 28
Carriageway elevation from the north

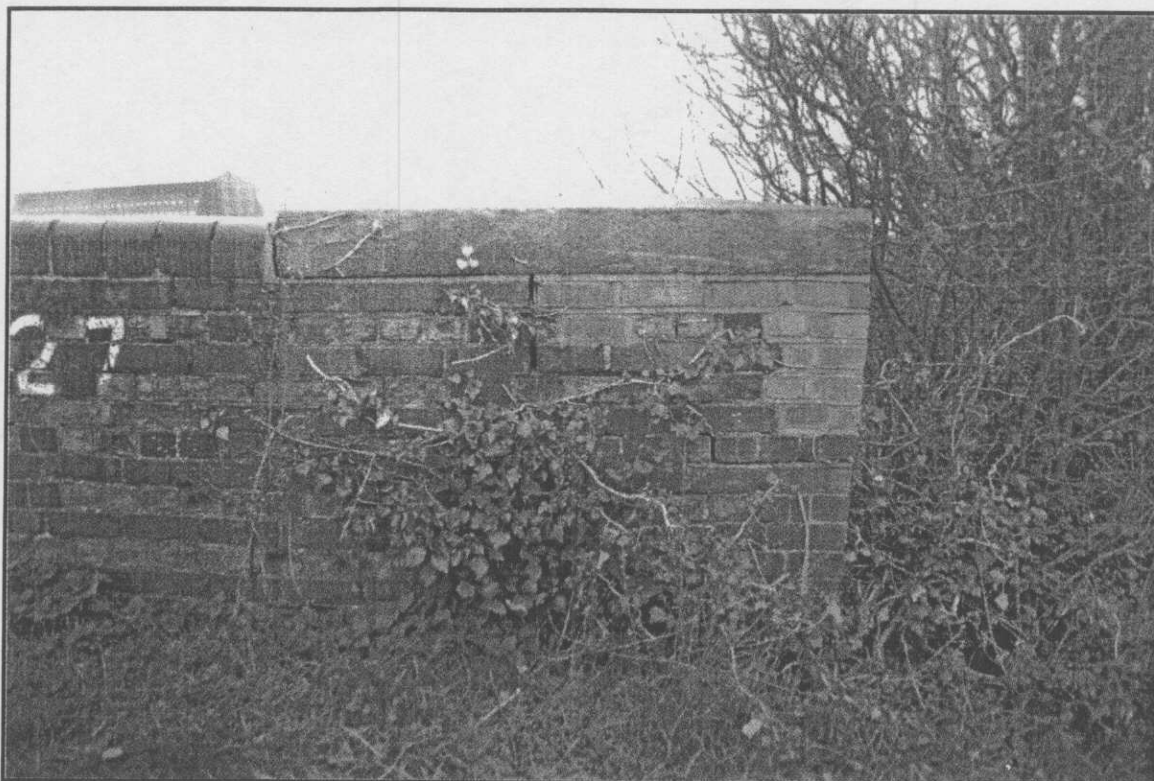
Plate 29
West parapet north end

4.24.1 Remove ivy roots from the parapet brickwork, repoint joints, and replace spalled and displaced/missing bricks and copings to prevent further deterioration and restore parapet strength.

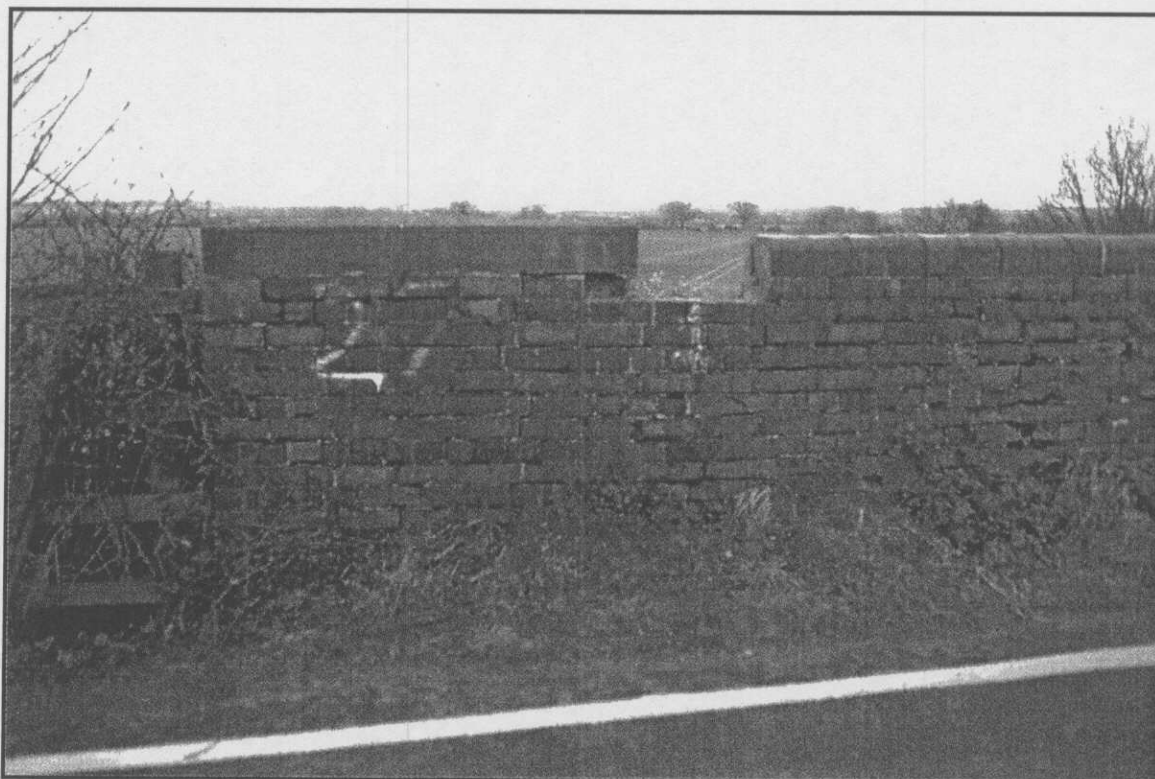
- 3.08 The surfacing defects are minor only and do not require repair at the present time.
- 3.09 The east parapet has many open joints and spalled bricks, which would appear to have been caused by the growth of ivy along the wall, there still being many roots in the joints. The wall requires repointing, and the spalled and missing brickwork and copings replacing, to restore the parapet strength. The dislodged brickwork to the west parapet end appears to be due to vehicle impact. The wall requires the dislodged section rebuilding and the ivy growth removing and joints repointed.

Plate 30
East parapet north end
