**BE4 ASSESSMENT AND INSPECTION REPORT**

**Mill Tack Road Bridge  
Nr Turriff, Aberdeenshire**

**BRIDGE REF: IMD/433**

**December 2010**

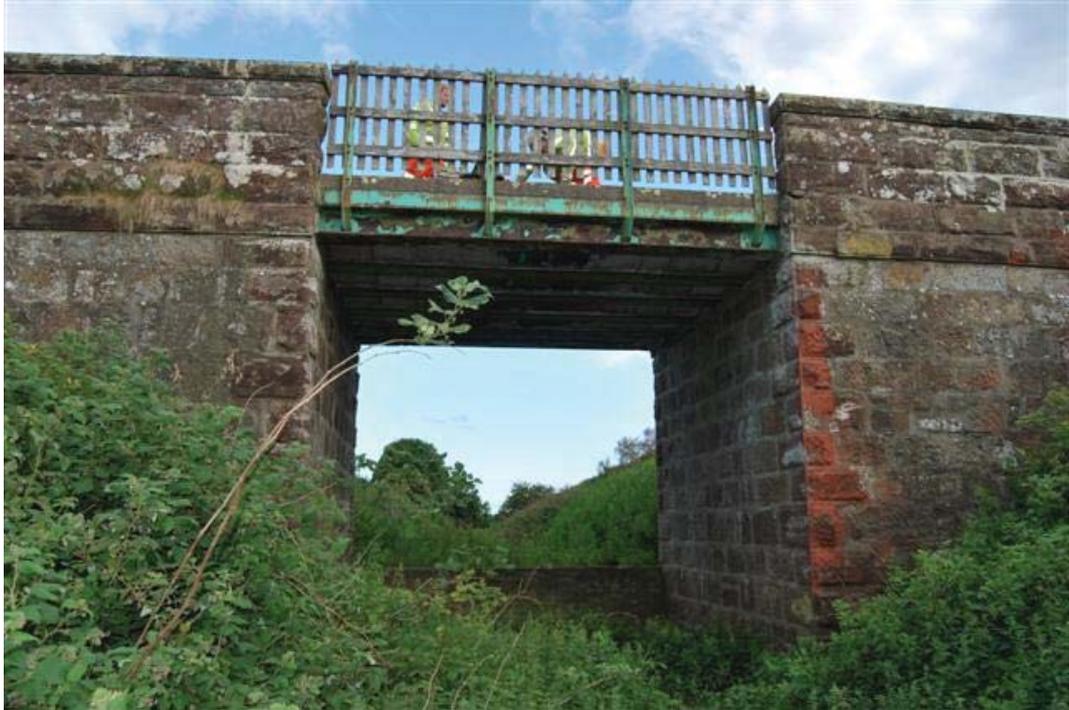
1. North elevation

The structure is a single square span overbridge with a clear span of 4.57m (15' – 0") between abutment faces (Photos 1 and 2).

The formation is overgrown. A 1.2m high brick wall has been constructed between the abutments at the south end of the bridge opening (photo 1).

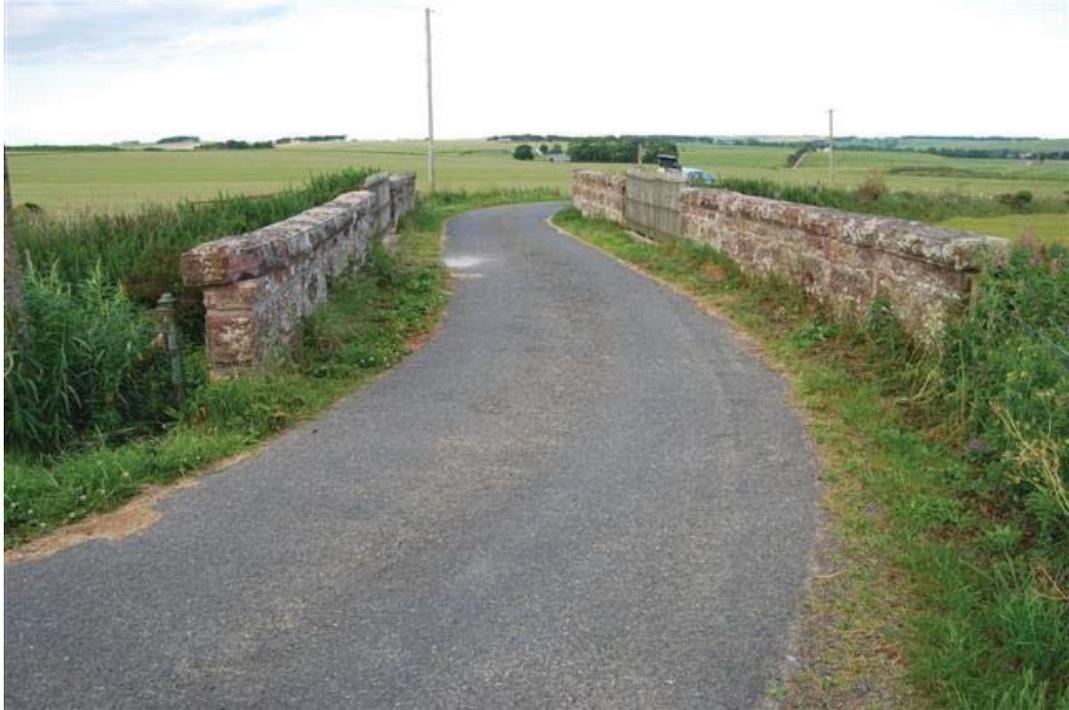
3. Road looking East

The road is a single carriageway 2.74m wide with 0.77m wide soft verges both sides (photos 3&4). The national speed limit of 60mph applies although practical speeds are severely limited by the road geometry. Only occasional light vehicles were observed on the road at the time of inspection.

The road surface is in good condition (photos 3&4).

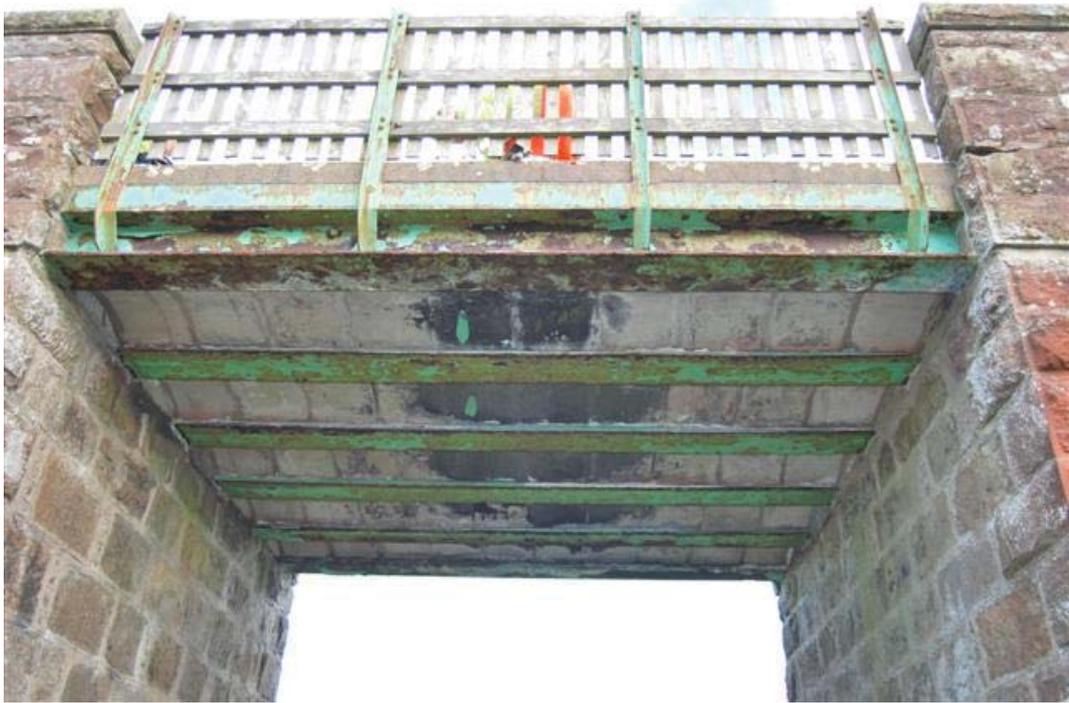
5. Soffit and north edge girder

The girders are in fair condition. There is some surface corrosion and loss of section, estimated to be a maximum of 5% of the bottom flange thickness to all girders. There is also some flaking at the east end of the north edge girder about 2 to 3 inches from concrete bearing stones (photo 8). There is flaking corrosion on the exposed face of the north edge girder. Green paint on the girders is still present but it is largely ineffective (photo 5).

The pre-cast concrete jack arches are in good condition with no visible cracking or dampness (photo 5).

The paint system is breaking down particularly on the exposed webs of the edge girders. Early maintenance would be beneficial to prevent further deterioration.

Maintenance painting of the edge girders is recommended.

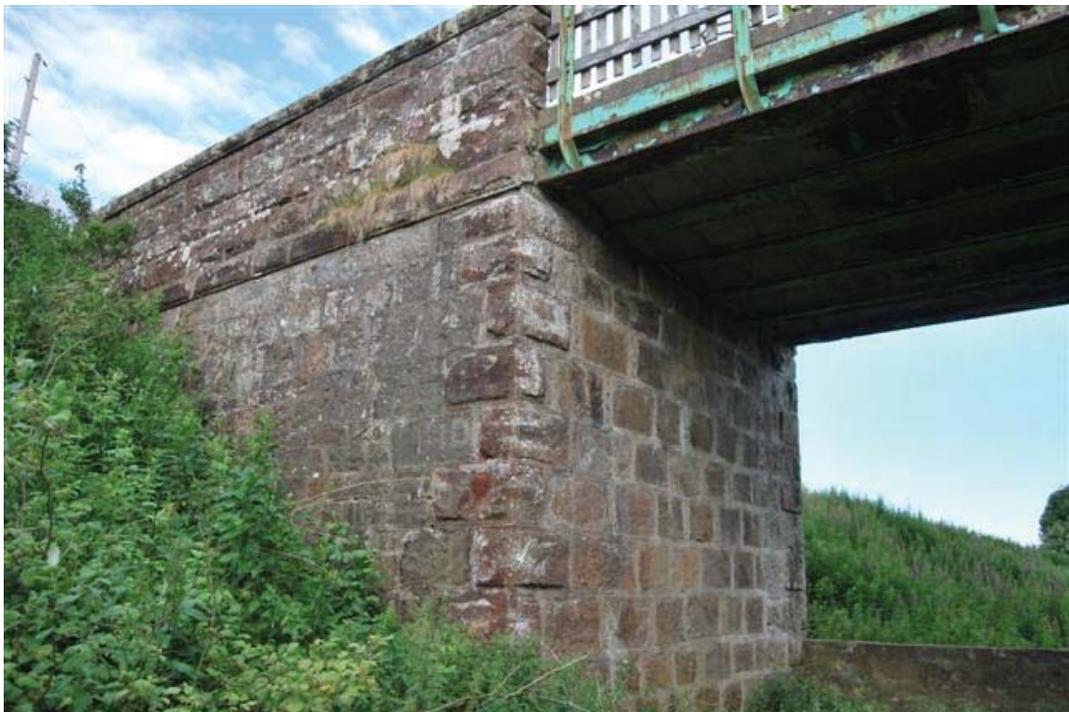
6. East abutment and North east wingwall

The abutments are constructed from squared large granite blocks, regularly coursed. The quoins are constructed from red sandstone blocks. The abutments are in good condition with no significant defects (photos 6 and 7). They are considered to be adequate for full BE4 Construction and Use loading.

The wingwalls lie parallel with the road and are constructed from regularly coursed squared granite blocks (photos 6 and 7). They are generally in good condition. There is a 2-3mm wide crack running through the mortar courses, starting from top of the north west parapet close to the east end and stretching vertically to near embankment level at foot of the north west wingwall.

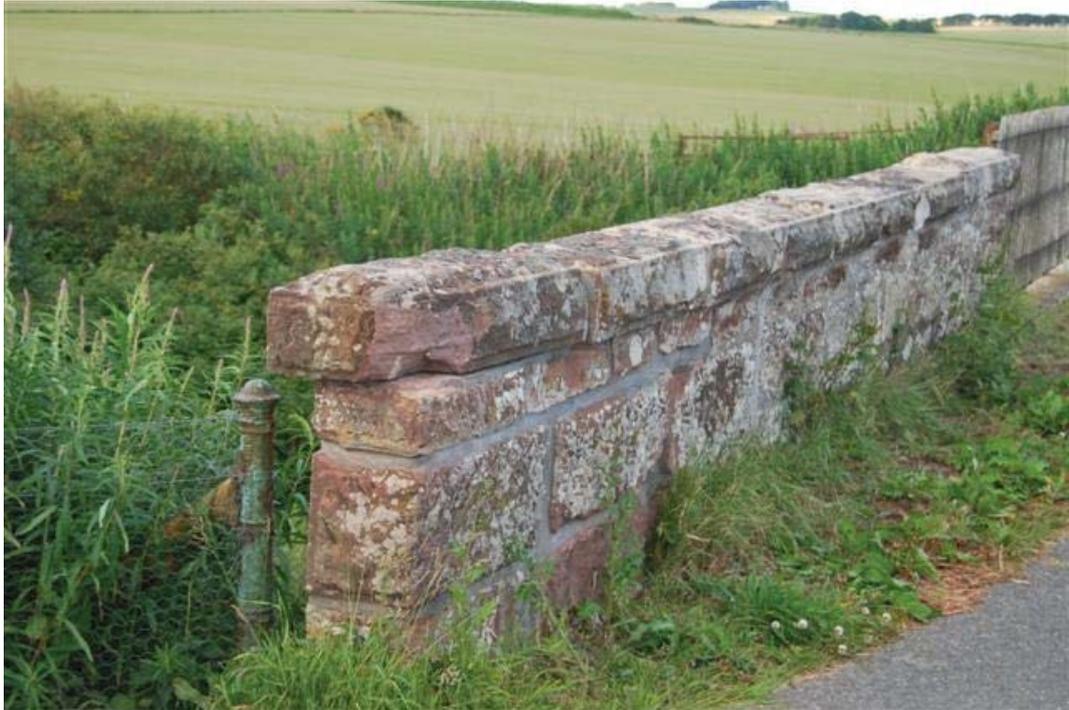
The parapets over the wingwalls are constructed from regularly coursed squared granite blocks. They are generally in very good condition. One coping stone at the west end of the north west parapet is slightly dislocated (photo 9).

The bridge deck parapets comprise simple wooden paling fences, which would have negligible vehicle containment capacity. A coping stone at the west end of the north parapet has been dislocated and needs re-setting.

9. Dislocated coping stone at north west parapet

A coping stone at the west end of the north parapet needs re-setting.

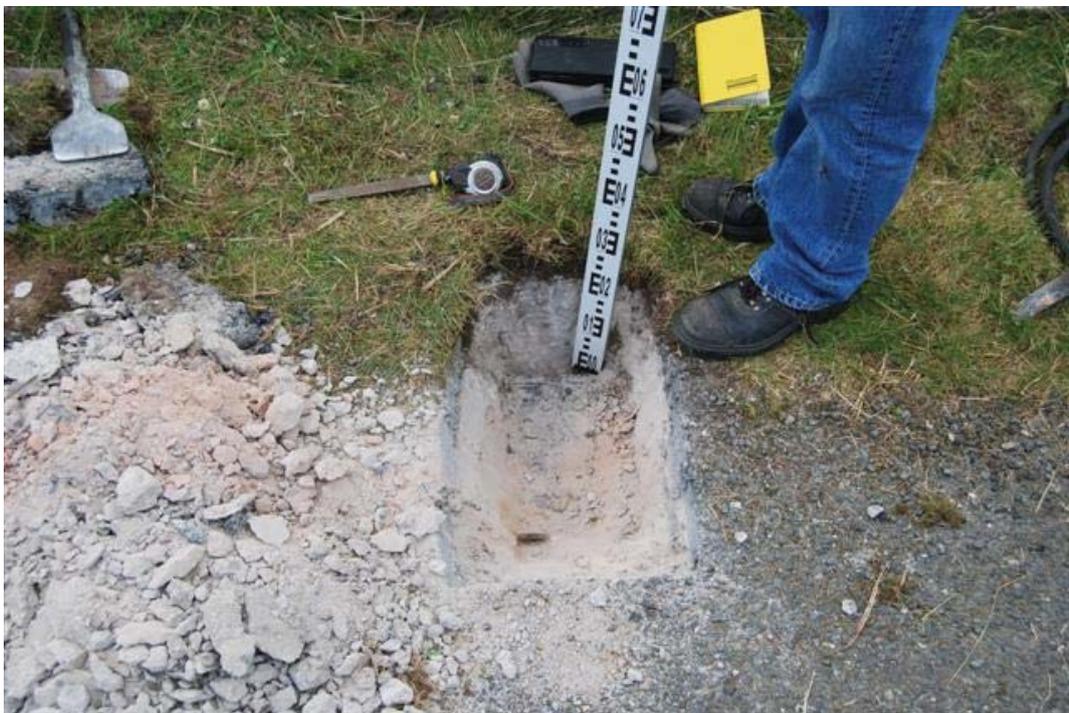
10. Trial pit at north verge mid-span

A trial pit was excavated as part of the survey located at the edge of the carriageway to expose the top flange of the first internal girder from the north.
