RAIL PROPERTY LTD

ASSESSMENT AND INSPECTION REPORT

HAMPSTEAD NORRIS BRIDGE NO.23

OVERBRIDGE REF: NDL(7m46 $\frac{1}{4}$ ch)

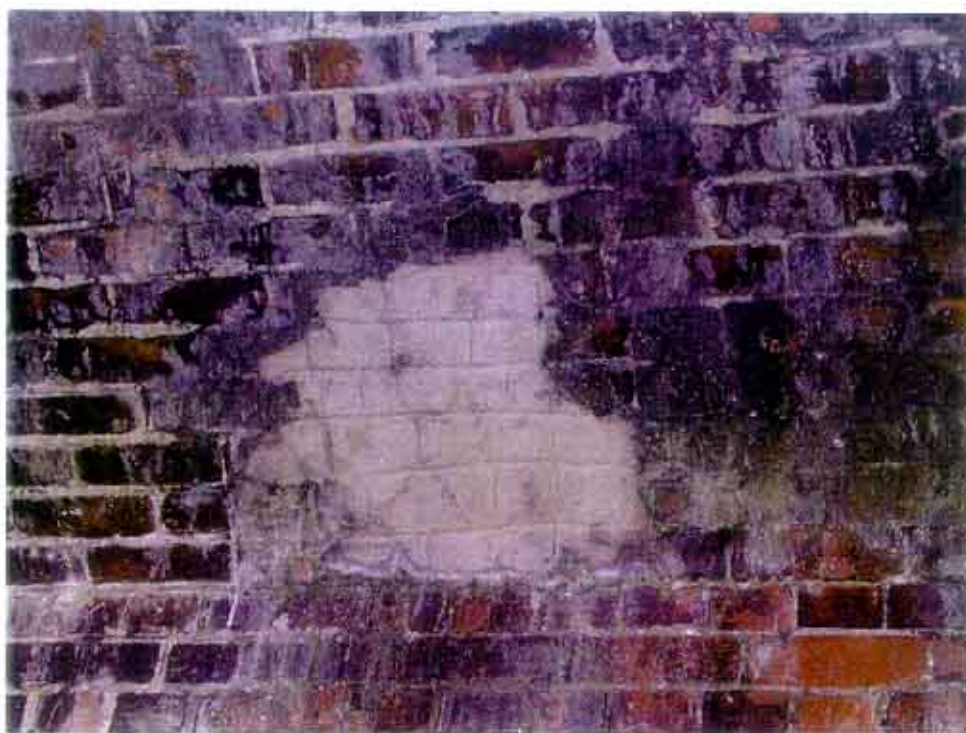
Photo 13 Detail at East Abutment showing previous repair

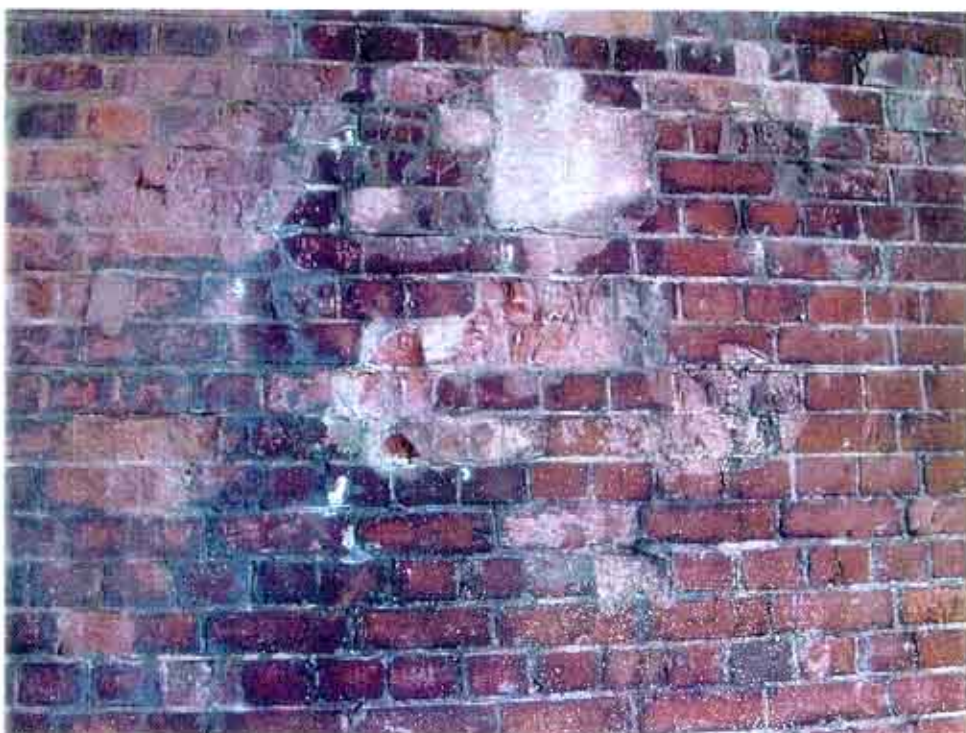
The arch is generally in fair condition but exhibiting some signs of weathering. There is a crack between the arch barrel extrados and the spandrel wall. The brickwork of the barrel is also exhibiting some loss of mortar at joints and some loss of section to the soffit brick face of the arch barrel at centralised locations.

Photo 14 Detail at soffit of arch barrel showing widespread spalling and mortar loss

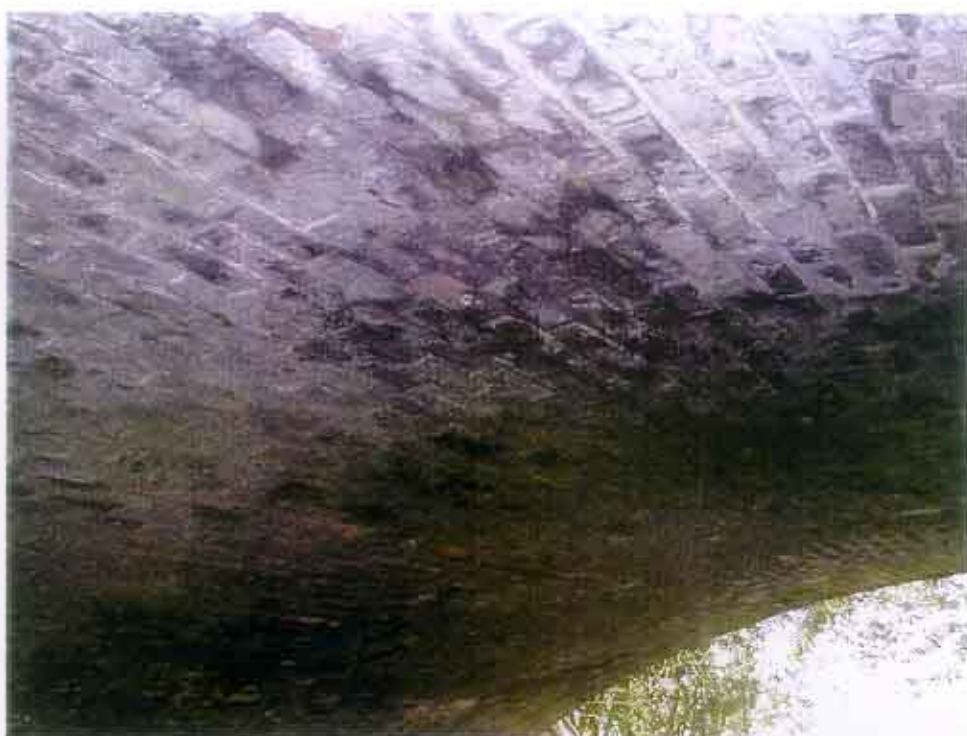
Photo 15 General view of the arch barrel soffit showing widespread staining and spalling of brickwork

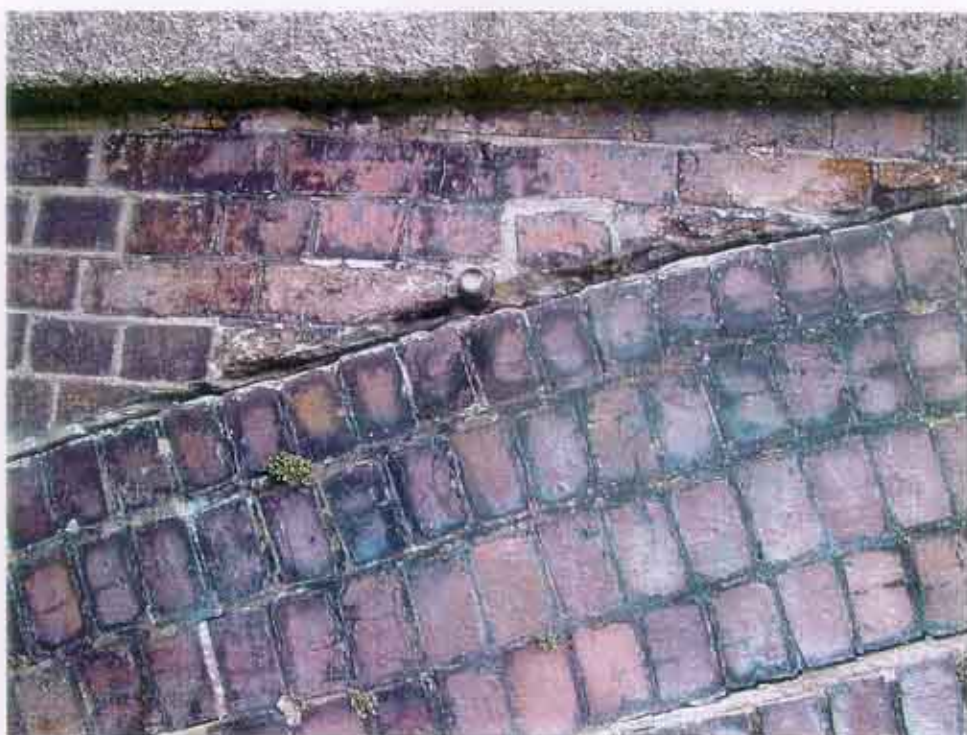
There is a crack at the top of the arch barrel at the connection line with the spandrel wall. There are no signs of rotation of the spandrel and parapet wall.

Photo 16 Detail of severe cracking on the extrados on the south elevation of the arch barrel

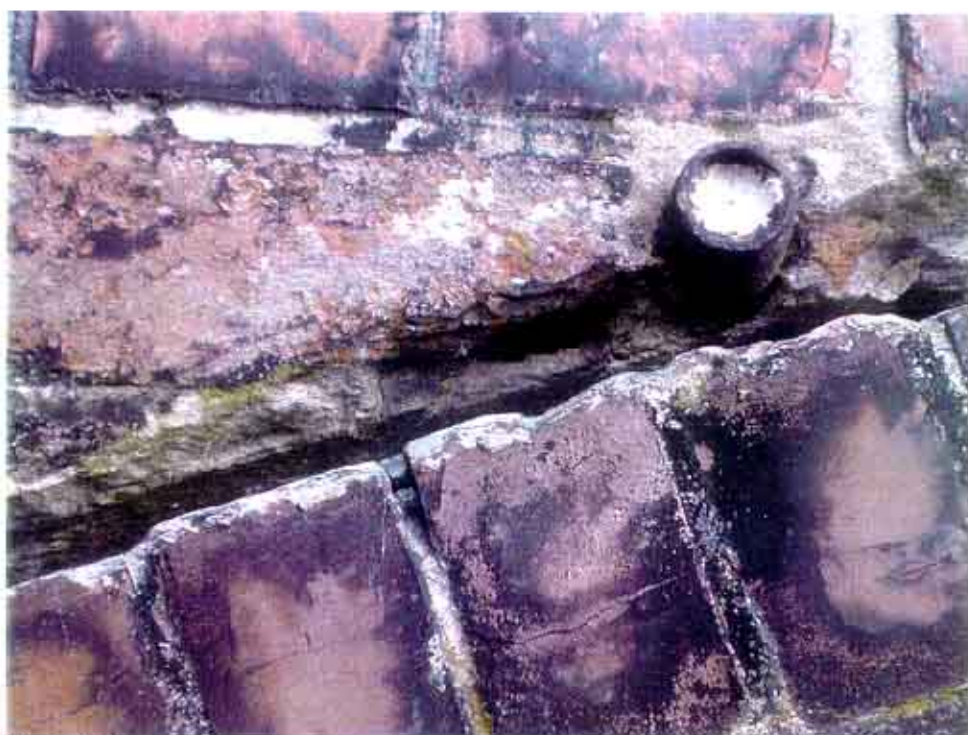
Photo 17 Close up of severe cracking on the extrados on the south elevation of the arch barrel

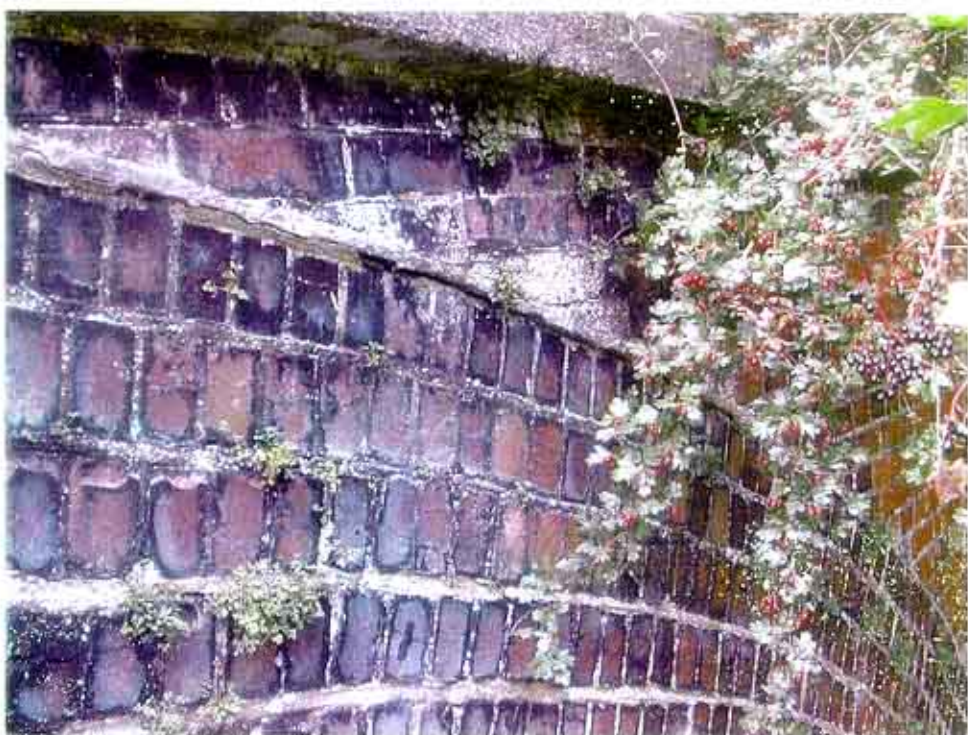
Photo 18 Detail of cracking on the extrados on the north elevation of the arch barrel

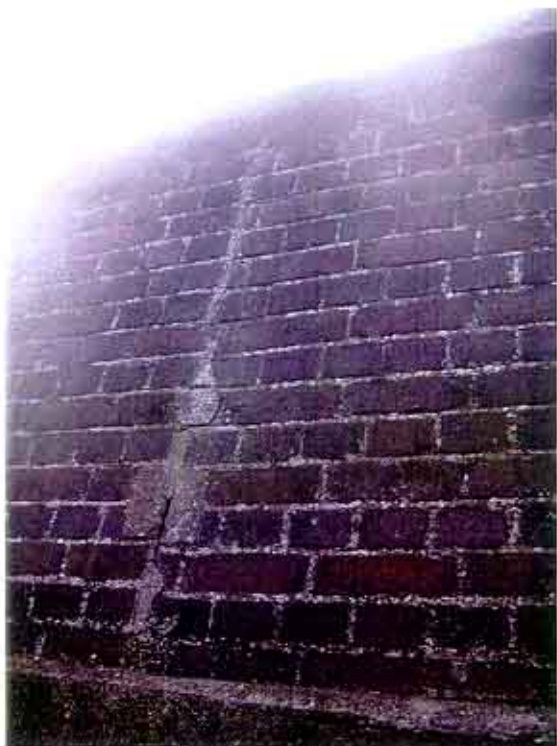
The arch barrel was found to be generally in fair condition, some weakening and mortar losses in localised places. There is a visible vertical crack at the centre of the parapet wall. Both elevations have the same defects.

Photo 19 Detail of cracking to the parapet wall just above the centre of the arch barrel ring
