**BRB (Residuary) Ltd
Major Works Programme 2004/2007**

**VAR9-1220 BE4 ASSESSMENT
PROGRAMME**

**ASSESSMENT AND INSPECTION
REPORT**

BRIDGE REF: NPB 719

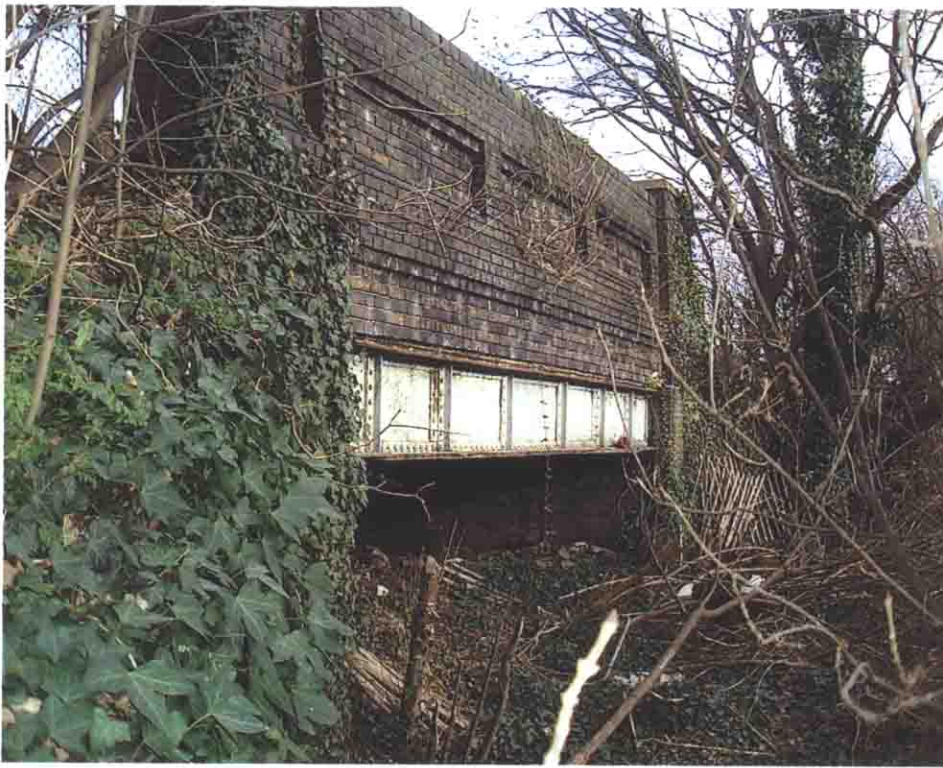
1. South elevation of bridge

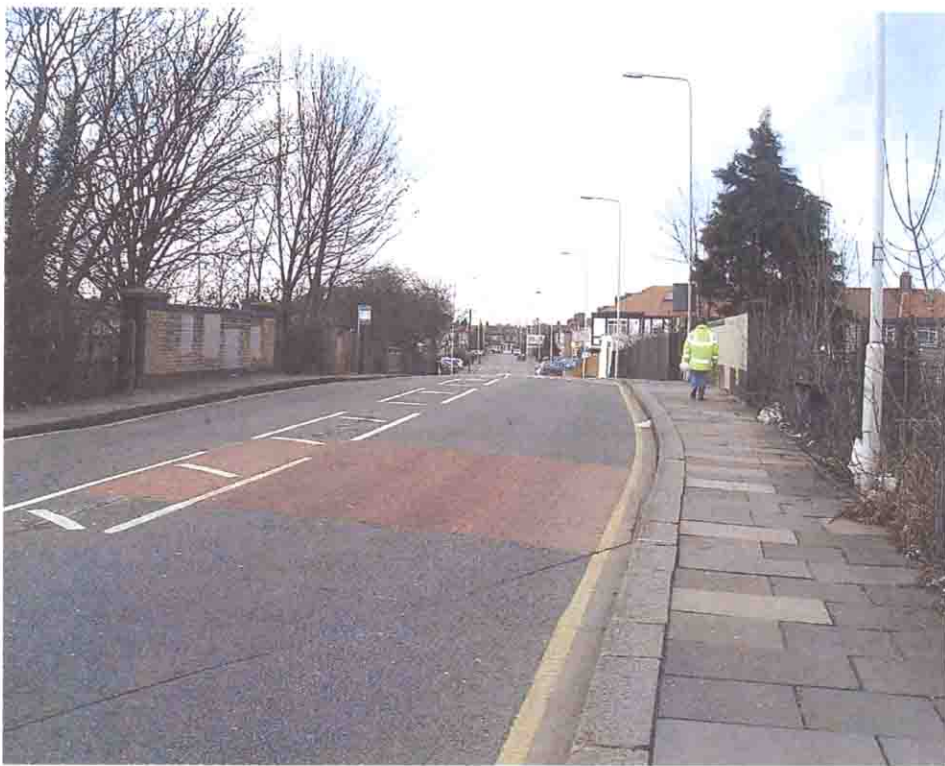
2. Benton Road over bridge looking west

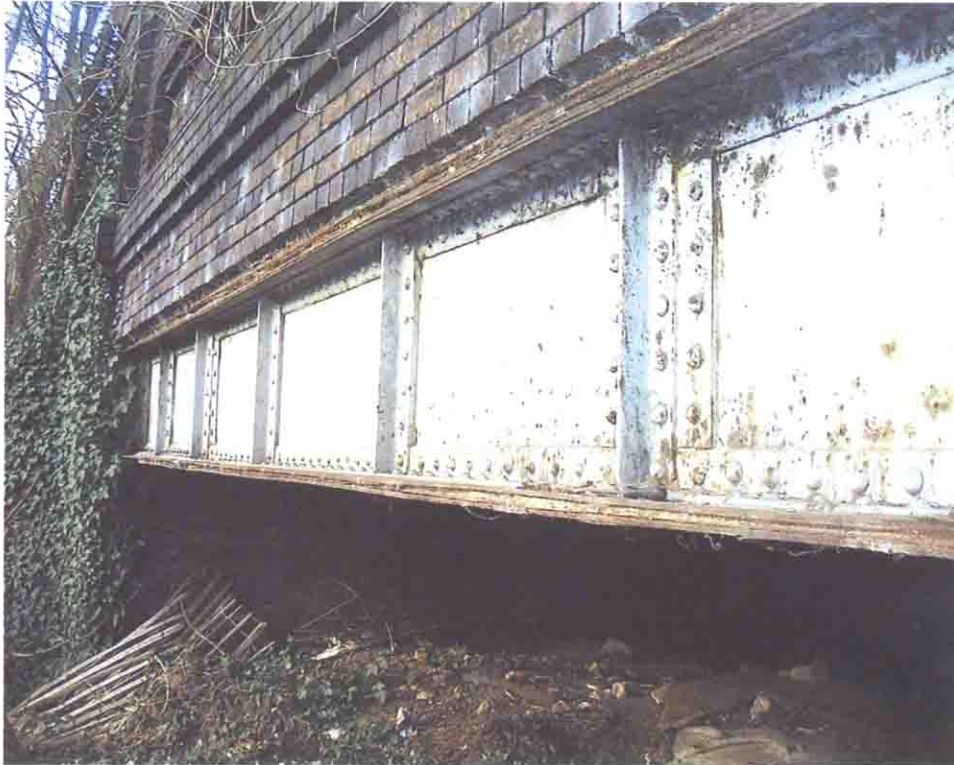
The face of the girder is in fair condition, with only slight breakdown of the paint system. (Photograph No. 3)

3. South edge girder

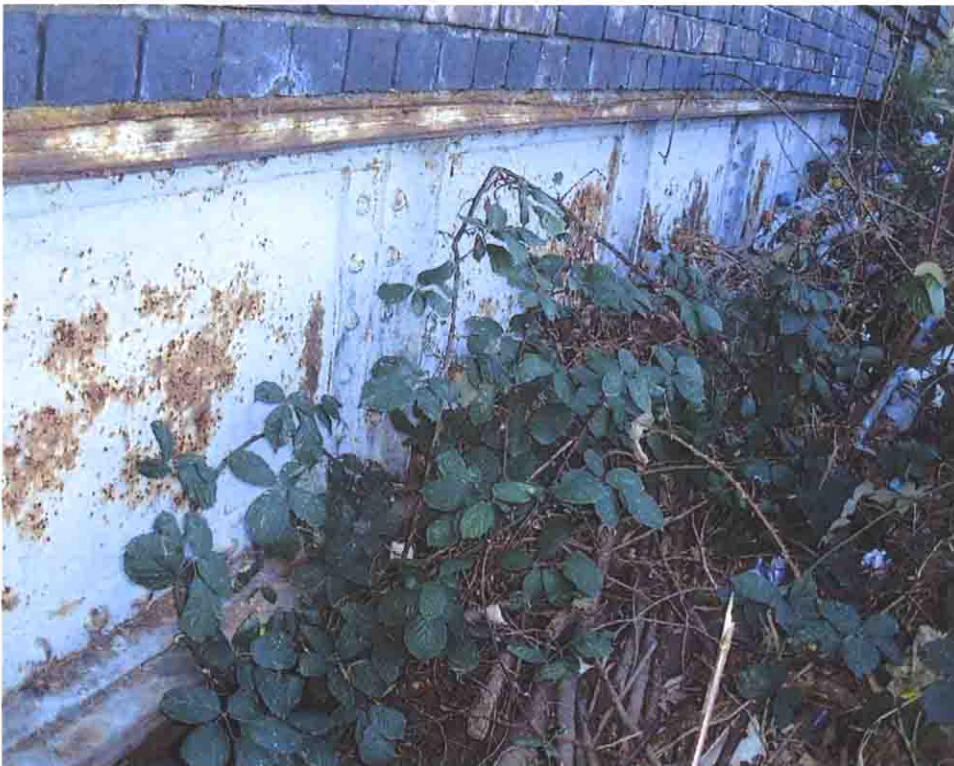
There is extensive laminar corrosion of both the bottom and top flanges throughout their length, having expanded to two or three times their original thickness. The expansion appears to have caused a crack in the parapet similar to that in the south parapet. At about 2.5m from the west abutment there is an exceptional bulge of corrosion in the outer leg of the bottom flange. In general, the outer section of the top flange beyond the rivet line must be considered as ineffective. The lower plate of the bottom flange is considered only 30% effective and the upper plate 70%. (Photograph 4)

4. North edge girder

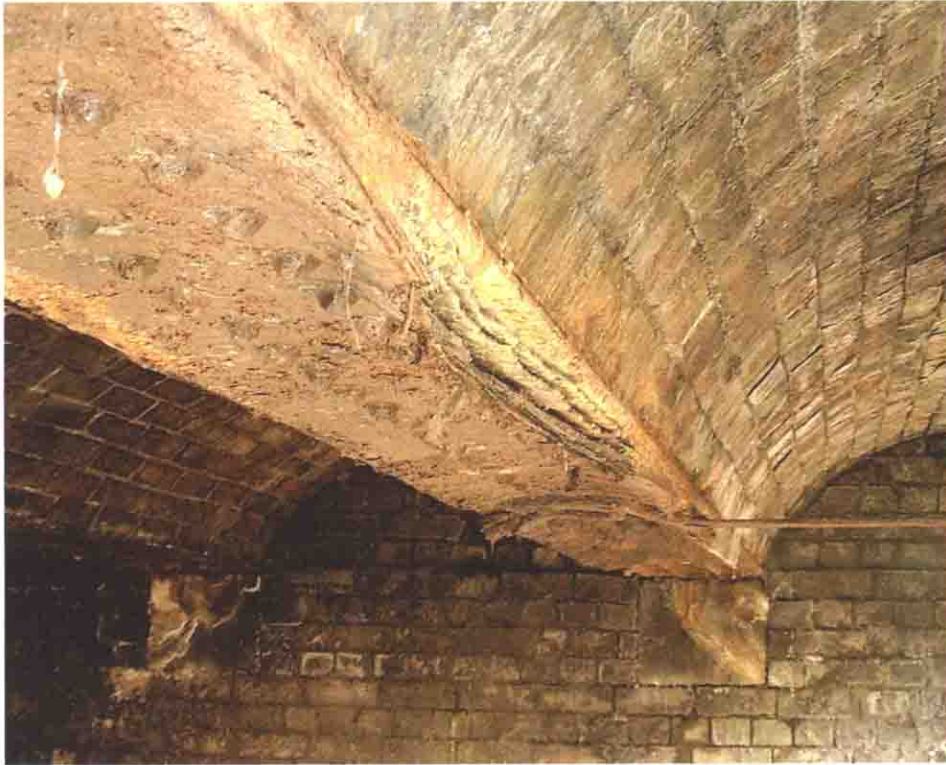
There is severe laminar corrosion of the bottom flange of the girder from the east end of the second plate to mid-span (Photograph 5). The upper plate is estimated to be only 60% effective and the lower plate 30%.

5. Laminar expansive corrosion of Girder No.2

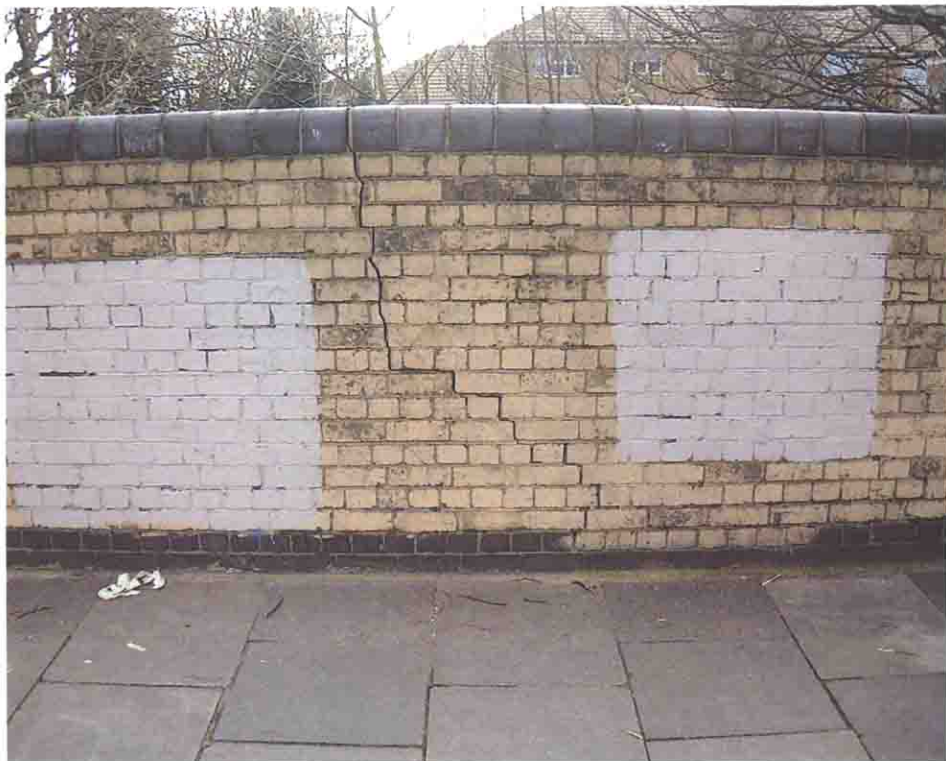
There is a substantial solid brick parapet on both sides of the bridge supported on the edge girders. On both parapets, at approximately one third-span, there are near vertical cracks emanating from the top of the girder and continuing through to the copings. The cracks are wider at the top than the bottom; typically 10mm wide at the top (Photograph No. 6). The pattern of the crack suggests the wall is being lifted upwards at the middle of the span. This could be attributable to the expansive corrosion of the top flange of the supporting beam.

6. Crack in south parapet wall

Minor brickwork repairs and repointing should be undertaken on the outside faces of the parapet walls and stitching of the vertical cracks. The wingwalls are mainly infilled however repairs should be undertaken to their visible parts.

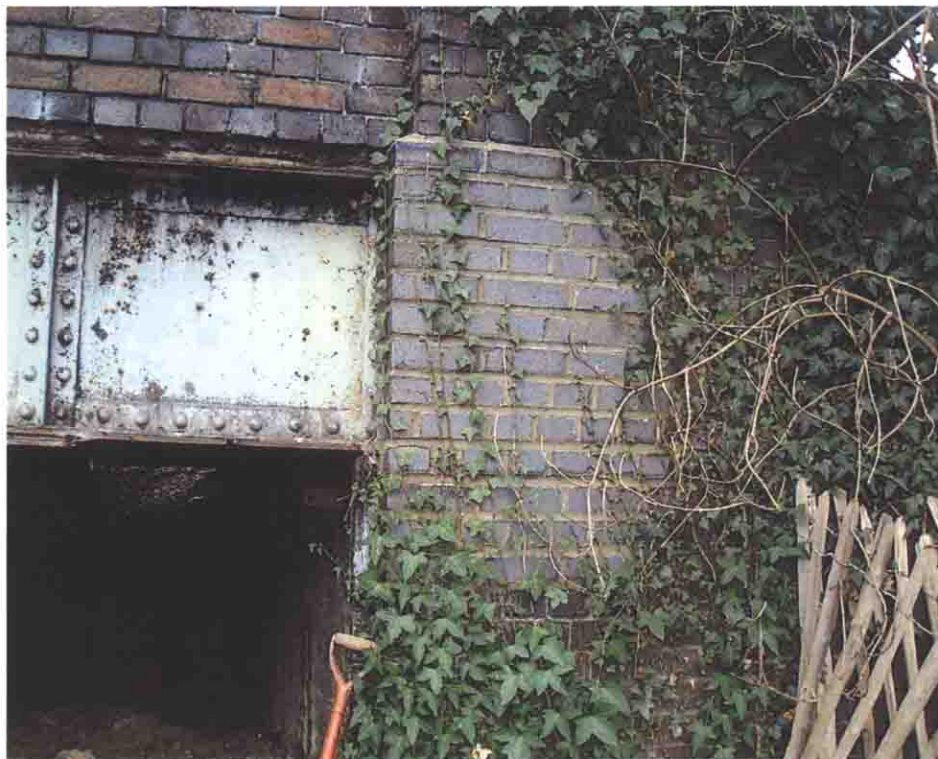
Only two tie straps remain on the entire bridge. These appear to have been 2½" by ¼" flats riveted to the underside of the bottom flange of the girder and these remaining ones are highly corroded. The tails of the other straps are still visible at their girder connections. There is evidence that both the edge girders have moved outwards by 5 – 10mm, through repaired damage to the south east cheek wall (Photograph No.7) and cracks at the ends of the outer jack arches.

7. SW Pilaster showing repair to side wall believed to have been caused by outward movement of the girder from lack of tie restraint

- replace tie-straps to outer girders
- remove corrosion and apply paint system to arrest further corrosion.
- Minor brickwork repairs to jack arches, parapets and wingwalls.

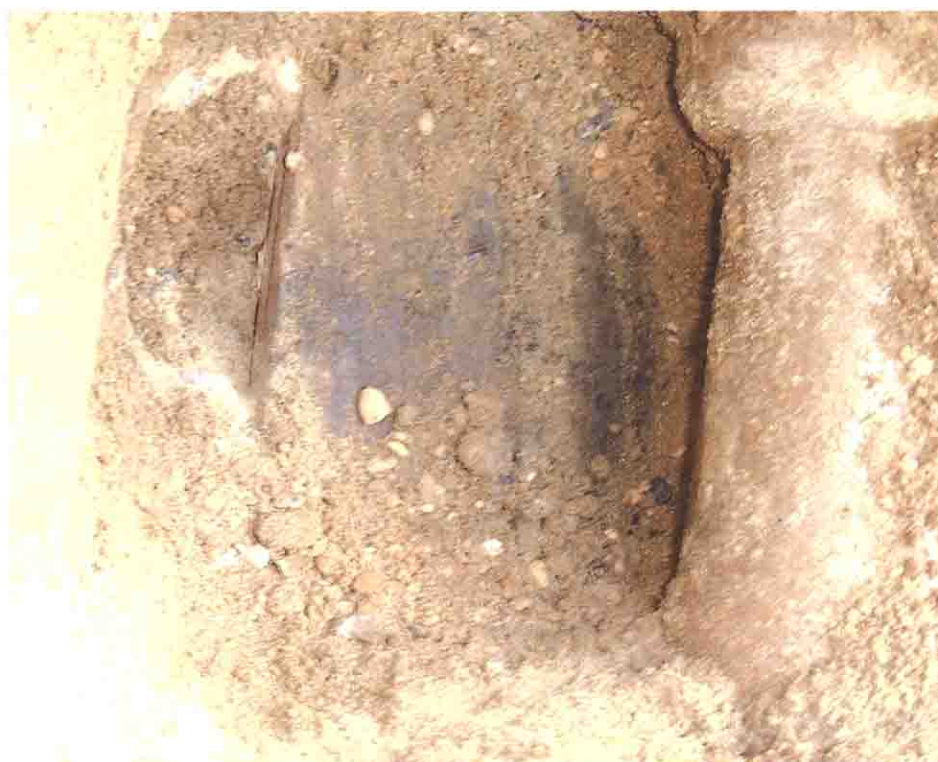
This is similar to girder No. 7, but has an additional corrosion zone 2.5m from the east abutment. The top flange of Girder No.8 was exposed by the trial hole. This flange appeared to be in near perfect condition.

8. Trial Pit showing top flange of girder No.8
