## SMB/2062 CS454 Assessment and Inspection Report

### Braughing, Puckeridge, East Hertfordshire

National Highways – Historical Railways Estate  
VAR9/7070

HRE Assessment Programme

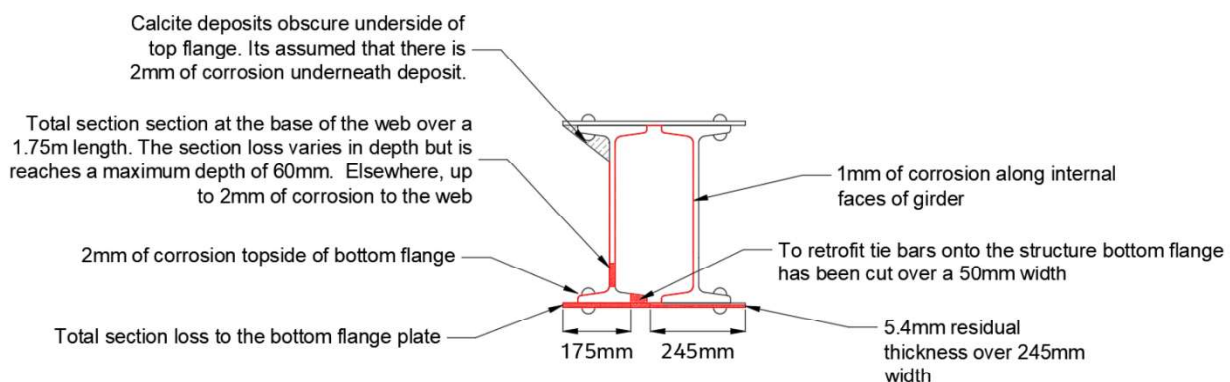
At midspan, the girder has sustained a severe amount of corrosion; at a minimum, the exposed external faces have at least 2mm of section loss.

The section loss that has occurred around the bottom flange of the external RSJ has separated the bottom flange from the rest of the double joist compound girder and is rendering it ineffective in supporting loading.

Calcite deposits obscure the underside of the top flange plate and the top flange of the external girder; both are assumed to have sustained up to 2mm of corrosion, similar as seen elsewhere on the girder. There was also 1mm of pitting and corrosion to the internal faces of the double joist compound girder.

Figure 3. South Edge Girder – Midspan corrosion

The southern edge girders do not have the capacity to sustain any form of live loading. It is recommended that a road restraint barrier be installed, as soon as is practical, to protect the southern edge girder from any accidental vehicle loading.

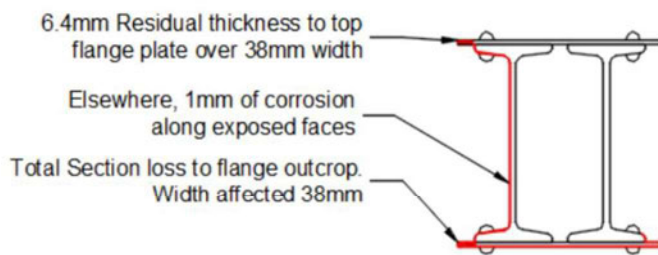
At support, there is total section loss of the bottom flange plate over a width of 38mm. The underside of the top flange plate has a 6.4mm residual thickness over a 38mm width. Elsewhere there is 1mm of corrosion across the exposed faces of the girder.

Figure 4. South Edge Girder – Support corrosion

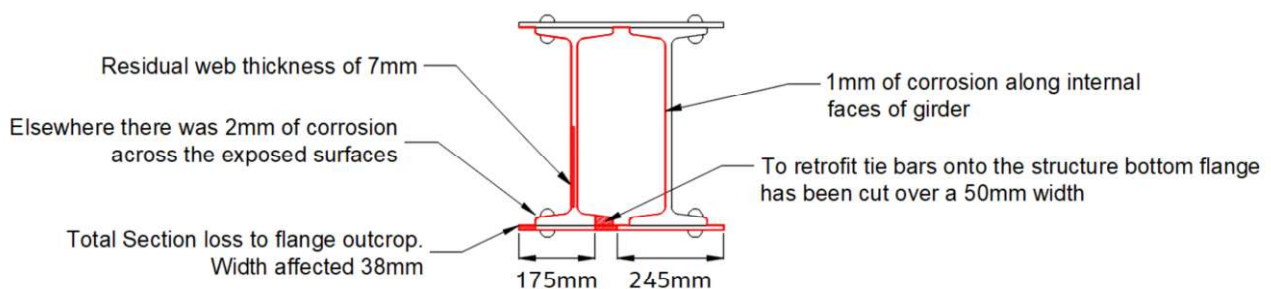
On the external RSJ, the web has become severely corroded, and the corrosion is concentrated toward the base of the web. UTG measurements indicate that the web thickness has reduced to a residual thickness of 7mm from the mid-depth of the girder to the base. There is total section loss of the bottom flange plate over a width of 38mm. Elsewhere, the girder has sustained up to 2mm of corrosion on the exposed faces of the girder. There was also 1mm of pitting and corrosion to the internal faces of the double joist compound girder.

Figure 5. North Edge Girder – Midspan corrosion

The north edge girders passes for 40/44 tonnes accidental vehicle loading. The condition of the north girder should also be monitored as it displayed a similar pattern of section loss to that seen in the south edge girder. If section loss develops in the web of the external RSJ, it may become ineffective, reducing the bending resistance to approximately match the south girder's section.

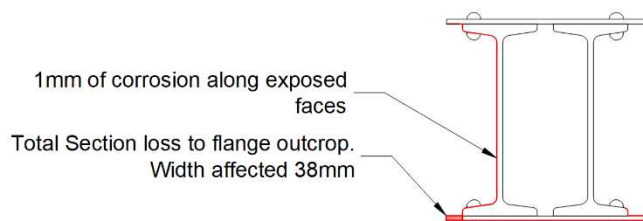
At support, there is total section loss of the bottom flange plate over a width of 38mm. Elsewhere there is 1mm of corrosion across the exposed faces of the girder.

Figure 6. North Edge Girder – Support corrosion

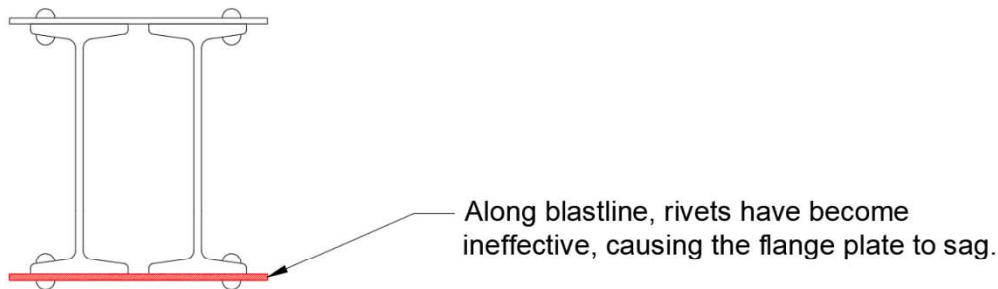
All of the internal girders were in a similar condition. At midspan, total rivet head loss has caused the bottom flange plate to become detached from the steel RSJs at the approximate location of the blast-line. Where the plate has detached, it has slightly sagged rendering it ineffective.

Figure 7. Internal Girders – Midspan corrosion

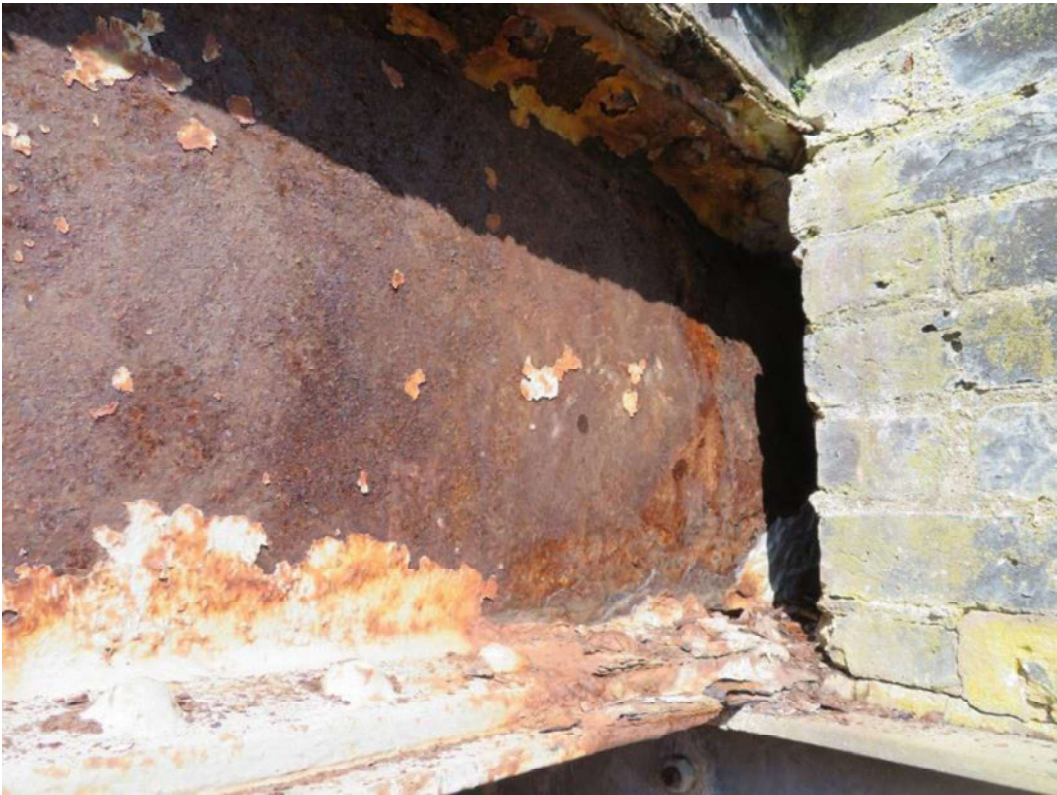
Photograph 14. South Edge Girder at East Support - Web

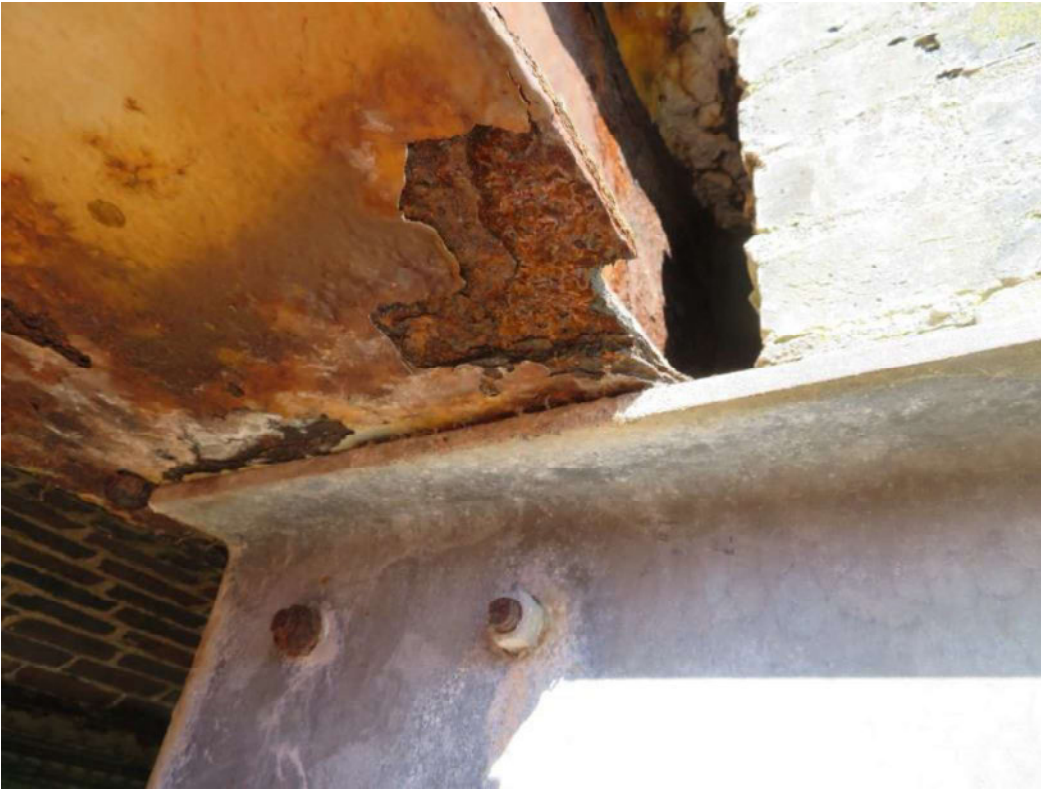
Photograph 15. South Edge Girder at East Support – Underside of bottom flange plate

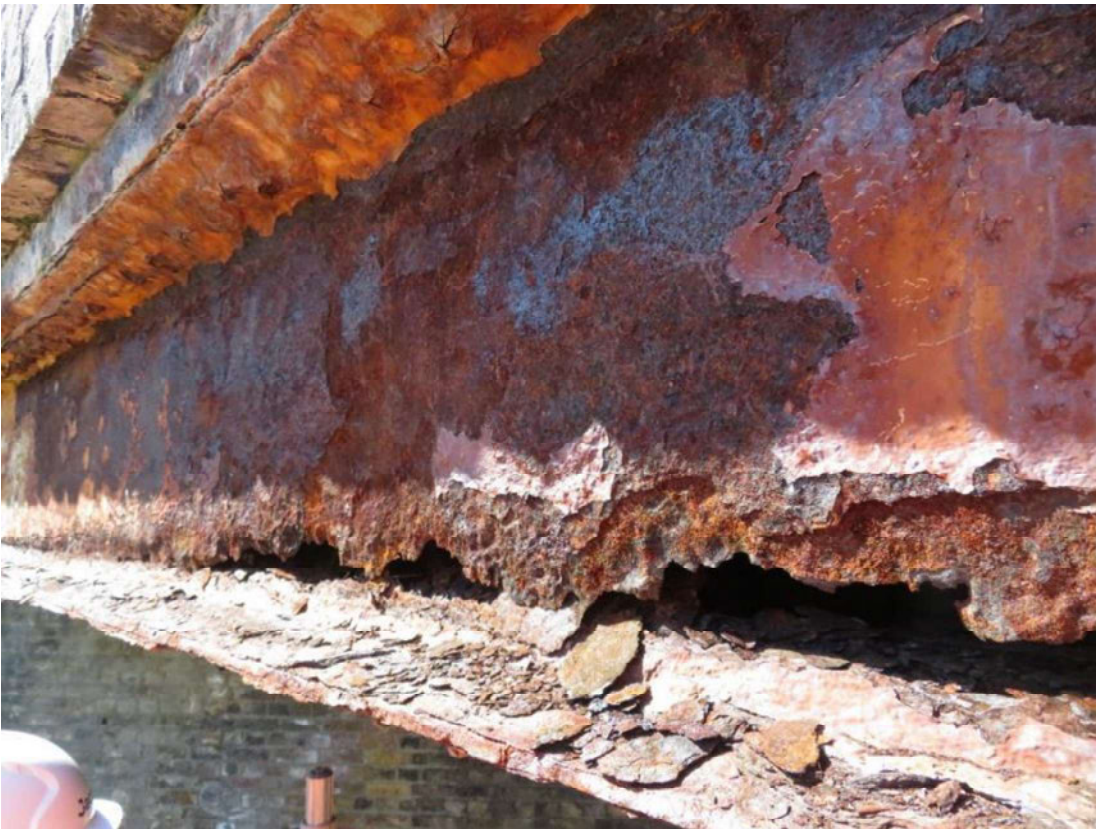
Photograph 16. South Edge Girder at Midspan – External face and web

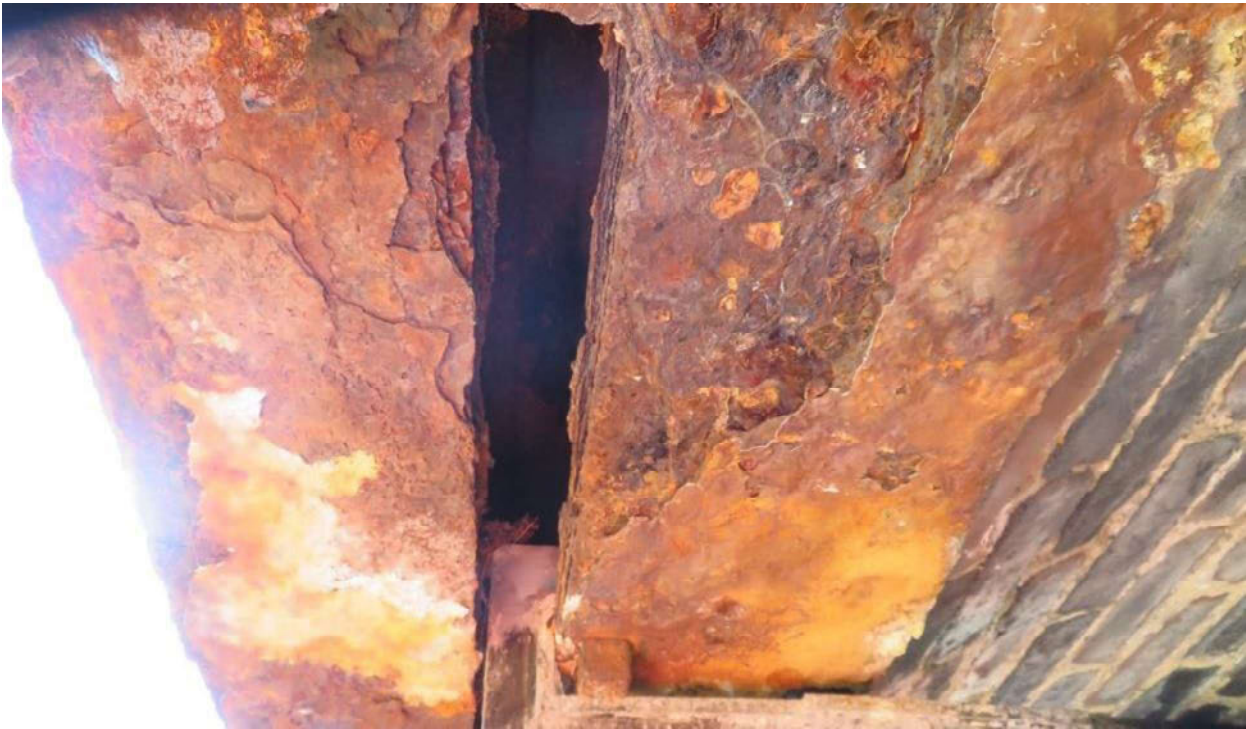
Photograph 17. South Edge Girder at Midspan – Underside of Bottom Flange

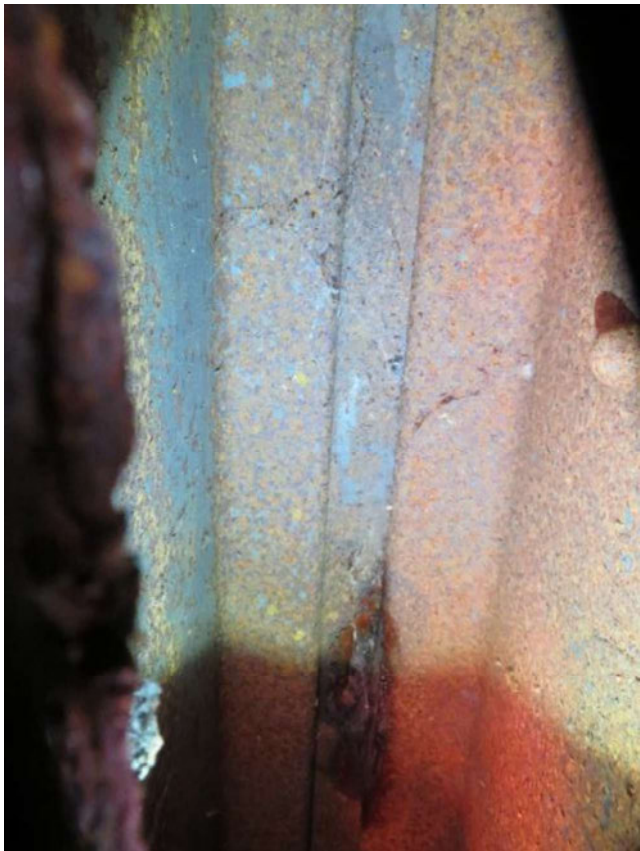
Photograph 18. South Edge Girder at Midspan – Internal Faces

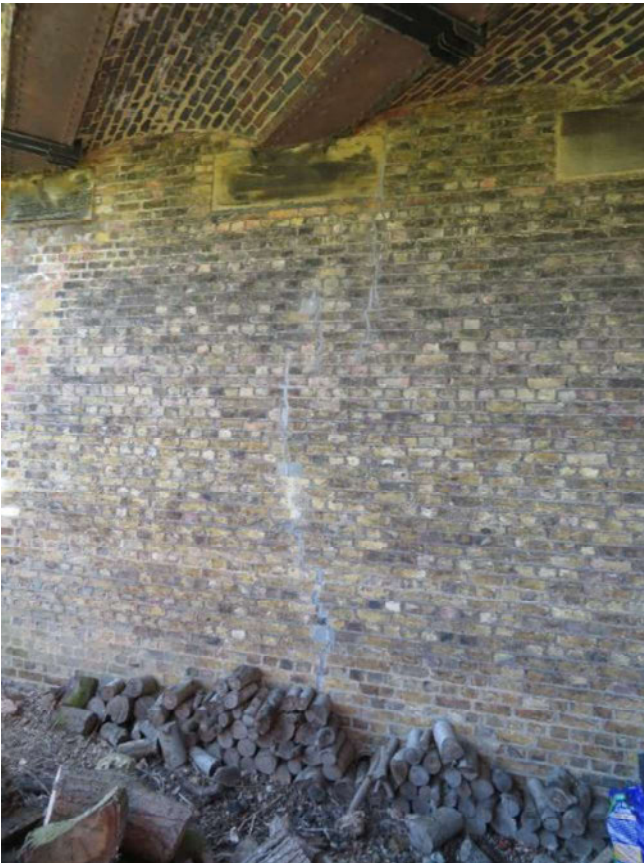
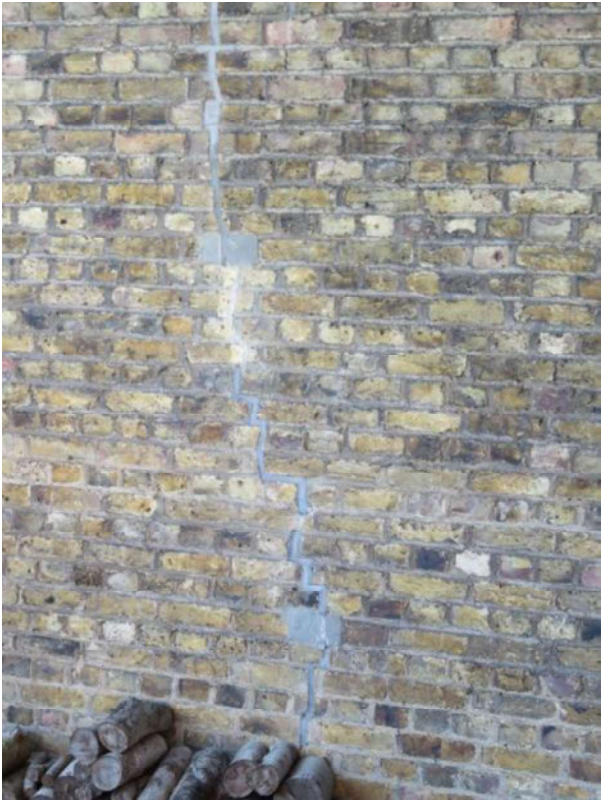
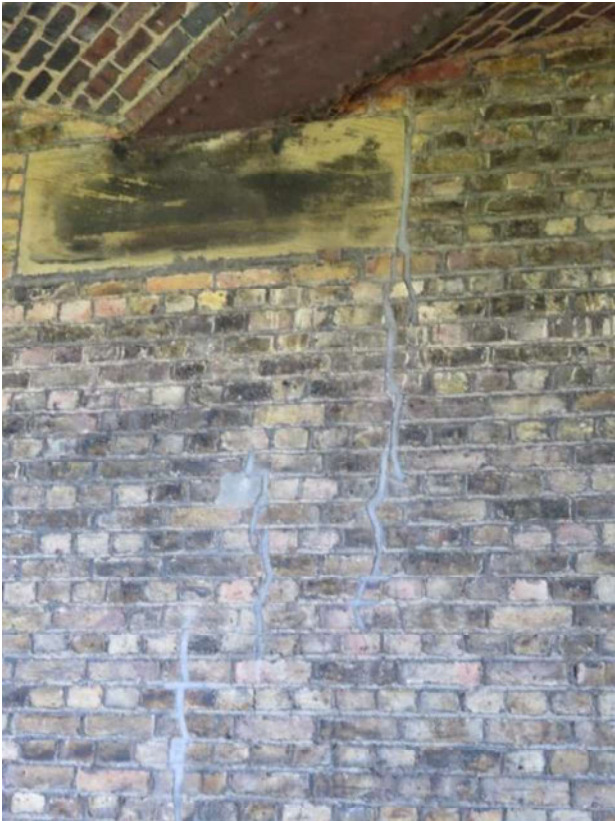
There are a series of three repointed vertical fractures connecting through the full height of the abutment below the bedstone for the second internal girder from the south. Three mortar tabs dated 5/68 were placed, and all appear to have broken and then been repointed at a later date. The repointed mortar has remained intact. There is also another repointed vertical fracture beginning below the north edge girder. The fracture begins 2m from ground level, extending vertically into the bedstone mortar joint and then continuing to the jack arch. A mortar tab dated 58 was installed but has broken. Additionally, a strain gauge has been placed, although one half has broken off.

Photograph 26. West abutment – Fracture below second internal girder from south

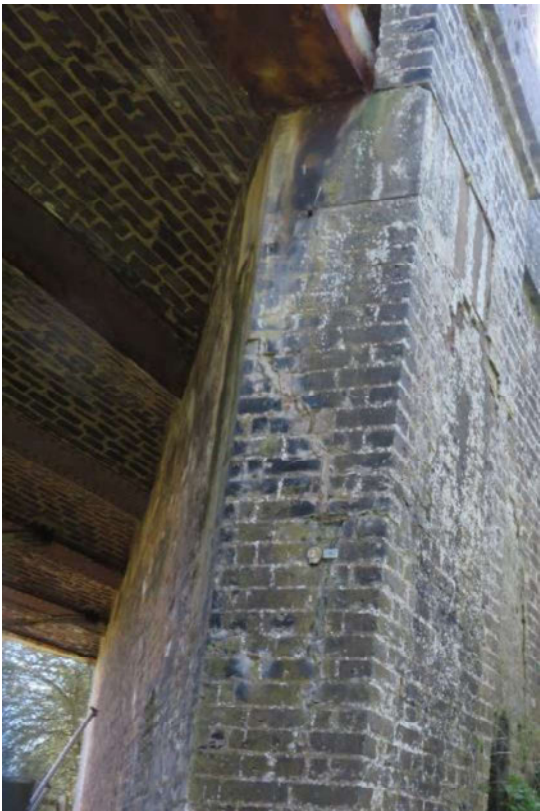
Photograph 29. West abutment – north edge fracture

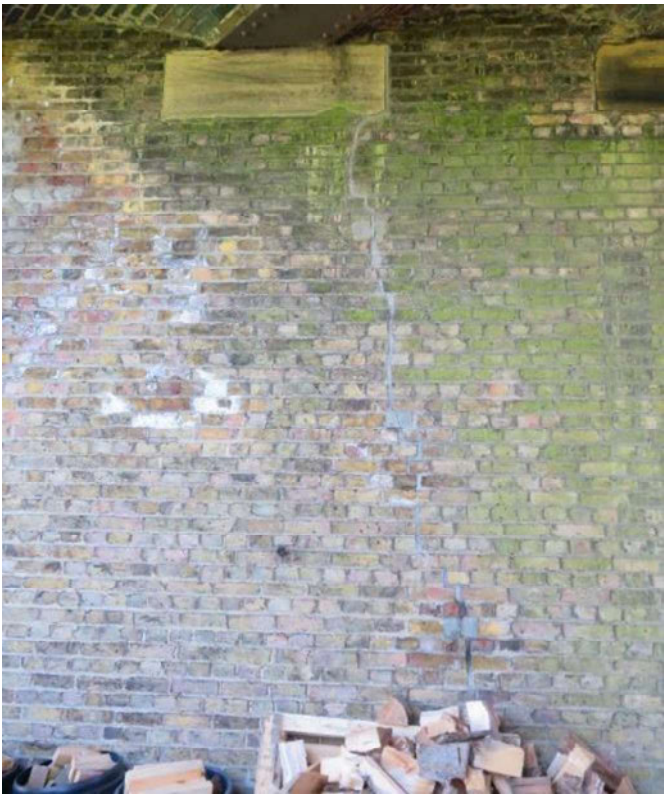
There is a full-height repointed vertical fracture underneath the bedstone for the second internal girder from the north. There is a broken mortar tab dated 5/68 on the fracture. At the broken mortar tab, the fracture is 1mm wide. At the quarter points of the wall, there is damp and algae staining around the bedstones.

Photograph 30. East Abutment – Vertical fracture under second internal girder from north

\*The vertical fractures in the substructure should be monitored to determine if there is any further widening. If there is no evidence of movement, the substructures are considered suitable by qualitative assessment for vehicles conforming to Normal Traffic Loading (40/44 tonnes) as defined by CS454.

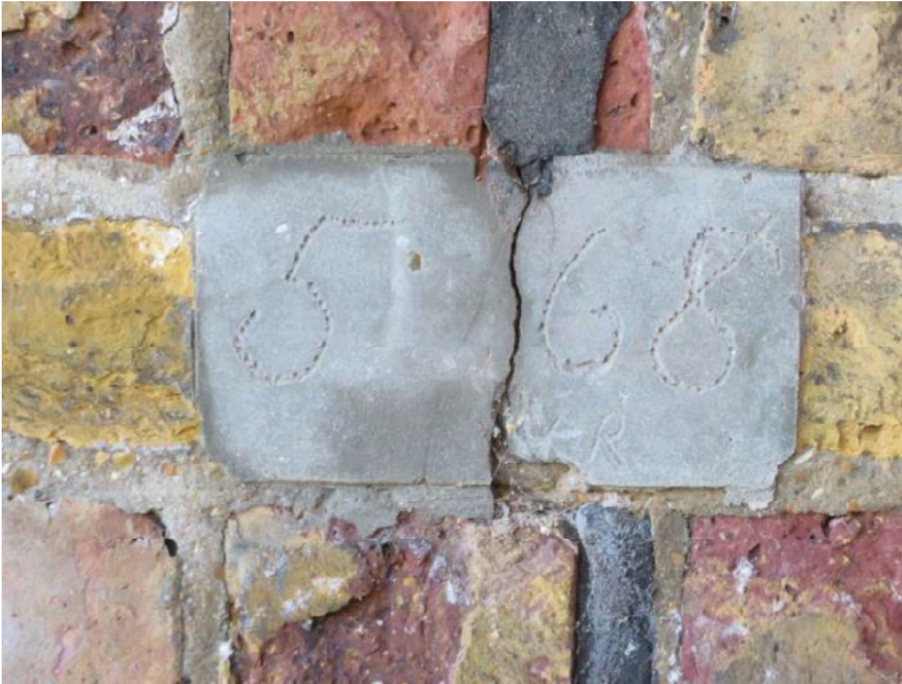
Photograph 31. East Abutment – Vertical fracture under second internal girder from north -broken mortar tab

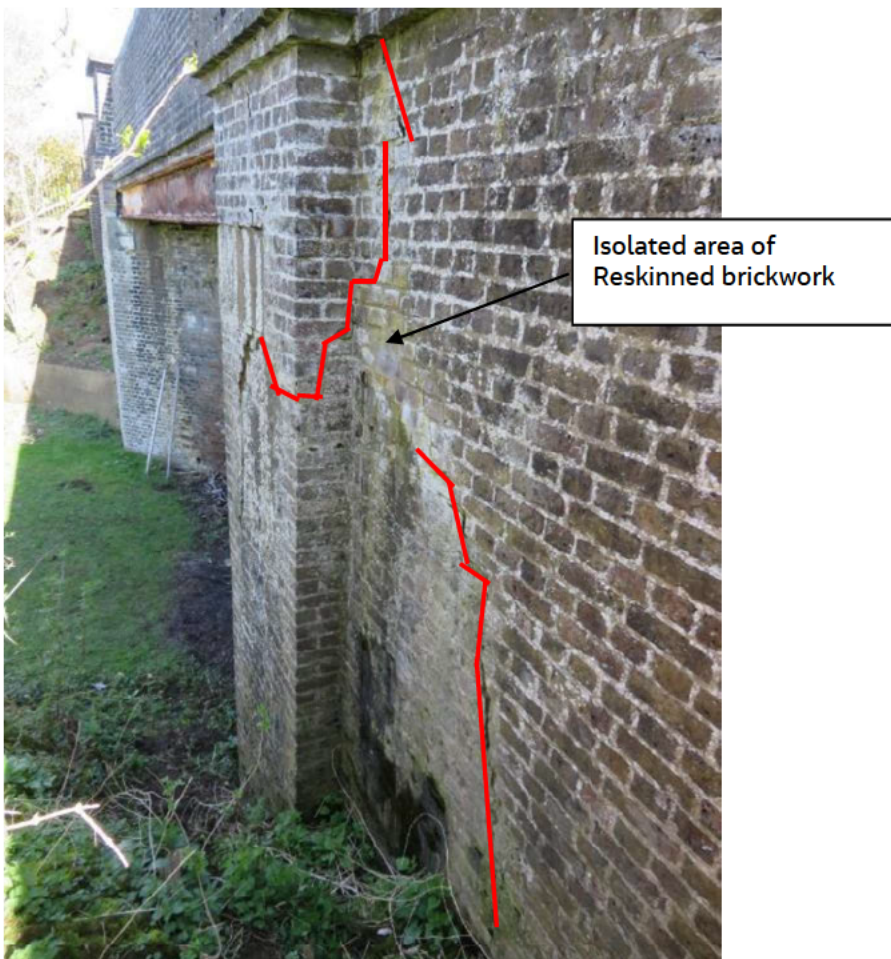
There is a repointed diagonal fracture extending from the bearing stone, passing through the buttress and connecting onto the wingwall. Along the fracture, there is up to 10mm displacement of the brickwork around the bearing stone and there are isolated areas of spalling in brickwork adjacent to the fracture.

The buttress has spalled up to 15mm along its base at ground level

Photograph 32. Northwest wingwall – Diagonal fracture

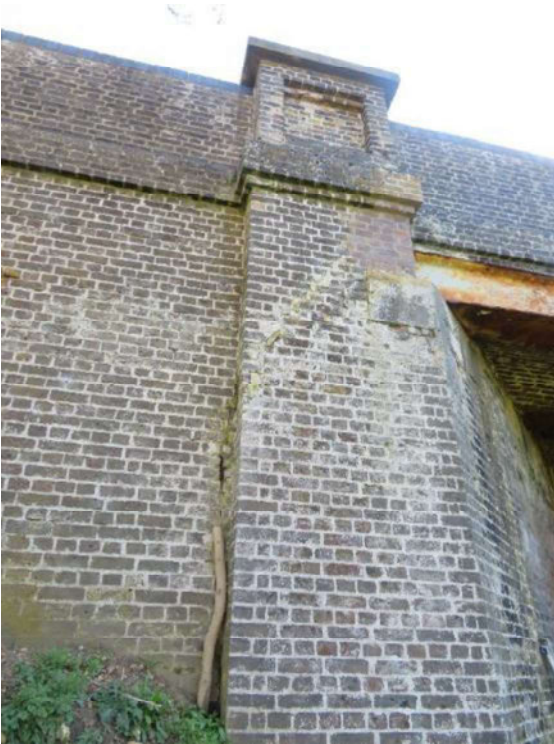
There is a full height vertical fracture, which has been previously repointed, begins at the interface between the wingwall and buttress before stepping through the buttress and string course before halting at the interface between the buttress and parapet walls. Along the repointing mortar, a new 1mm fracture appears to have

developed, and there is some mortar loss in the repointing. The new 1mm fracture has also stepped through a single brick in an isolated area of reskinned brickwork.

Photograph 33. Northeast wingwall – Vertical fracture

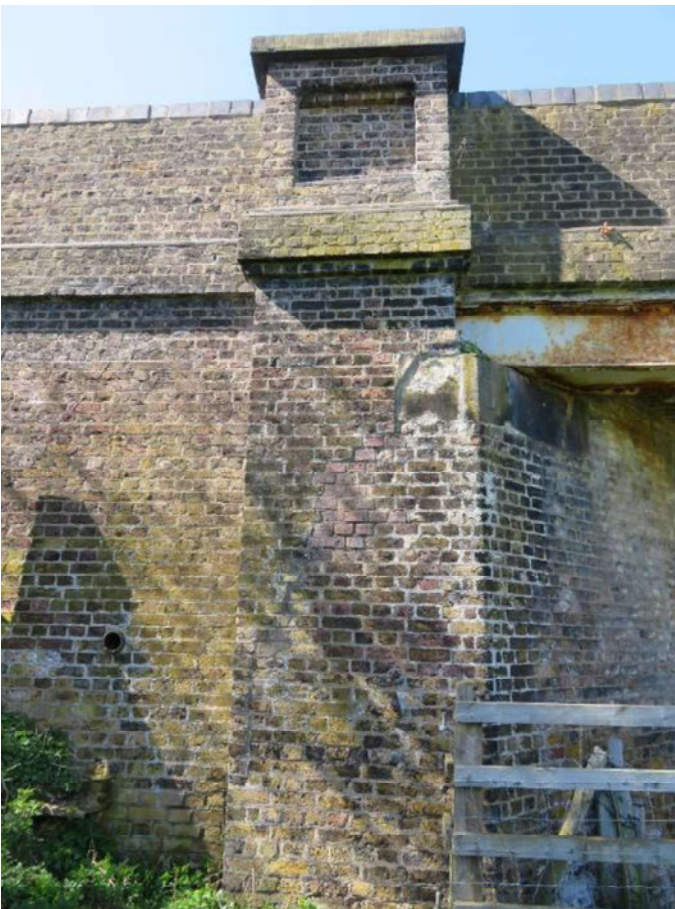
There is a stepped fracture on the buttress which has been filled. Joining the step fracture there are two hairline fractures. The Pilaster has been displaced outward by 5 to 10mm at the stringcourse

Photograph 34. Southwest wingwall – Fracture

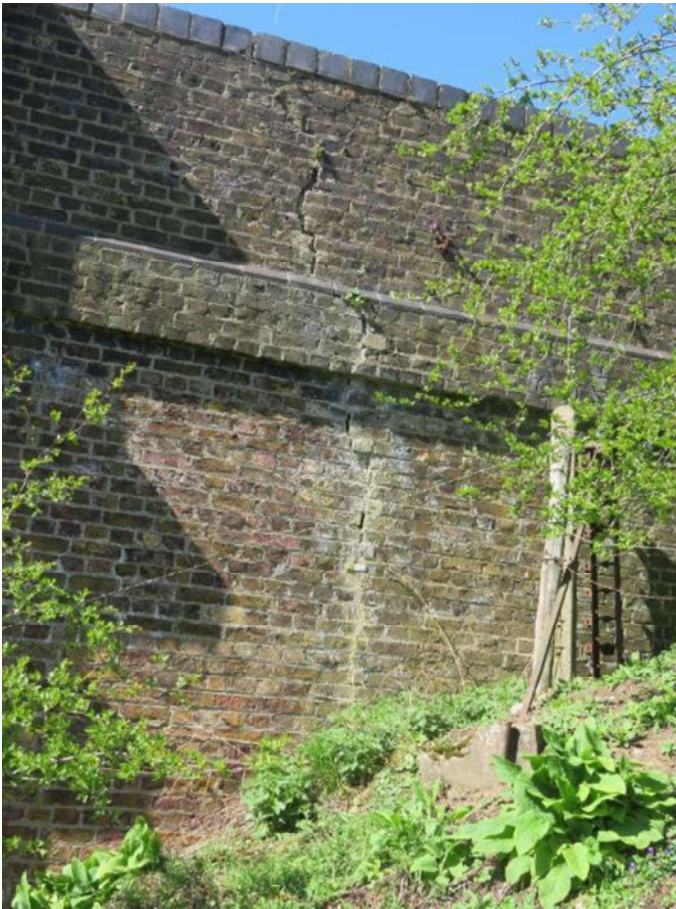
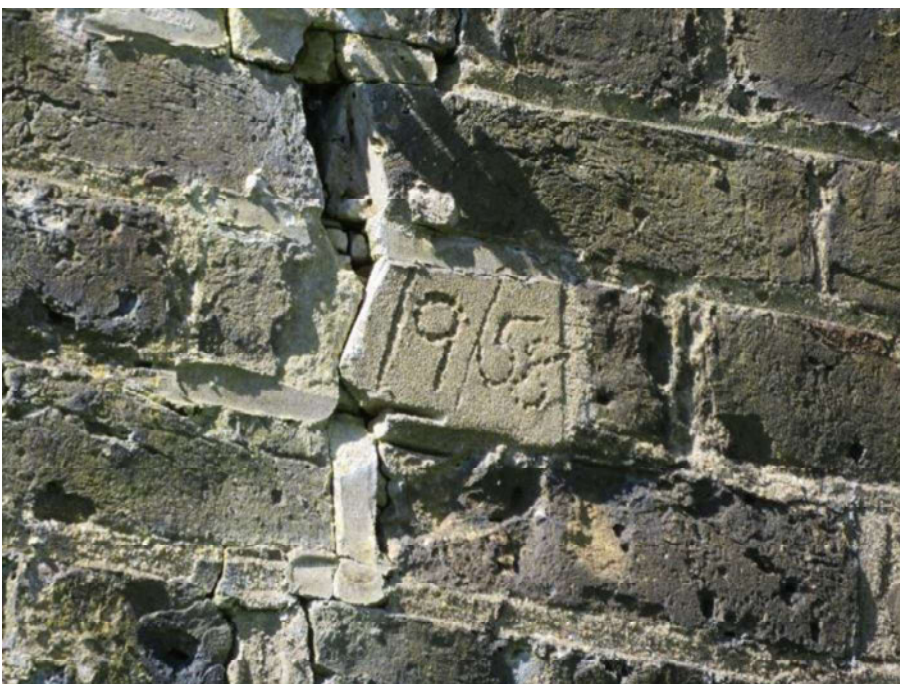
There is a full height 10mm vertical fracture at the centre which has been previously filled. Along the fracture, the material used in the repointing of the fracture appears to be loose and spalled away in isolated areas. There is a broken mortar tab on the fracture, dated 5/68.

Photograph 35. Southeast wingwall – Fracture

Photograph 36. Southeast wingwall – fracture mortar tab

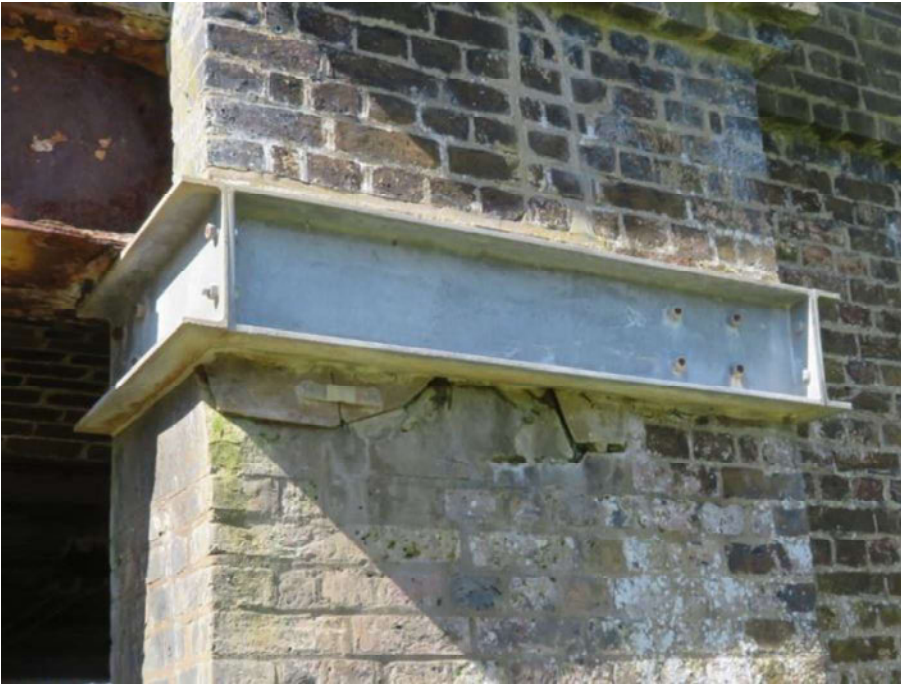
On the buttress, the bearing stones have multiple fractures and channel reinforcement has been added.

Photograph 37. Southeast wingwall - buttress

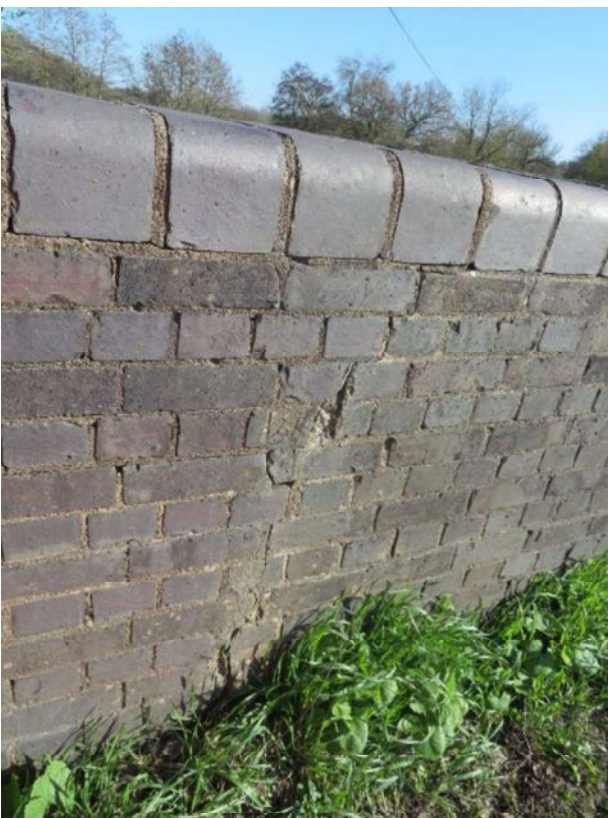
At the interface between the parapet wall and southeast pilaster, there is a full-height 3mm vertical fracture. Along the fracture, there is a broken mortar tab. There is also 2mm vertical fracture extending over a 1m length; the fracture is located 2m east of the Southeast pilaster. One the fracture there is a broken mortar tab.

Photograph 40. South Parapet – broken mortar tab

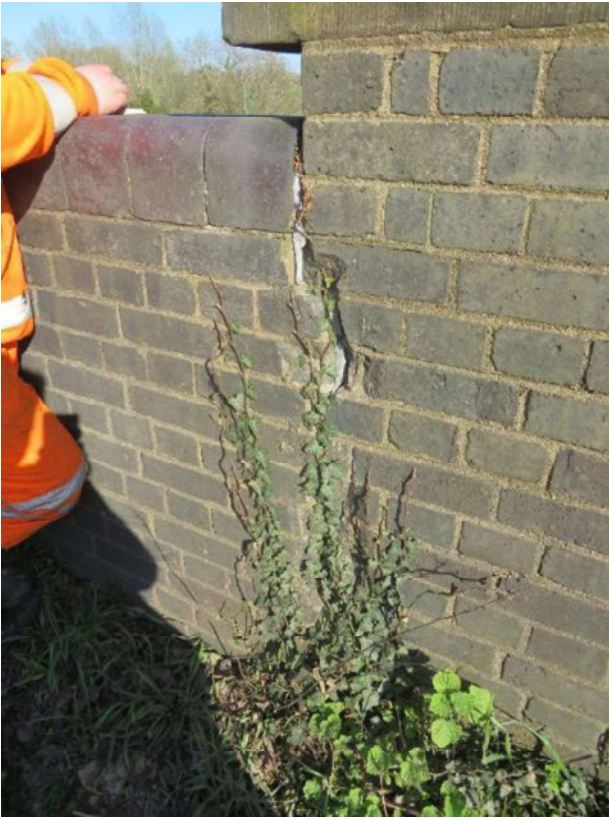
At the interface between the parapet wall and southwest pilaster, there is a full-height vertical fracture, which appears to have been filled with a polyethylene filler.

Photograph 41. Southwest Parapet – Filled fracture
