## **HRE Assessment Programme**

Highways England - Historical Railways Estate

**WAB/8, Waltham to Chadwell Road, Leicestershire**

**BD21 Assessment and Inspection Report**

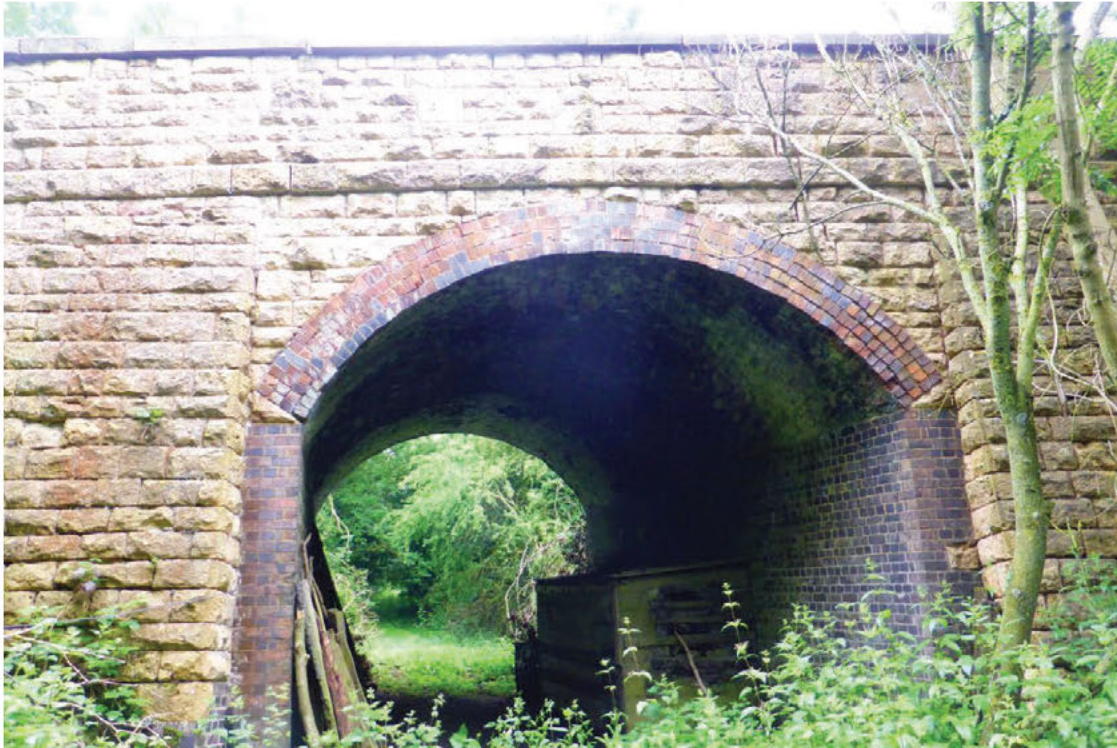
Mature trees are growing on the shallow cutting slopes both east and west of the structure (Photographs 23 and 24). There is a shed and materials storage on the formation beneath the arch with light vegetation growth towards the north east (Photographs 1 and 2).

1) East elevation

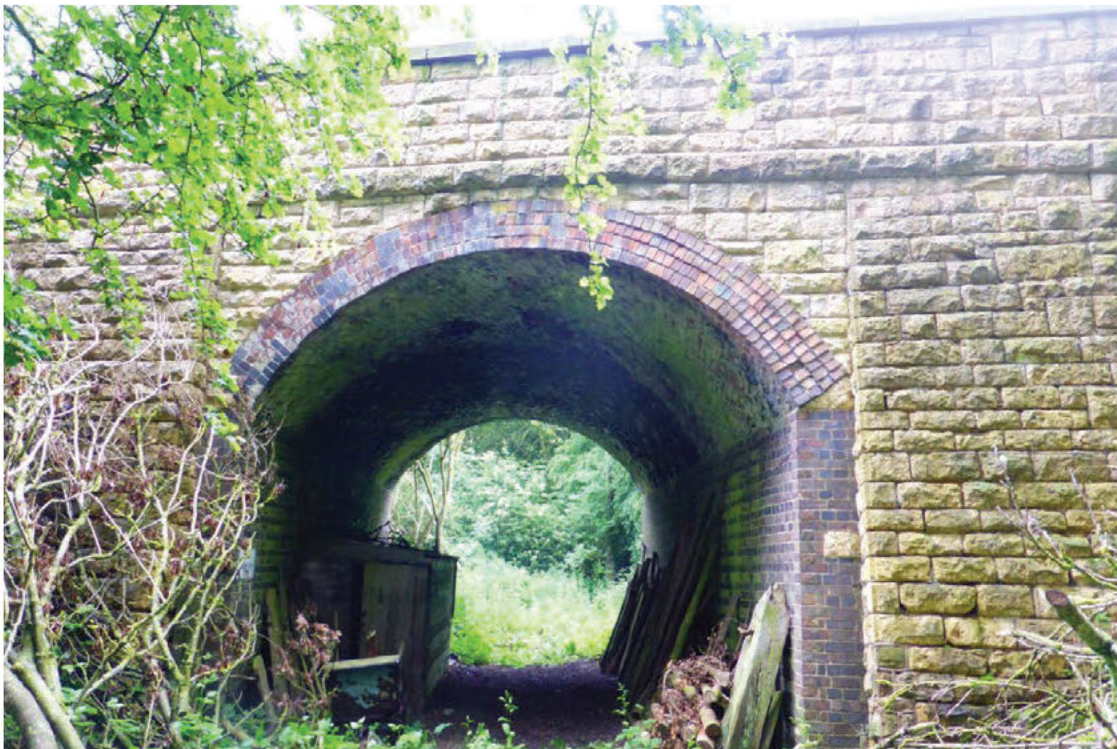
2) West elevation

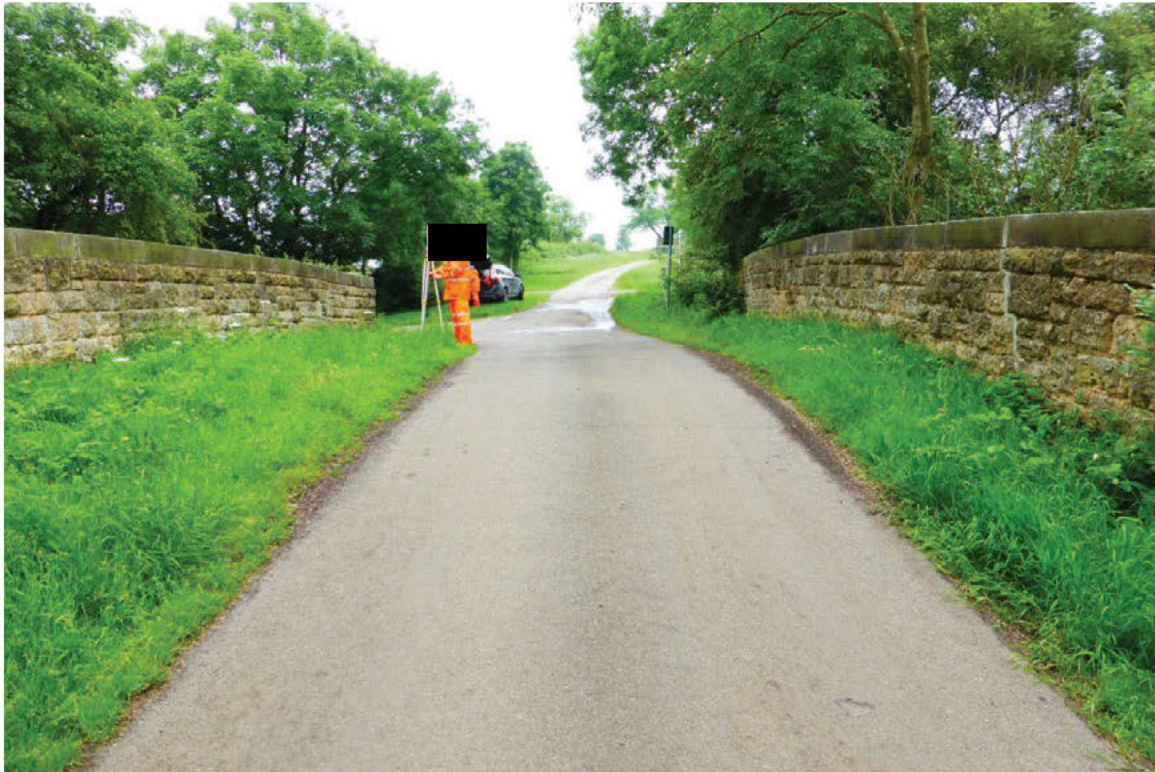
The road surface above the structure is in fair condition (Photographs 3 and 4).

3) View of carriageway approach looking north

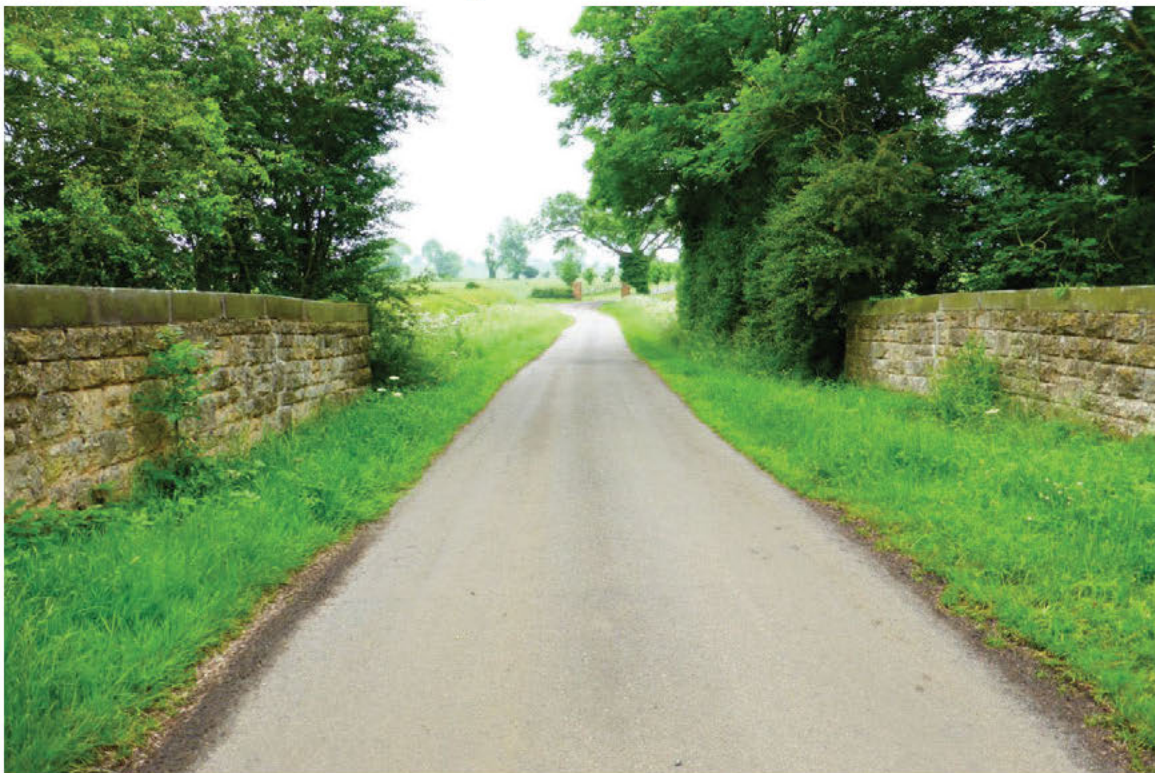
4) View of carriageway approach looking south

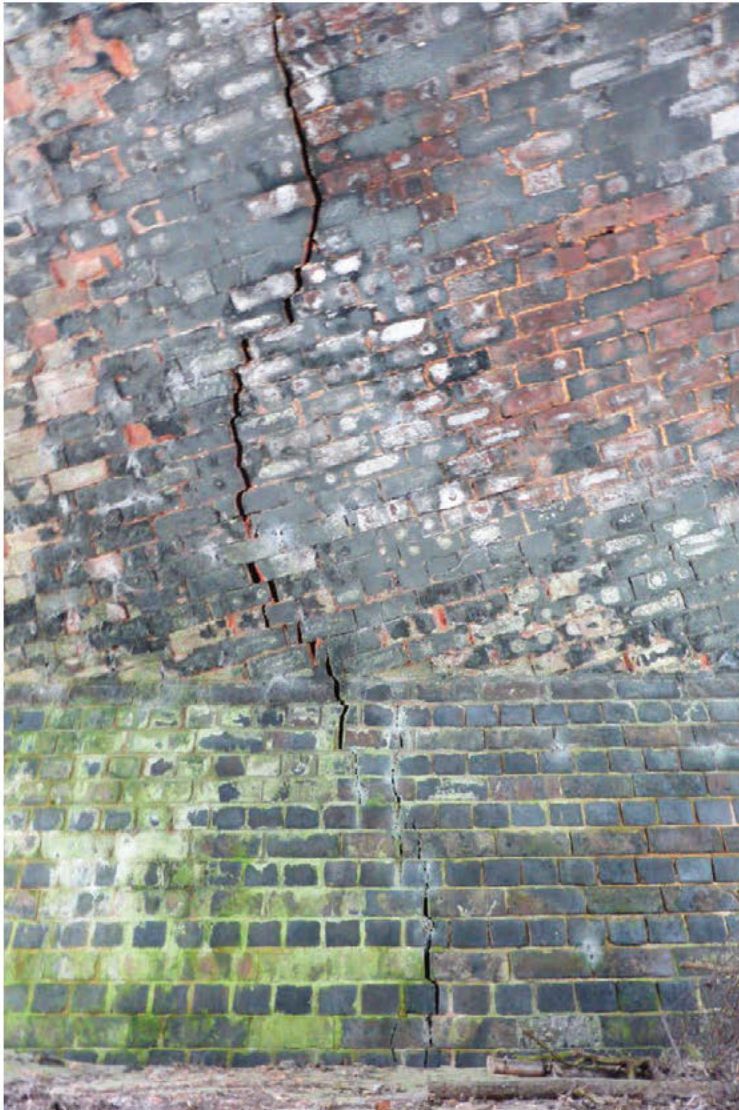
A 15mm wide vertical fracture, originating from the crown of arch extends down to the abutment face along the centreline of the barrel (Photograph 6). The fracture appears to be active judging by the freshly exposed brick surfaces. It is noted that although detailed monitoring is being carried out on cracks in the parapets, this fracture is not even tabbed. The arch appears to be breaking into two independent sections. A condition factor of 0.4 is derived accounting for the longitudinal fracture, slight flattening of the arch towards the north east corner and ring separation (Photograph 1); (BA16/97 Clause 3.17 – 3.21).

The fracture appears to be a result of differential settlement across the northern abutment. This is also reflected in movement in the parapets. Traditional brickwork repairs alone would not be sufficient to repair the fracture or prevent further movement. More extensive repair works, such as underpinning, may prevent further separation of the arch, though structural infilling may provide a more cost effective solution once the additional arch defect repairs are considered.

Previous examinations detail the fracture in a similar condition to that recorded during this assessment as early as 2003. Although it would appear that the fracture is old standing and no longer active, parapet fracture movements have been recorded in recent years. There are no devices such as mortar tabs or avonguards installed to monitor and confirm movement across the abutment or arch barrel. The fracture should be monitored closely for further movement prior to the completion of major works.

6) North west view of the arch barrel – fracture originating from arch barrel down to abutment

As determined by this MEXE assessment, the bridge can carry 40/44 tonne AW loading in accordance with BD21/01, however the longitudinal fracture through the northern half of the bridge's centreline raises concerns regarding the bridge's condition. The fracture is an indication that the arch barrel is actively breaking up into independent sections; it is recommended that major works to prevent further deterioration are undertaken.

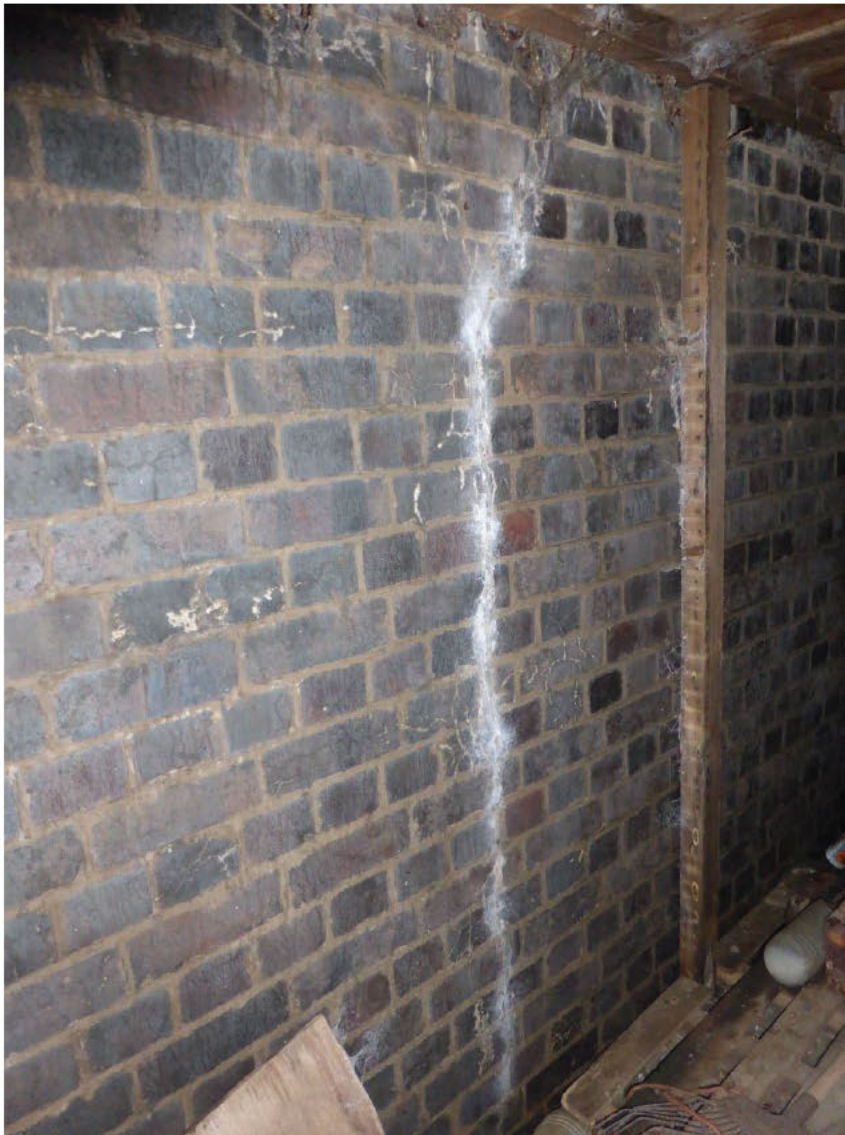
The north abutment is in poor condition. There is a fracture 15mm wide the height of the abutment which continues into the crown of arch barrel. Due to the presence of a timber shed adjacent to the abutment wall, a close inspection of the fracture was not possible (Photograph 9). There is algal staining throughout with isolated leachate patches across the whole surface. A vertical fracture, 2mm wide, originating from the north east springing point stretches approx. 1.9m down to the abutment face (Photograph 10).

The vertical fracture through the north abutment raises concerns regarding the capacity of the substructure. The substructure currently appears to be satisfactory for vehicles conforming to the Road Vehicles (Authorised Weight) Regulations (BD 21 (DMRB 3.4.3)), though should be monitored closely.

10) North abutment – fracture view behind the shed

The vertical fracture through the north abutment raises concerns regarding the capacity of the substructure also. This should also be monitored closely prior to the completion of major works.

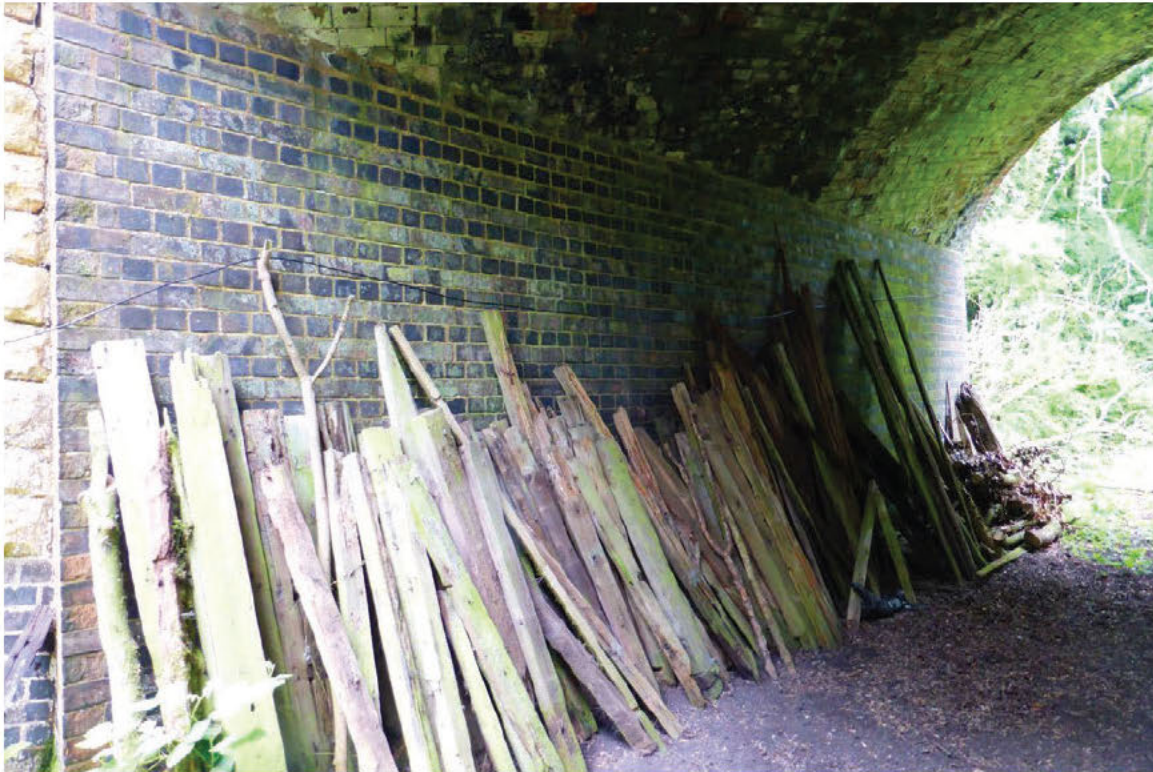
The south abutment is in fair condition with algal covering a third of the surface area. There are stowed materials across the wall which prevents the closest inspection of the lower half (Photograph 11).

11) South abutment

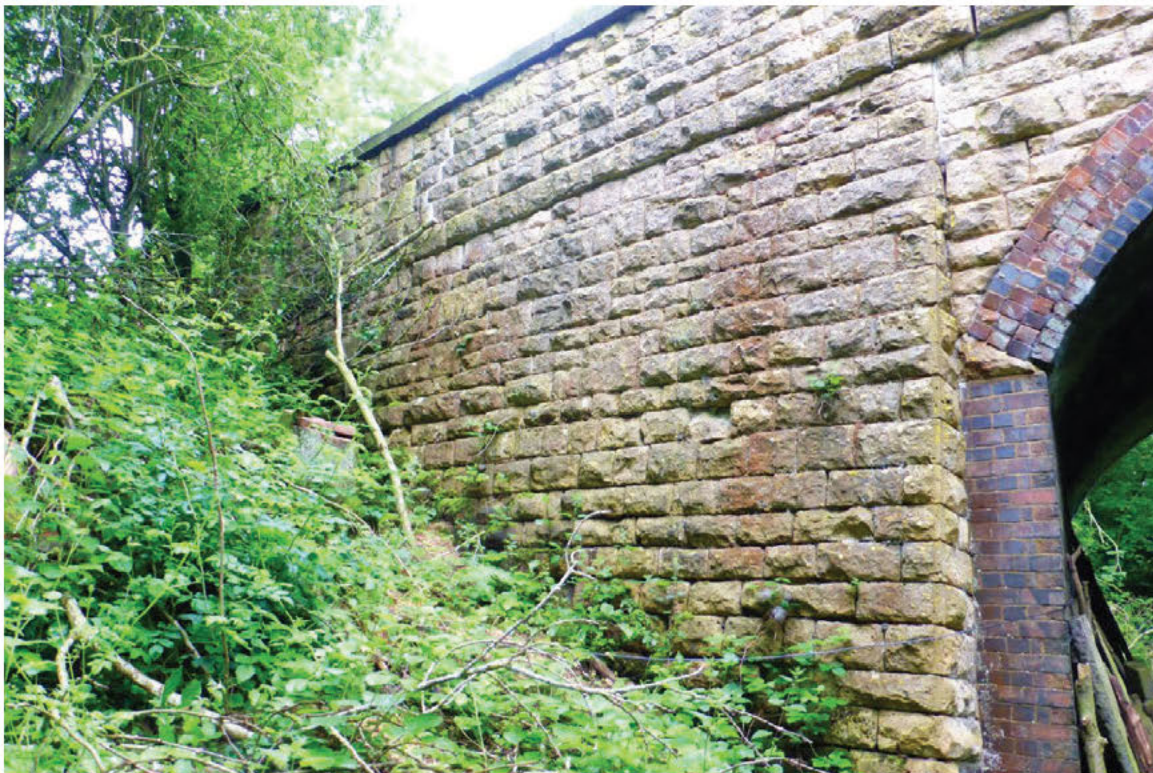
The north east and south west wingwalls are in similar condition with isolated fractured and spalled blocks. There are patches of open joints, up to 10mm wide. There is light vegetation growth within the open joints on the south east wall. Dense vegetation and mature trees growing in front of the north east wall limited close inspection (Photographs 12 and 13).

12) South east wingwall

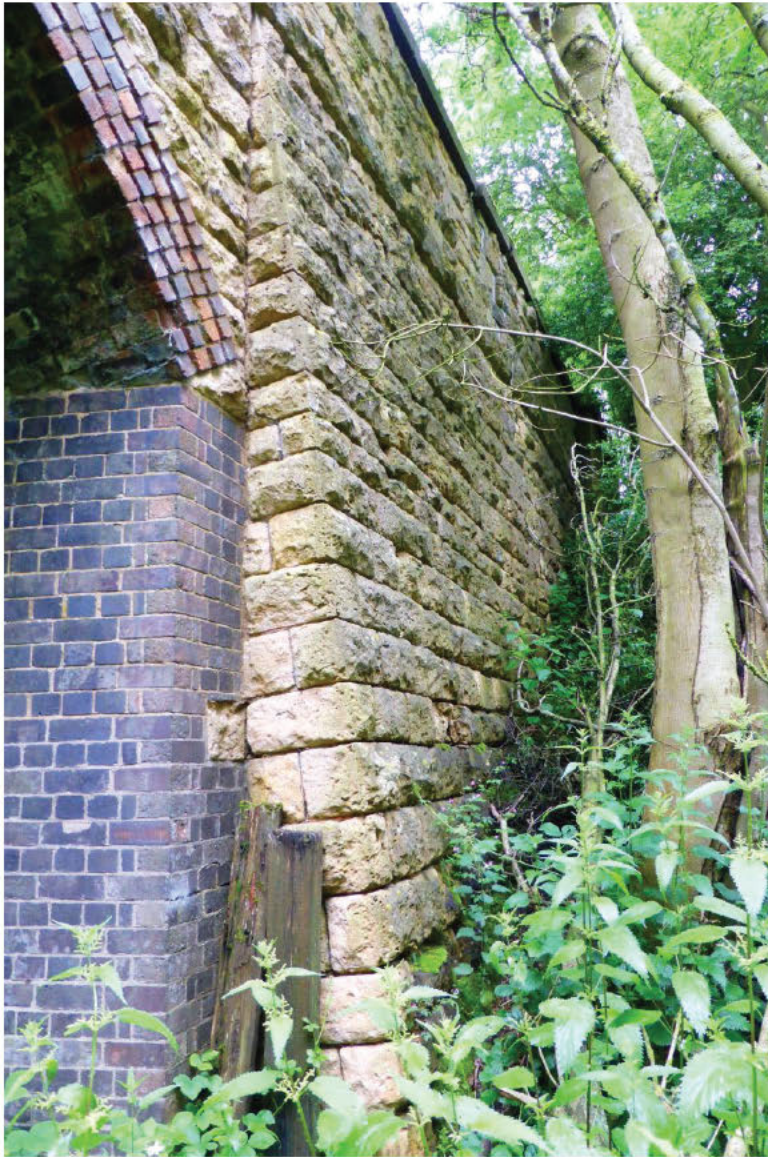
13) North east wingwall

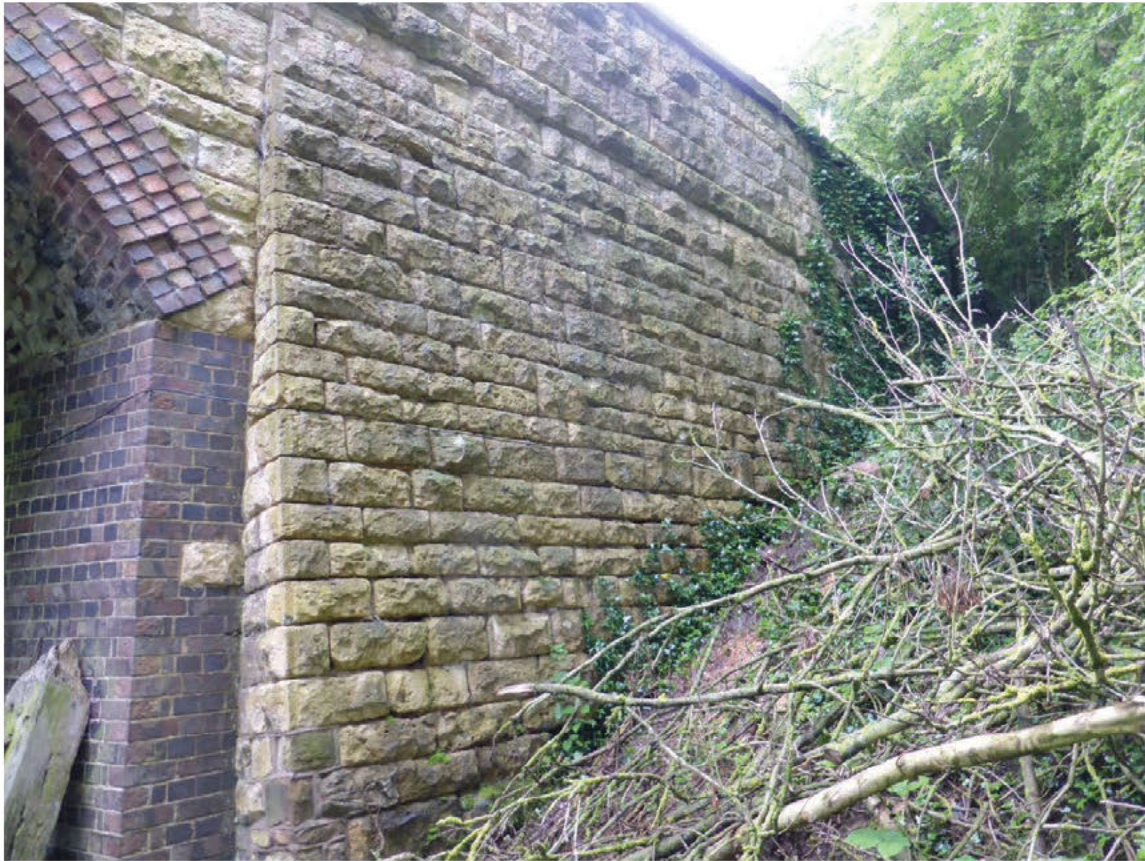
The north west and south west wingwalls have isolated areas of mortar loss. There is a mortar repair 0.5m<sup>2</sup> at the base of south west wall (Photographs 14 and 15).

14) South west wingwall

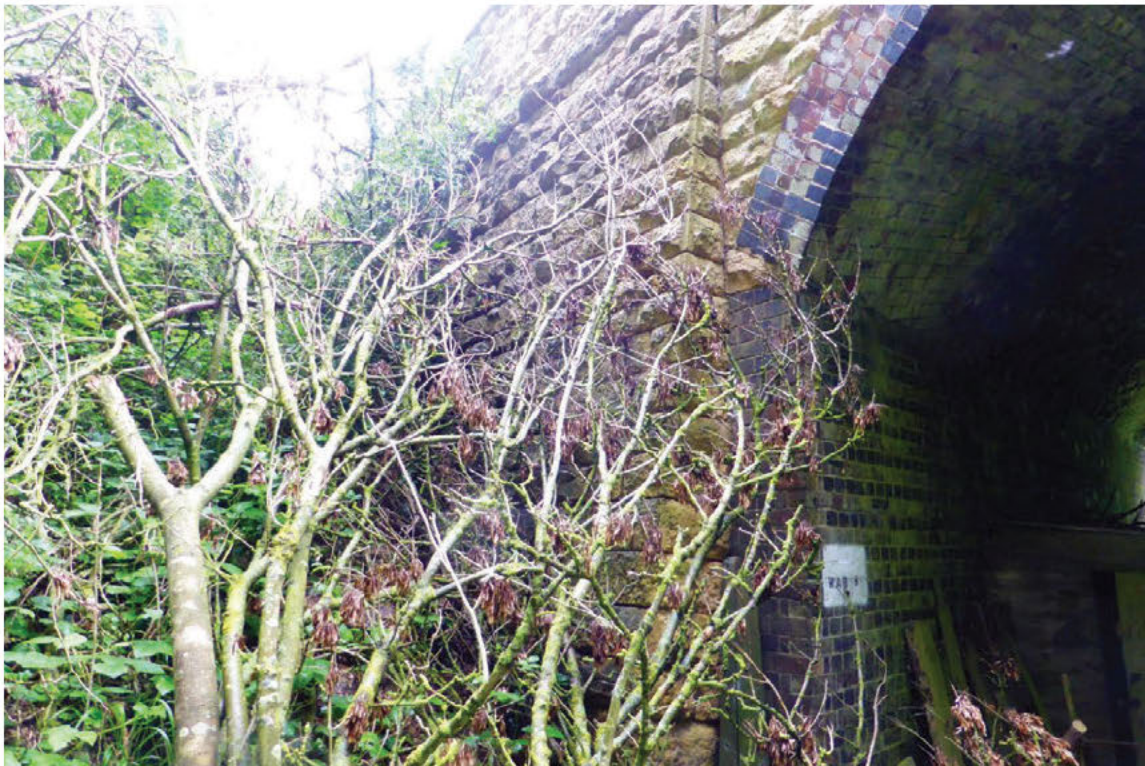
15) North west wingwall

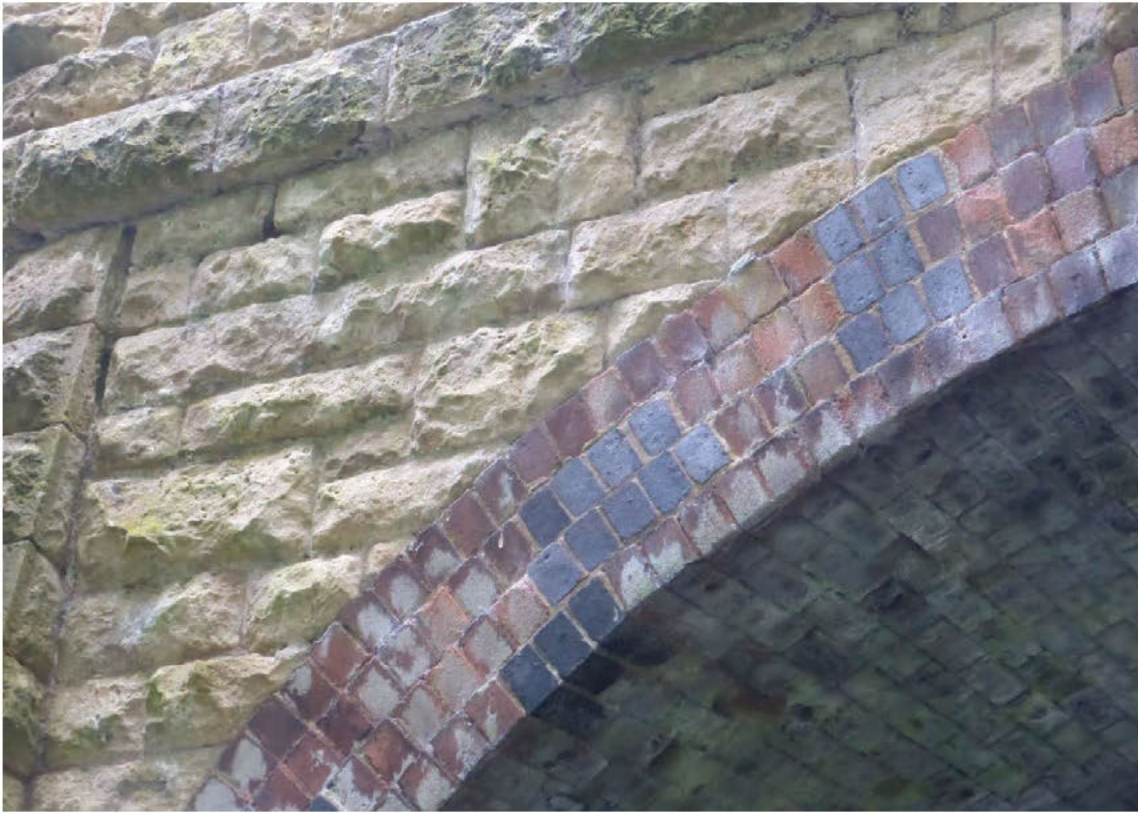
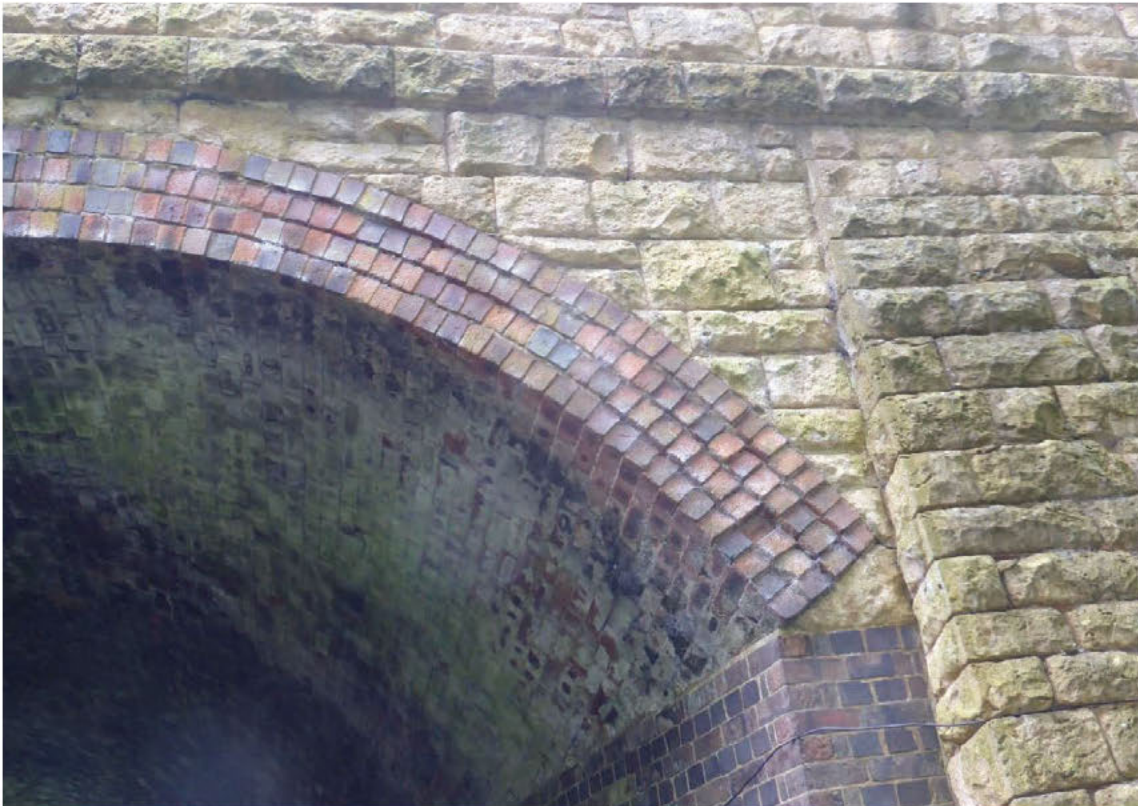
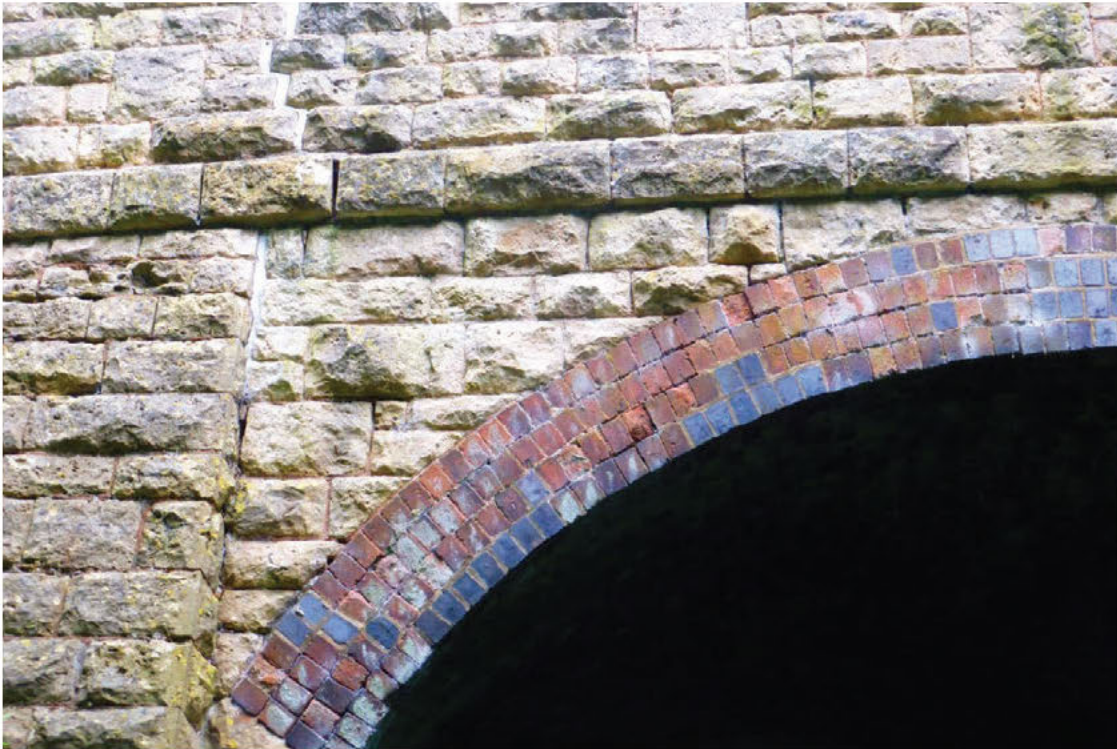
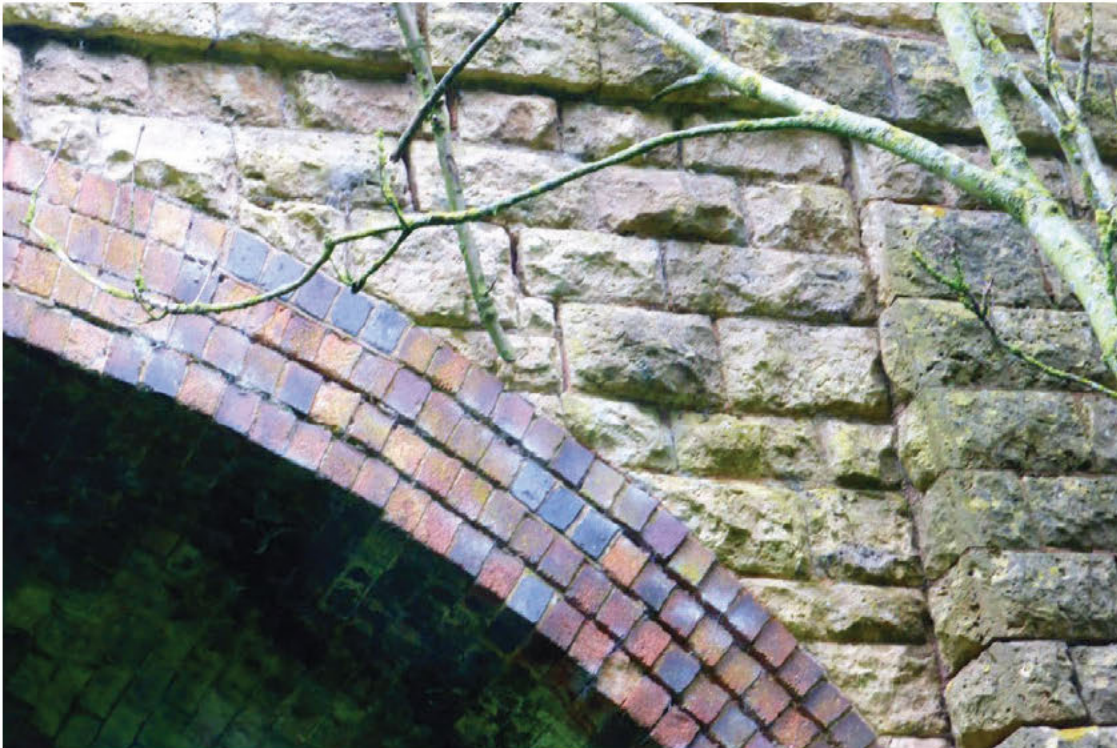
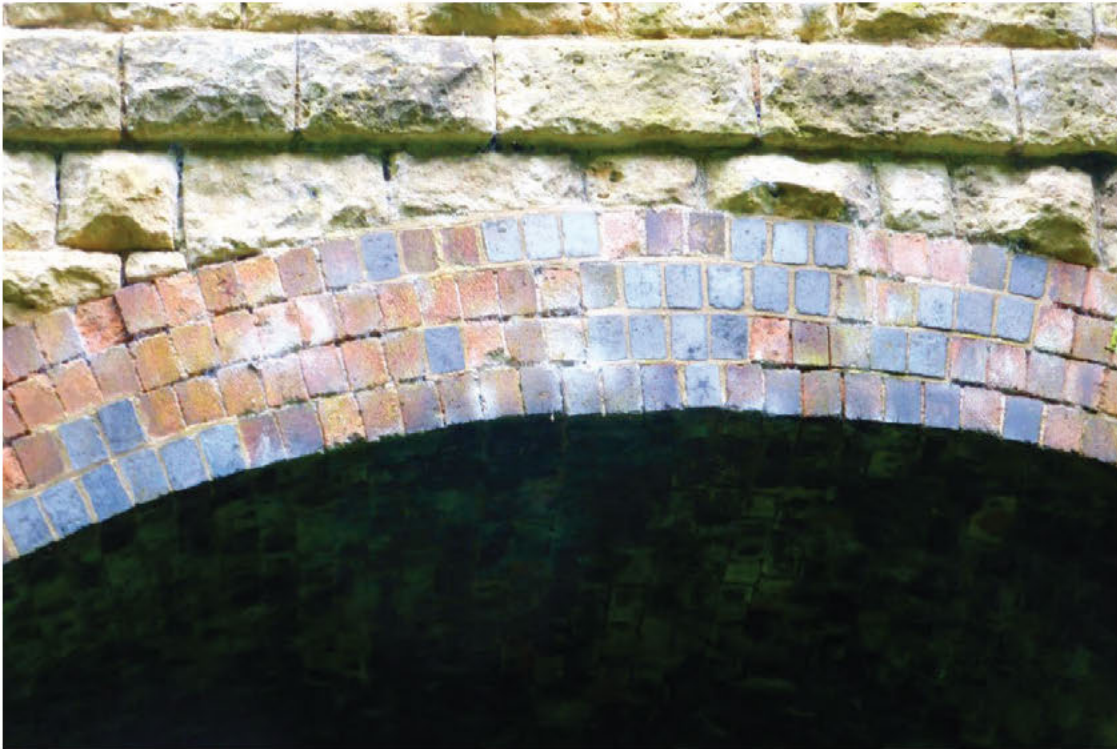
Both spandrel walls are in fair condition (Photographs 16- 20). Mortar repairs have been carried out between the south east spandrel and the buttress.

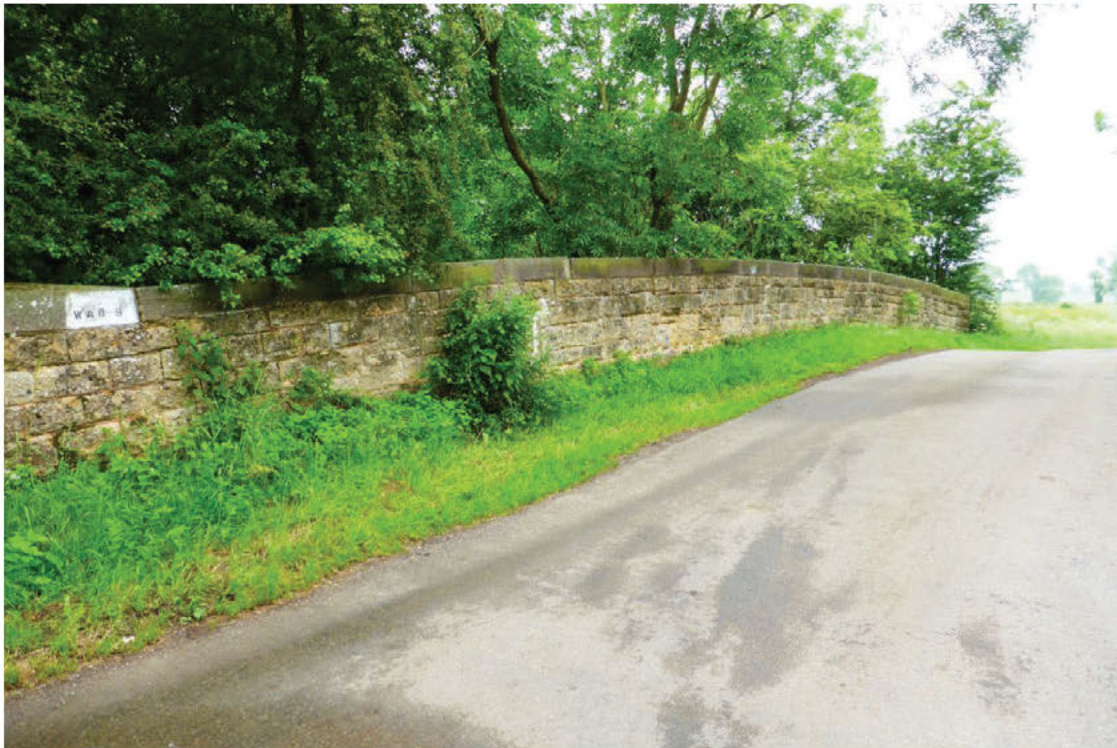
Both parapets are in fair condition with damp stains and weathering. On both sides of the parapets there are mortar repairs up to 20mm in width. The majority of the repairs are open up to 2mm. On both inner faces there are step fractures adjacent to repaired fractures with open up to 5mm (Photographs 20 and 21). This is could be a result of ground settlement above all wingwalls of the structure.

21) West parapet

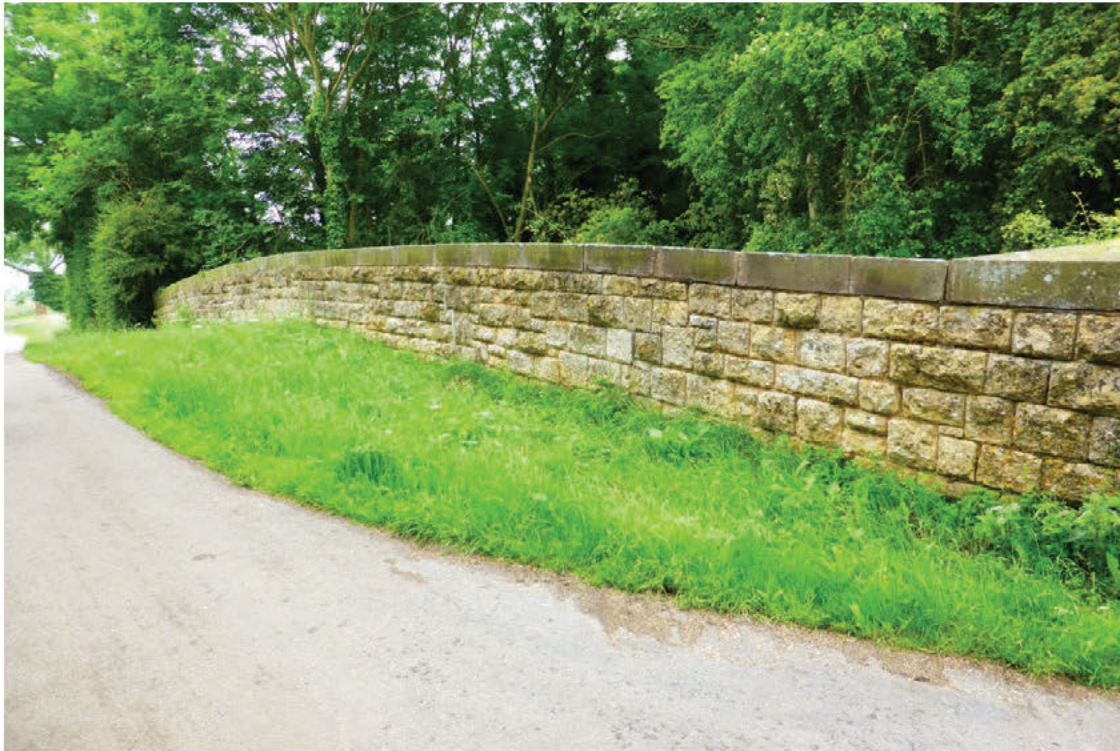
22) East parapet

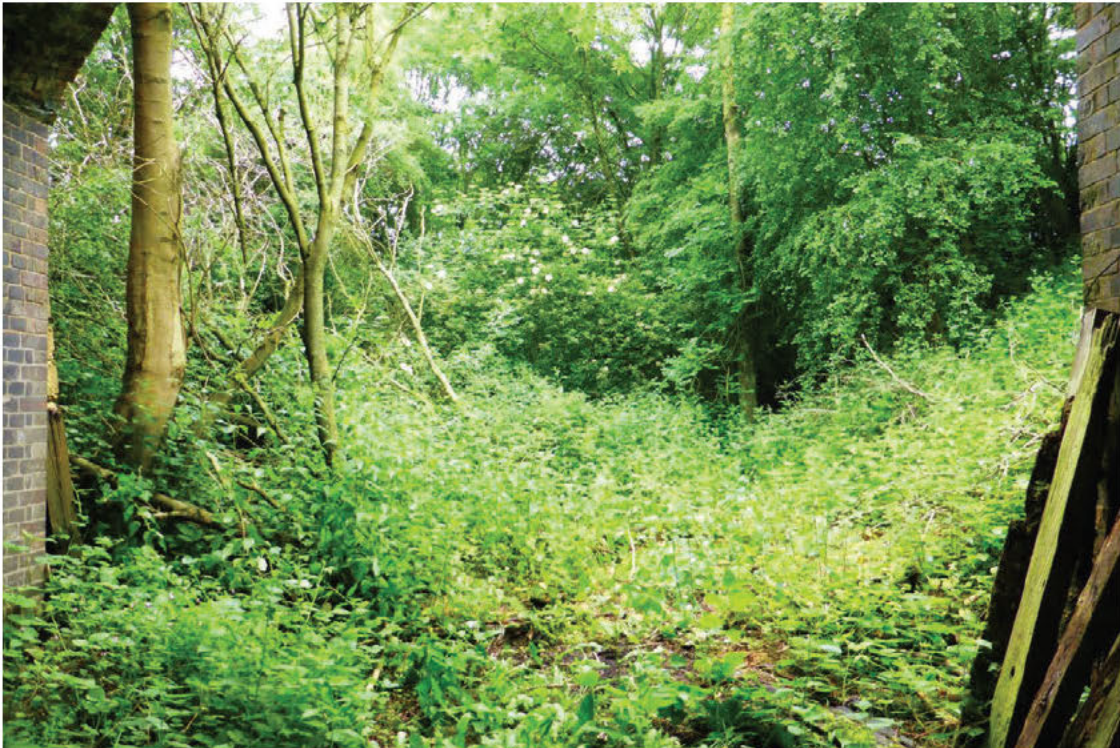
23) Formation looking east

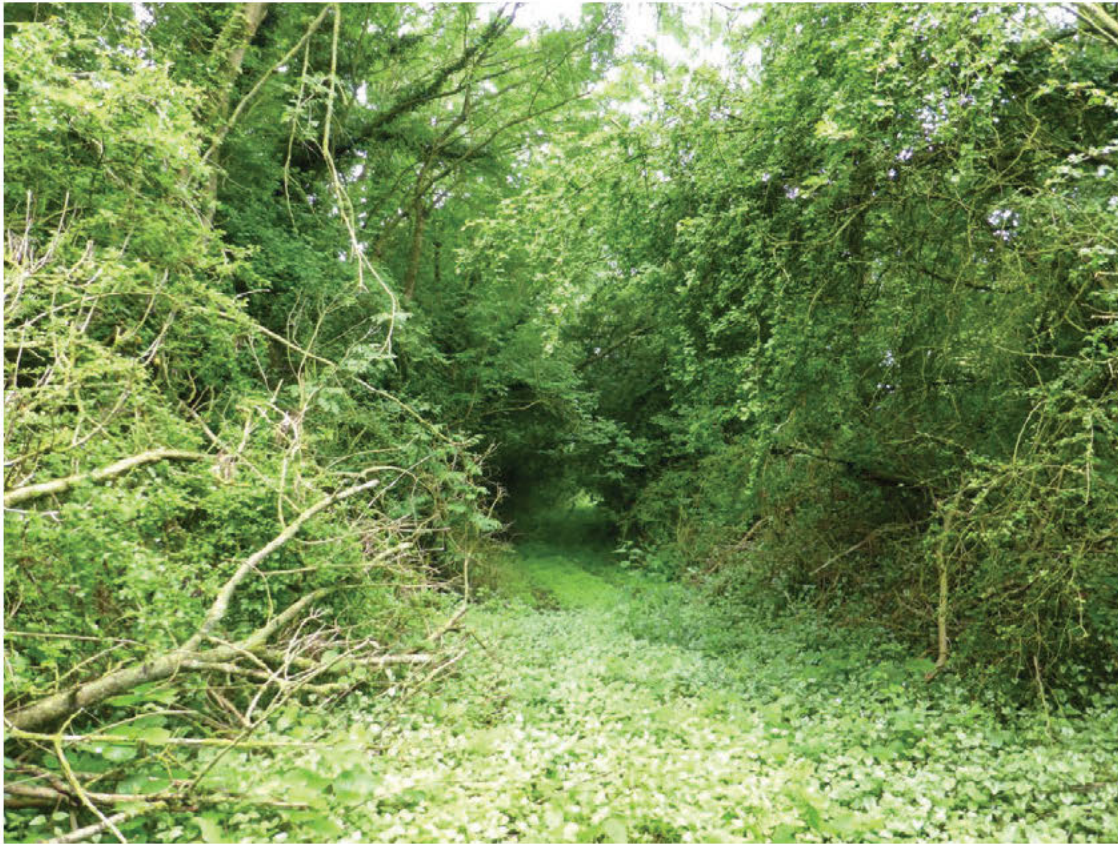
24) Formation looking west
