HRE Assessment Programme

Highways England - Historical Railways Estate

AYH/1, Limekiln Road, South Ayrshire

BD21/01 Assessment and Inspection Report

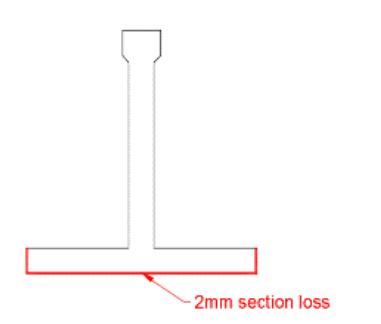
The internal girders are in fair condition. Up to 2mm of section loss was recorded across all the exposed parts of the girders. (Photograph 5 and 12)

Figure 4: Section loss observed on internal girder.

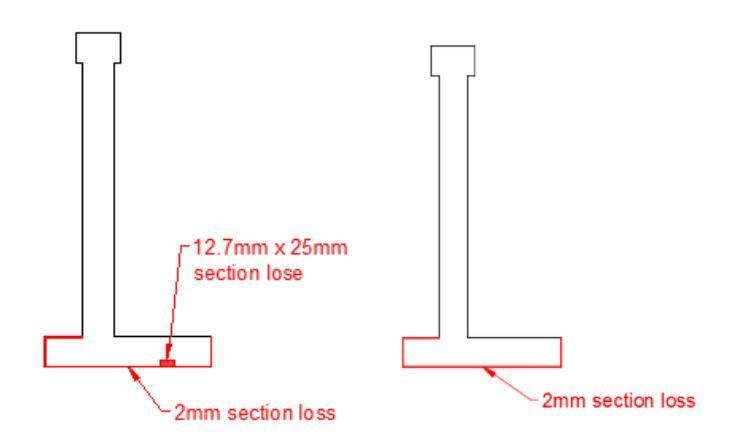
The edge girders are in a fair condition with section loss of up to 2mm observed along the underside of the exposed section of the girder. On the southern edge girder, a section 25mm by 75mm area near to the support has also experienced up to 13mm of section loss. (Photograph 13)

Figure 5: Section loss observed on edge girders at support (left) and midspan (right).

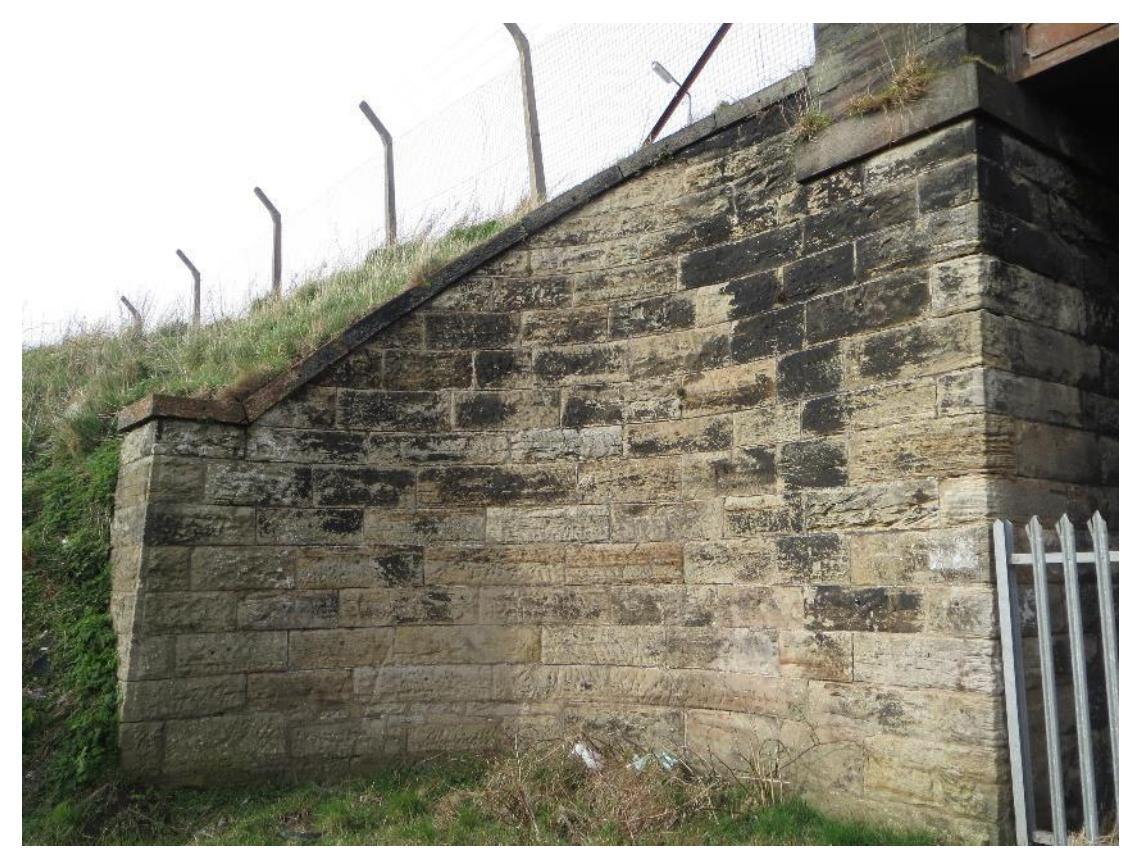
The wingwalls are in good condition. Minor weathering of the stonework and mortar loss in the joints was noted on all the wingwalls, especially on the south face (Photographs 6 to 9).

6) Southeast wingwall

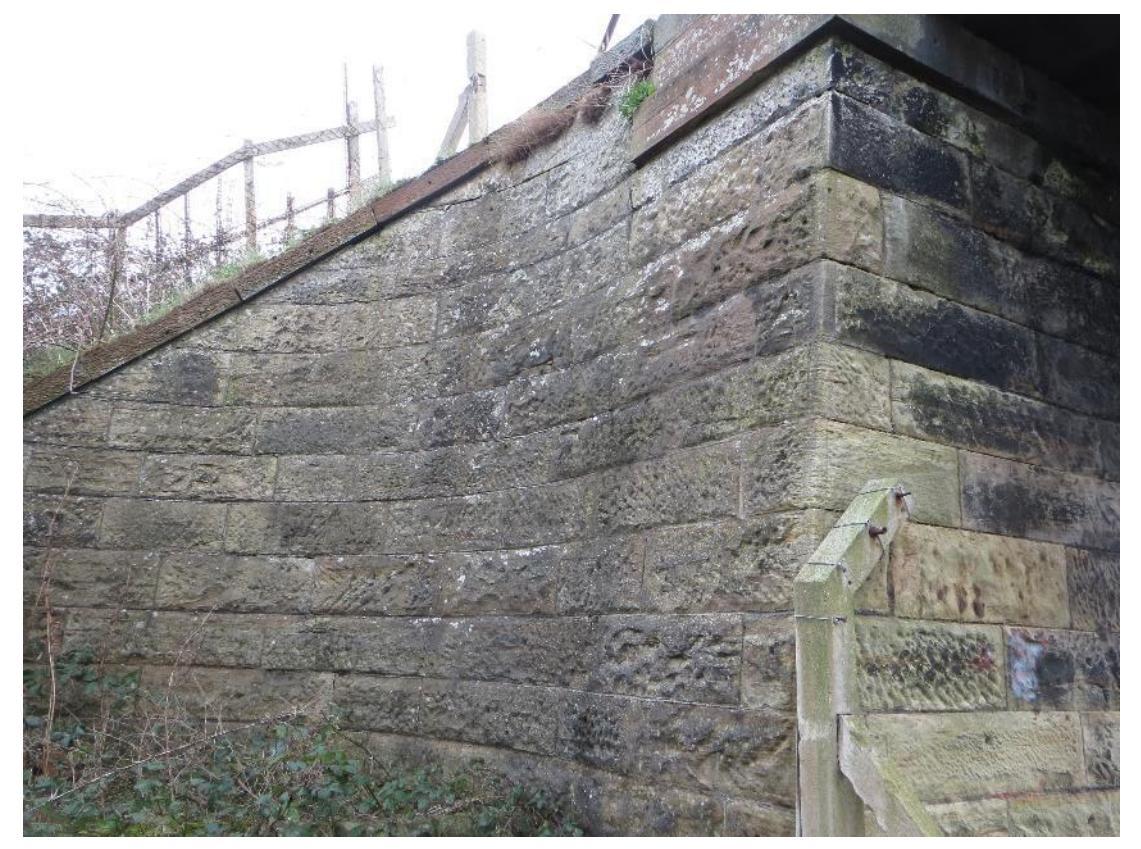
7) Southwest wingwall

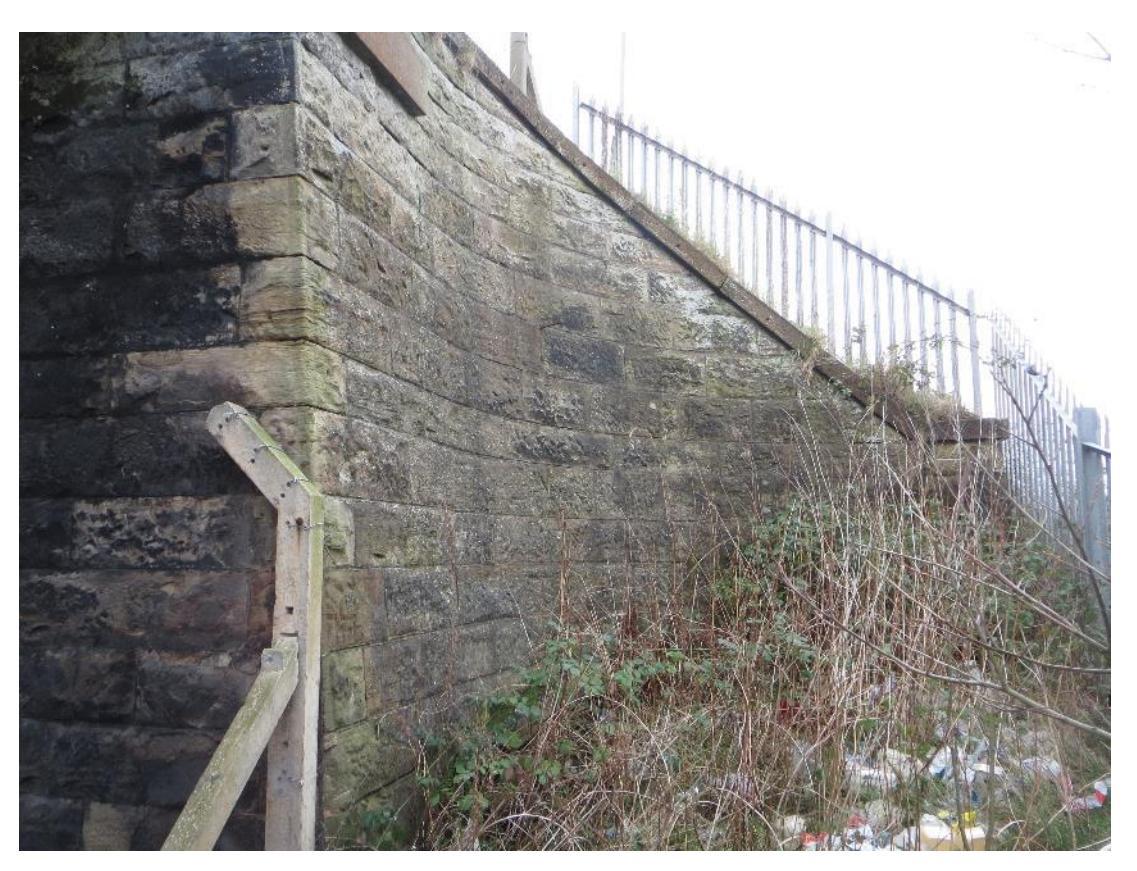
8) Northeast wingwall

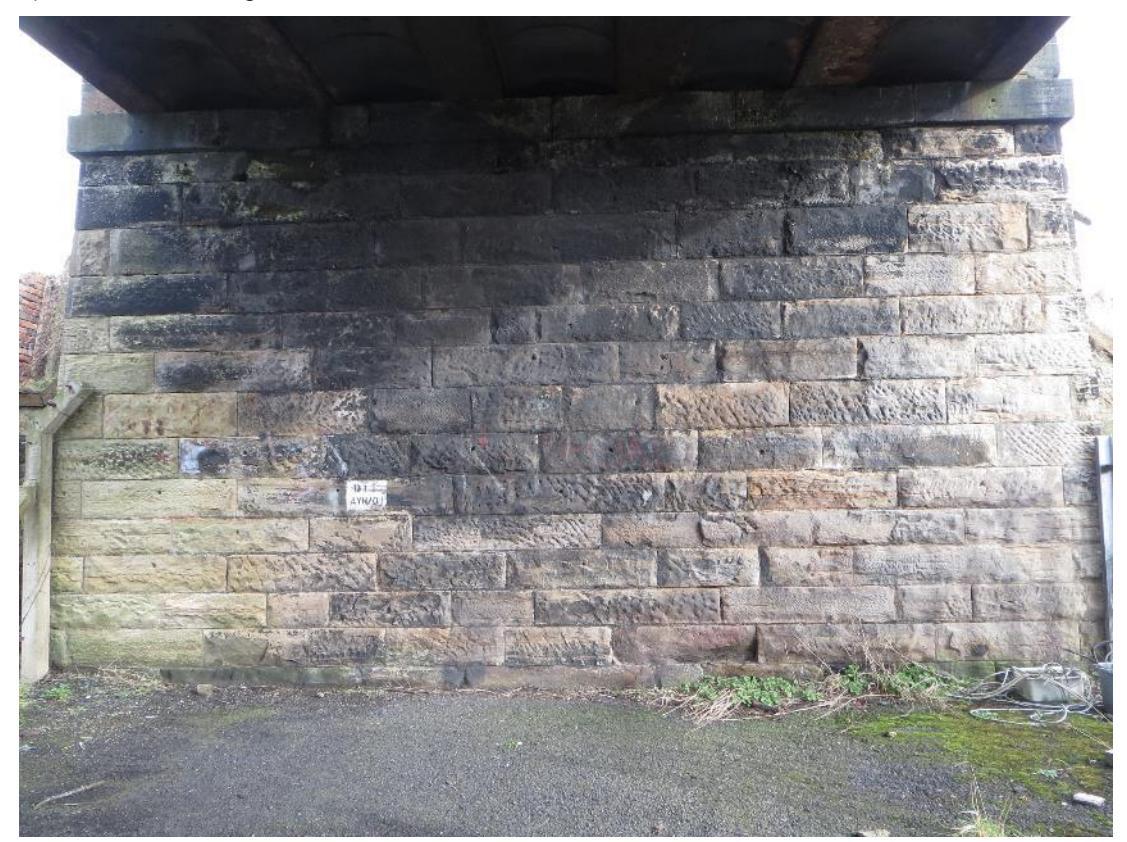
9) Northwest wingwall

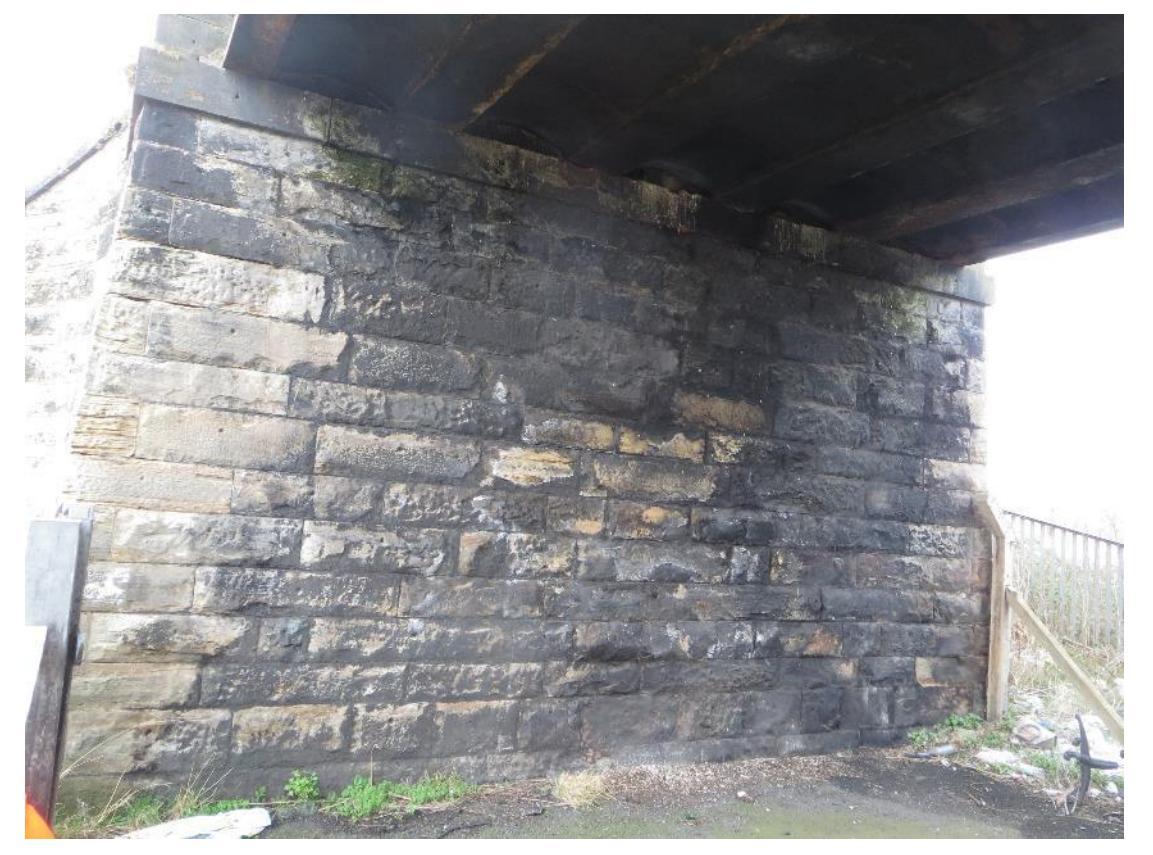
The abutments are in fair condition. There is extensive damp staining across both abutments indicating water ingress which has caused the observed spalling of the stone work. (Photographs 10 and 11).

10) East Abutment

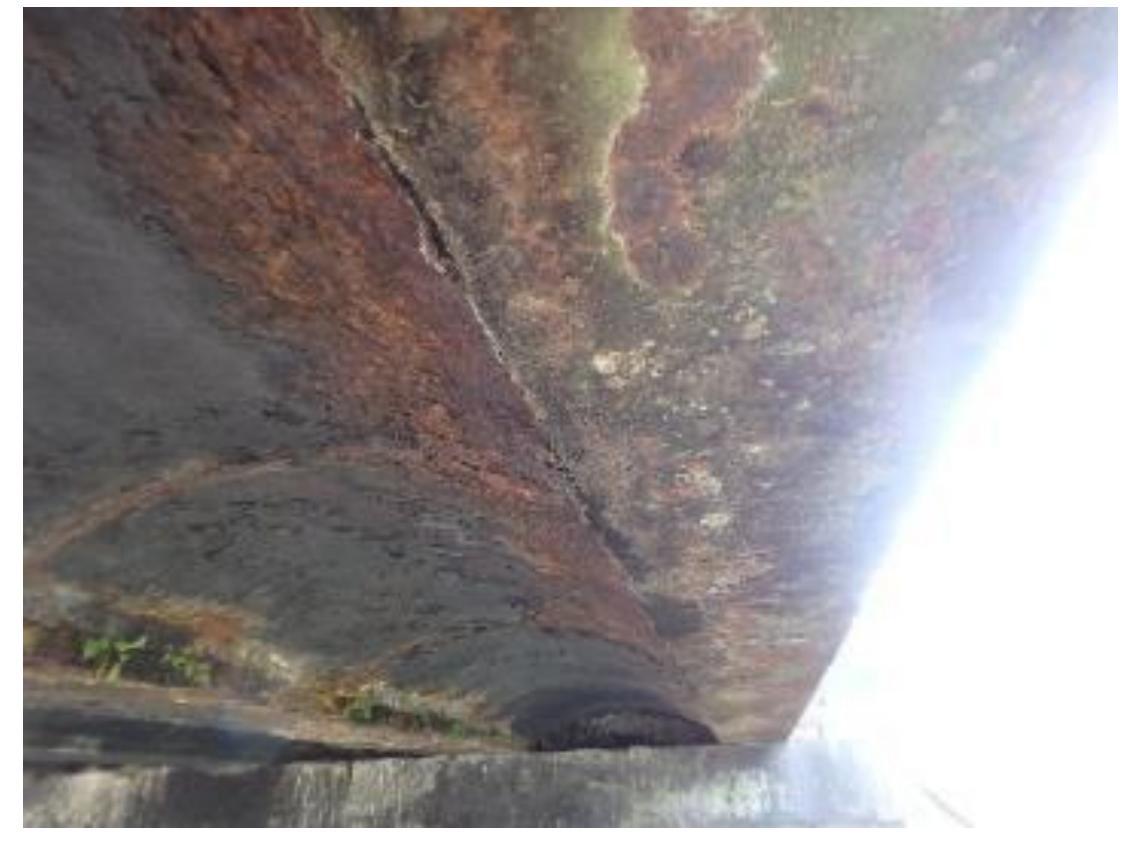
The hogging plates are in fair condition with section loss occurring to the lower 100mm on both springers with a depth of loss up to 3mm. (Photograph 12)

12) Underside corrosion of the internal girder

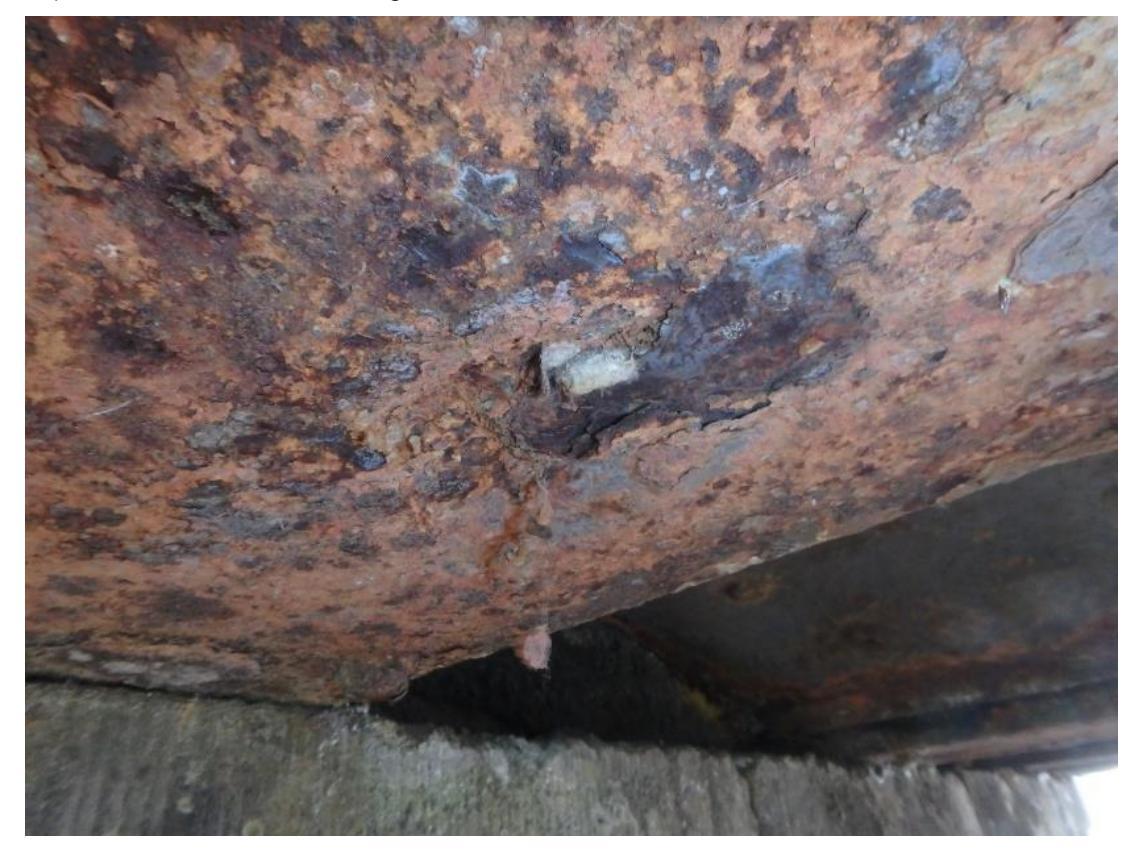
13) Corrosion of the external girder

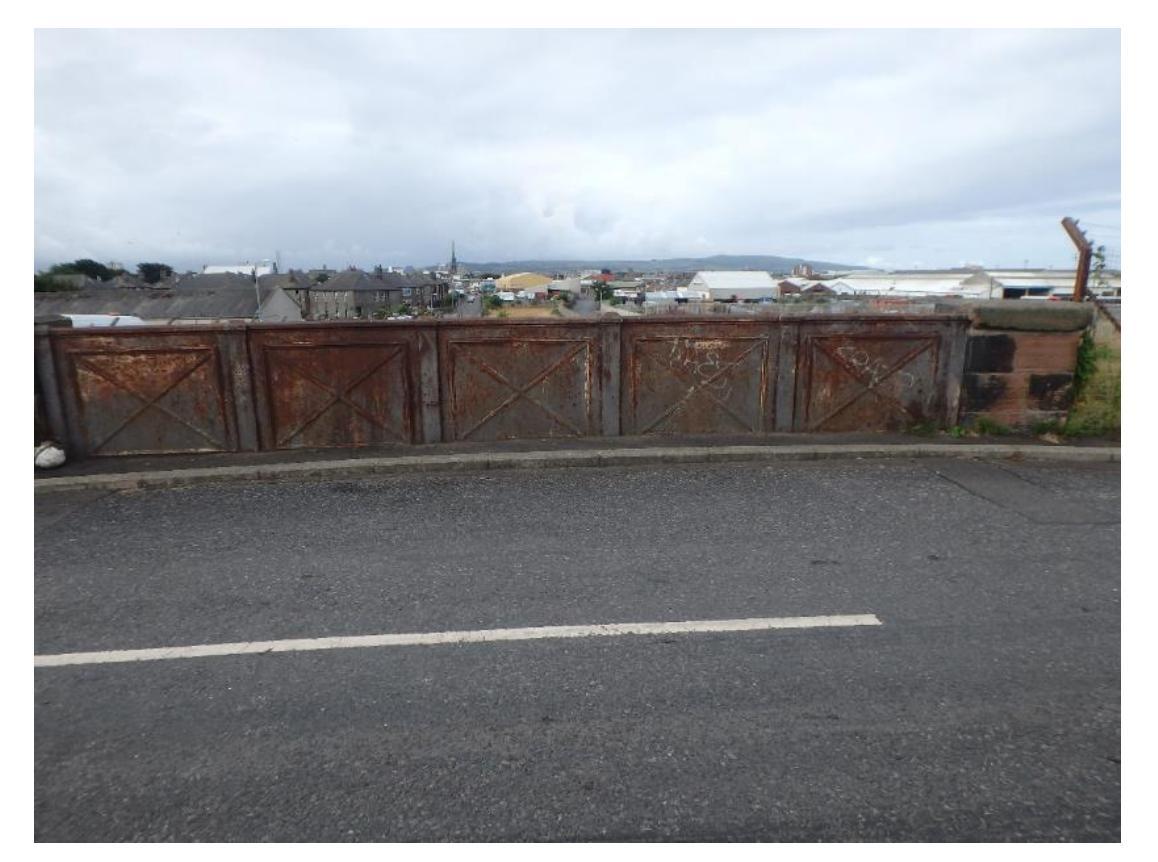
The parapets are in fair condition. The paint system is 50% lost across both parapets which has initiated minor pitting corrosion. (Photographs 18 and 19). A section of approach fencing is missing near to the north west pilaster.

18) North parapet

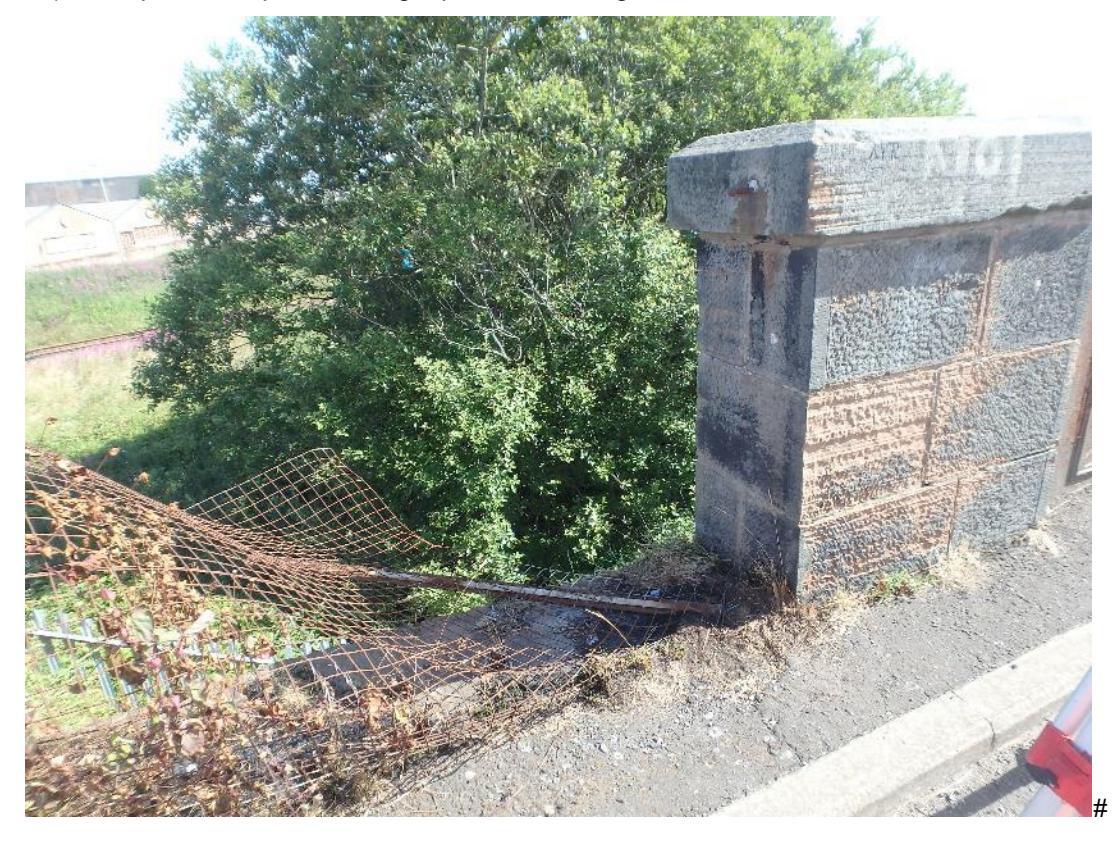
24) Approach fencing damaged at north-western pilaster.
