APPROVAL IN PRINCIPLE FOR THE ASSESSMENT OF DEBDEN ROAD BRIDGE

ECC BRIDGE NO. 1004
RAIL PROPERTY Ltd BRIDGE NO. AEB/2116

BRIDGE INSPECTION DETAILS AND CONDITION RATING

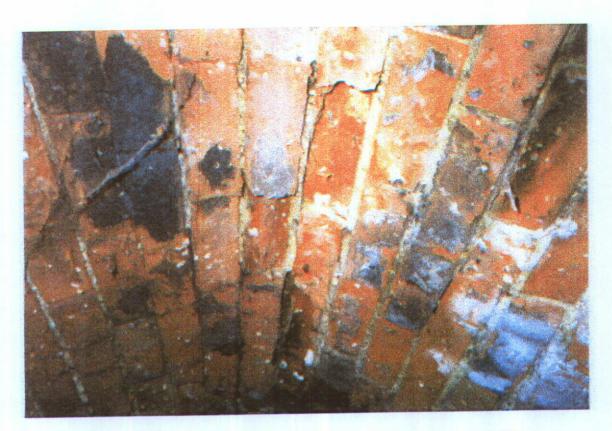
- 6.7 The brick jack arches are in poor condition. A hammer survey indicated localized separation of the arch rings. Repair work to loose brickwork will be required.

Photograph 5 - Typical spalling brickwork on jack arch soffit

- 7.6 A more extensive hammer survey should be carried out to the jack arch barrels and, if necessary, repairs carried out.
- 7.7 The corroded tie rods should be repaired and painted.

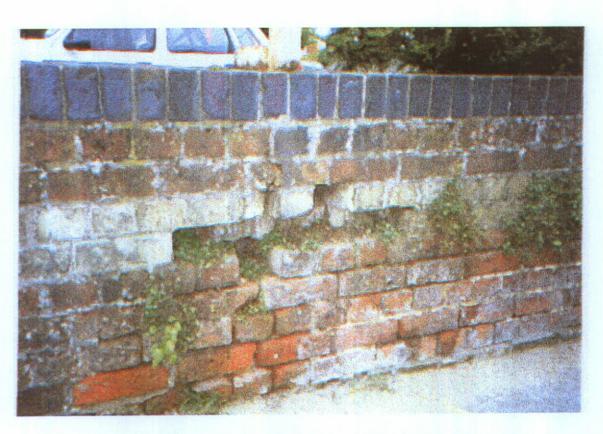
- Brickwork is missing to a depth of 230mm from the carriageway face of the west abutment (Photo 7). There are several smaller areas of spalling and brickwork loss to depth up to 130mm on both parapets.

Photograph 7 - Missing brickwork from west parapet

- Note that the following are maintenance recommendations and will not affect the proposed assessment.
- 7.5 The weathered, eroded and missing areas of brickwork should be replaced or repaired. All cracking to structure should be monitored and repaired as necessary.

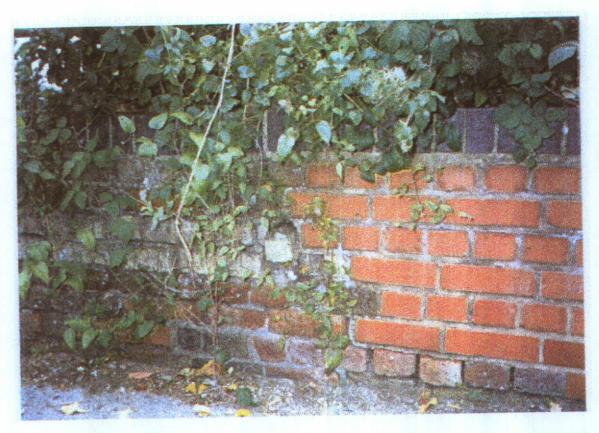
- There is a hairline crack running through the north west coping unit.
- The south end of the east parapet has been recently reconstructed. There are several loose and missing bricks where the new construction joins the old (Photo 9).

Photograph 9 – Loss of brickwork from joint between old and new brickwork at the south end of the east parapet

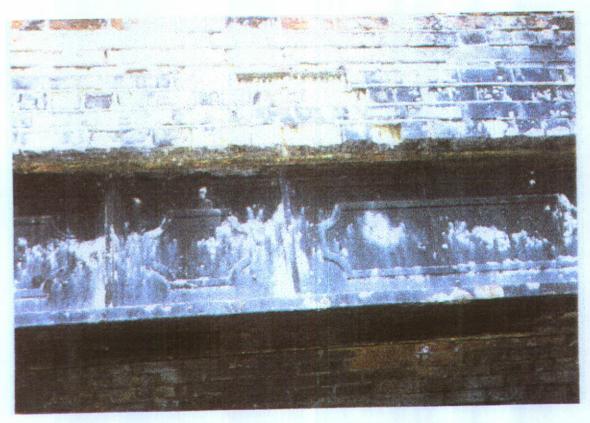
Photograph 10 - View of east beam. Note spalling brickwork on parapet plinth string course

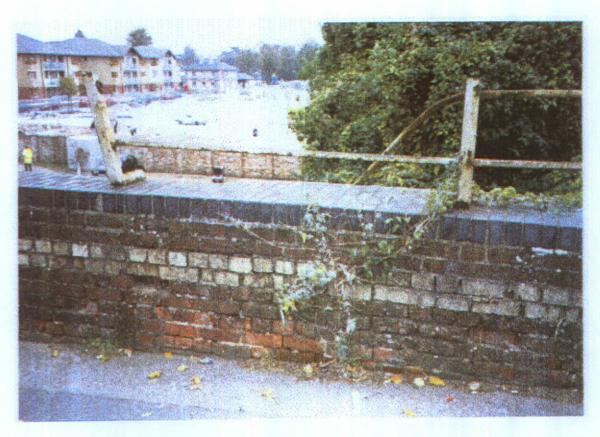
- Dense ivy growth covered the south east and the north west pilasters. Smaller areas of vegetation growth are also found on both parapets.
- One of the steel posts on top of the east parapet is bent and the top rail has displaced and is also bent. There is surface corrosion and paint loss to both the east and west post and rail sections (Photo 11).

Photograph 11 - Damage to steel post and rail at south end of east parapet

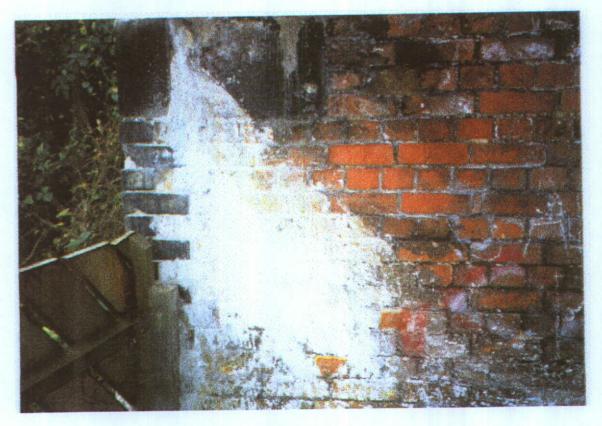
- There is leach staining on the south abutment under the east padstone as well as on the east side face of both abutments (Photo 12).

4.9.1 The areas of leach staining on the abutments indicate the lack of an effective waterproofing system (Photo 12). Since no intrusive testing was carried out on the upper surface of the deck this could not be confirmed. However, extracts from an Examination Report supplied by the client indicate the presence of a bituminous waterproofing layer. If this still remains it has failed in some locations.

Photograph 12 - Leach staining on south abutment

- The lack of an effective waterproofing system is indicated by the water rundown and staining to the jack arches. The installation of a waterproofing membrane to the deck should prevent further deterioration of brickwork.

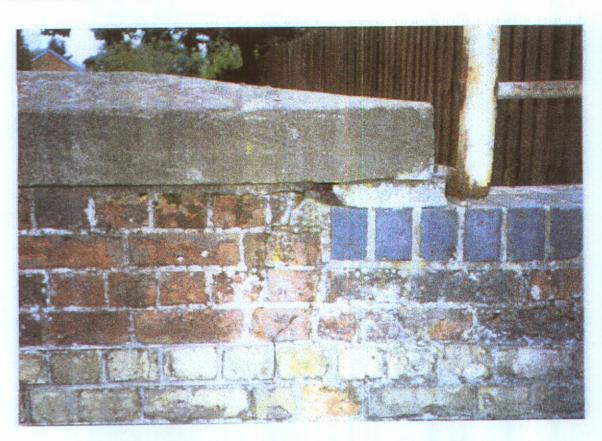
- The coping unit to the south west pilaster has been displaced, possibly by vehicular impact. There is mortar loss and spalling along the joint between the coping unit and the pilaster (Photo 13).

Photograph 13 - Displaced coping stone to south pilaster

- 6.8 The parapets are in poor condition. Impact damage is evident to the south pilaster which will require re-setting. Repairs should be carried out to these defects. In addition one of the steel posts and railings on the east parapet have been damaged and it is likely that, if required, the entire metal section of the parapet will need replacing. It should be noted that the west parapet is redundant and that this should be taken into account when considering the cost implications of any repairs.

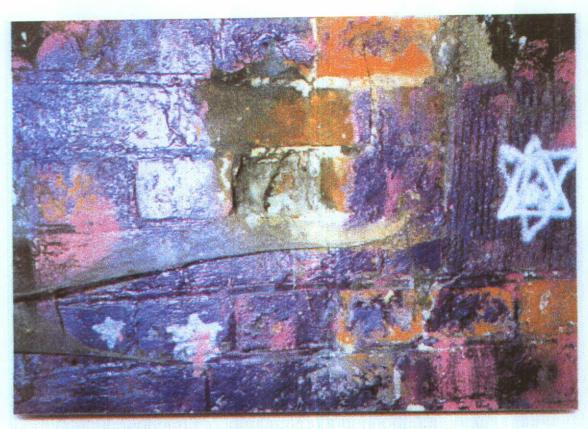
- There are several individual bricks missing from the south abutment with the voids up to depths of 130mm (Photo 15).
- Minor spalling has occurred in small areas on both abutments.

Photograph 15 - Missing brick, typical to the east abutment

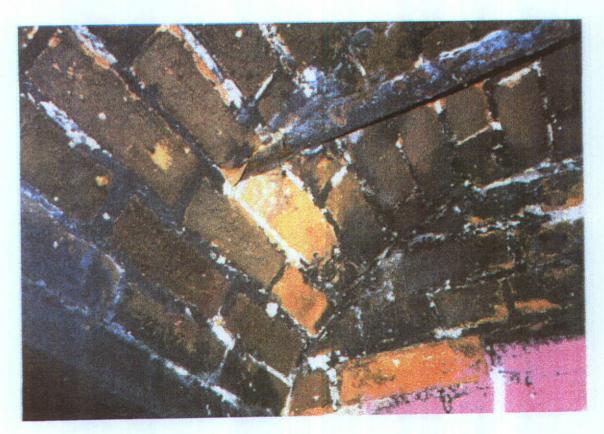
- The tie bars joining adjacent beams are severely corroded and it is estimated that they have 70% section loss. The badly corroded areas will require repair or replacement and remaining areas cleaned and repainted.

Photograph 16 – Typical corrosion to tie rods
