**B6259 – GREAT MUSGRAVE RAILWAY BRIDGE NO 25**

**CUMBRIA COUNTY COUNCIL - CONSTRUCTION SERVICES**  
**BD 21/97 LOAD ASSESSMENT REPORT**  
**FOR: B6259 GREAT MUSGRAVE RAILWAY BRIDGE**

Great Musgrave Railway No 25 consists of a 8.45m single skew span sandstone masonry arch structure carrying the B6259 over a disused railway line, 0.5km west of the village of Great Musgrave.

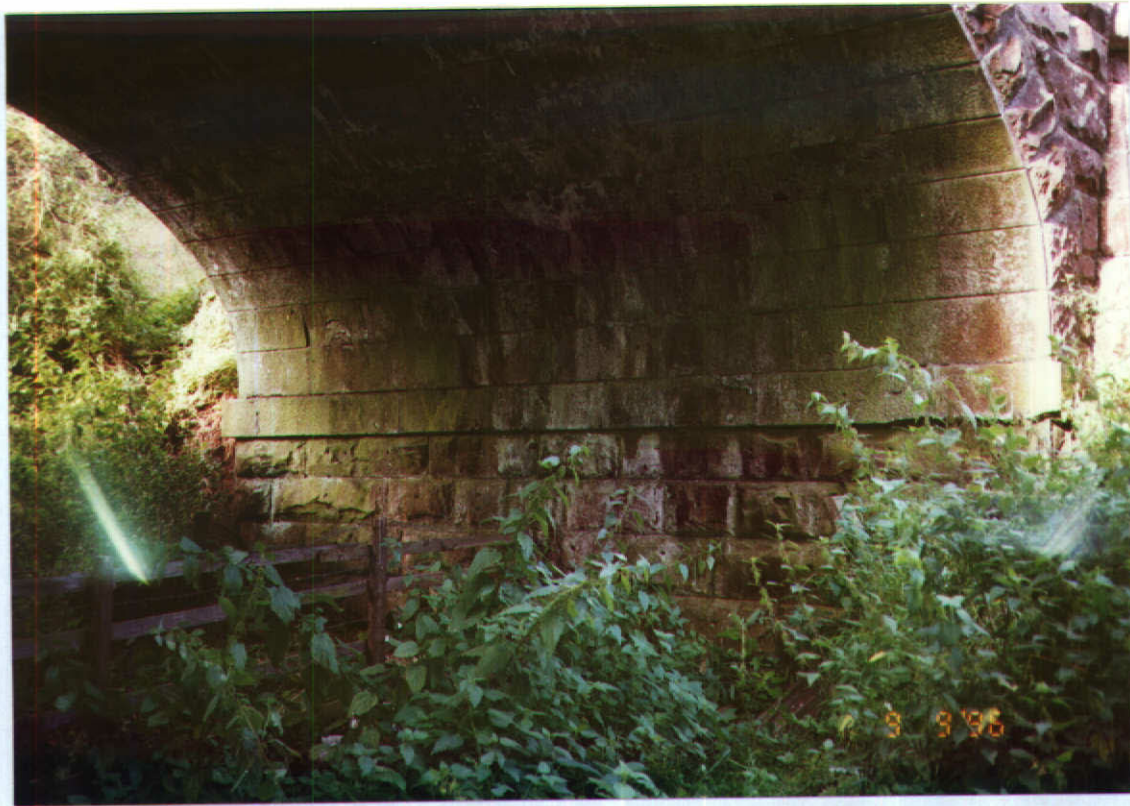
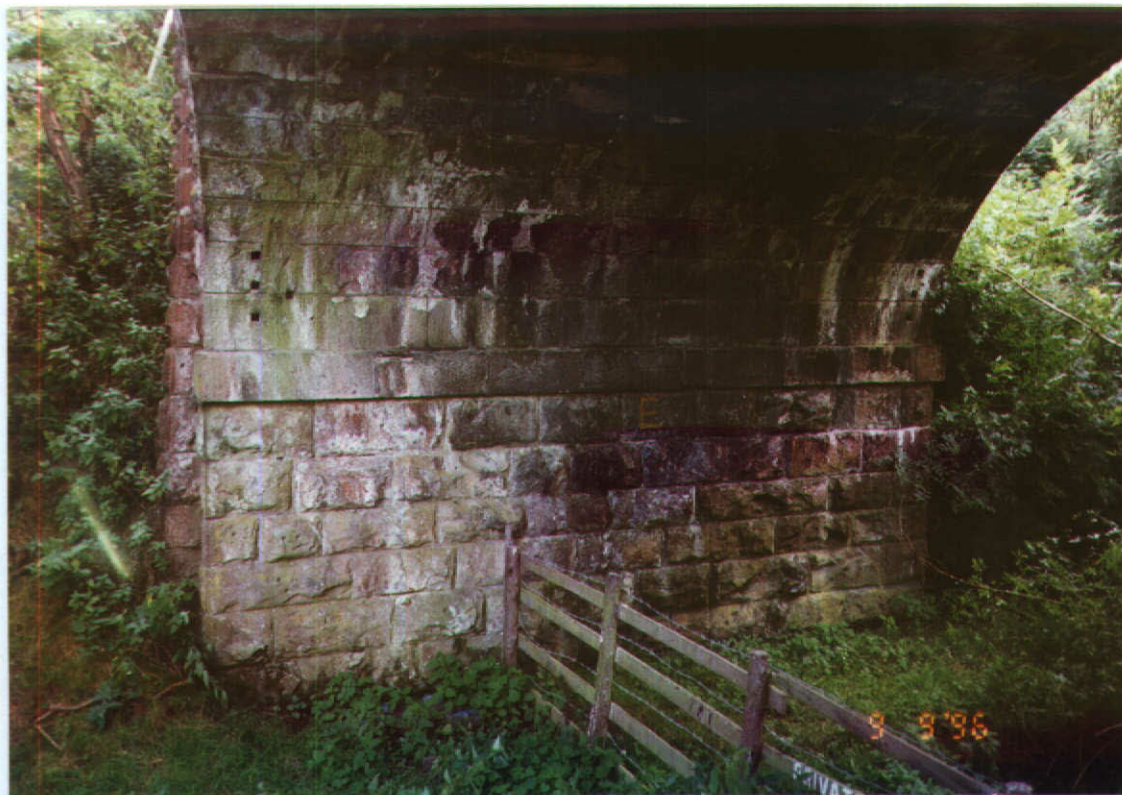
PHOTO NO. 5 - WEST ELEVATION

Both east and west abutments were constructed from large rectangular, course, rockfaced sandstone masonry blocks following a good uniform alignment (Photo No 5 & 6). The mortar joints to the abutments were generally intact and filled with reasonable quality. Inspection of the abutments did not reveal any defects which would reduce their ability to carry the current imposed loading.

A longstanding vertical crack 0.3mm wide was present through the full depth of the NW springing bedstone, visible on the north face.

Monitor

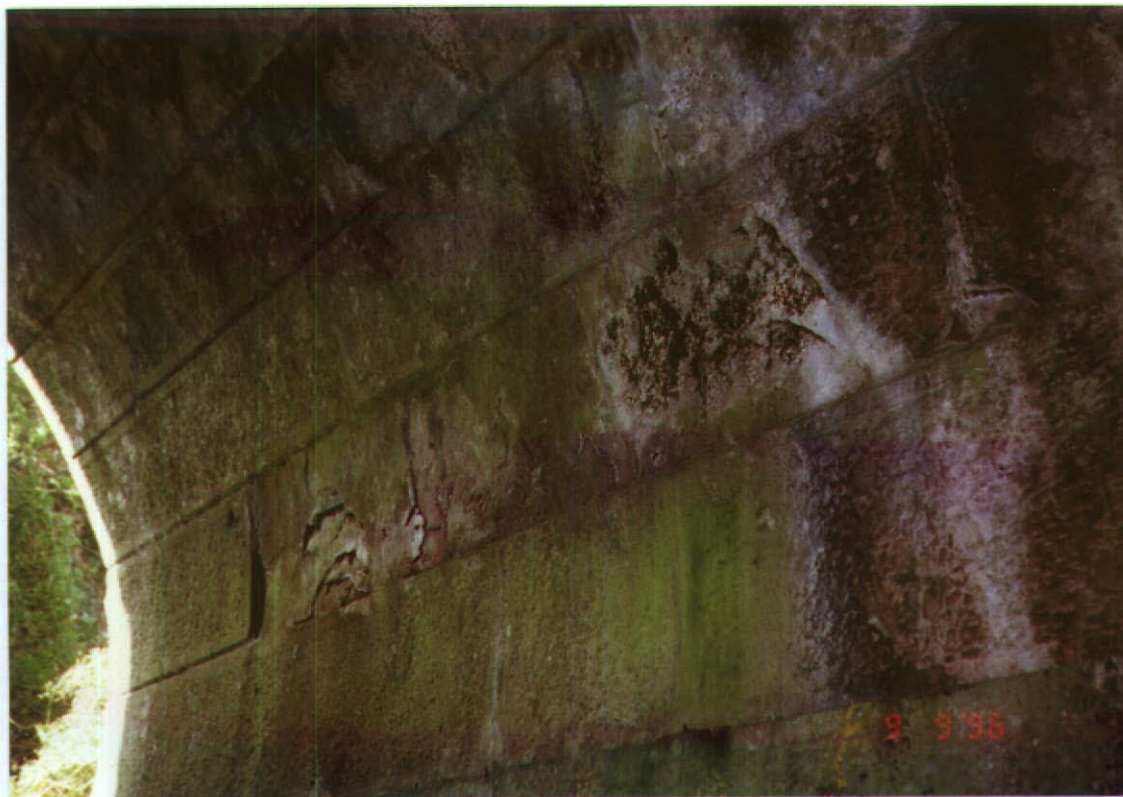
PHOTO NO. 9 – SPALLING TO BARREL STONES 2<sup>ND</sup> COURSE ABOVE WEST SPRINGING

Barrel constructed from coursed, dressed sandstone masonry ( $F_b = 0.95$ ) with 6mm - 10mm wide mortar joints ( $F_w = 0.9$ ). The faces of 4No barrel stones had spalled away to a depth of 30mm on the second and third courses above the west springing, 2No 500mm from the north edge and 2No 500mm from the south edge (Photo No 9). The face of 1 No number block has spalled away to a depth of 75mm over a 300 x 450mm area (Photo No 8), 2 No courses west of the crown 1.5m from the south edge. The mortar to the joints to this spalled barrel stone was missing for the full arch barrel depth. At the time of inspection the arch barrel was dry, however leachate deposits were present for a distance of 2m in from each edge indicating that water has or still is penetrating through the arch barrel construction. Random open joints were evident to 10% of the barrel soffit in the crown area.

Local repair

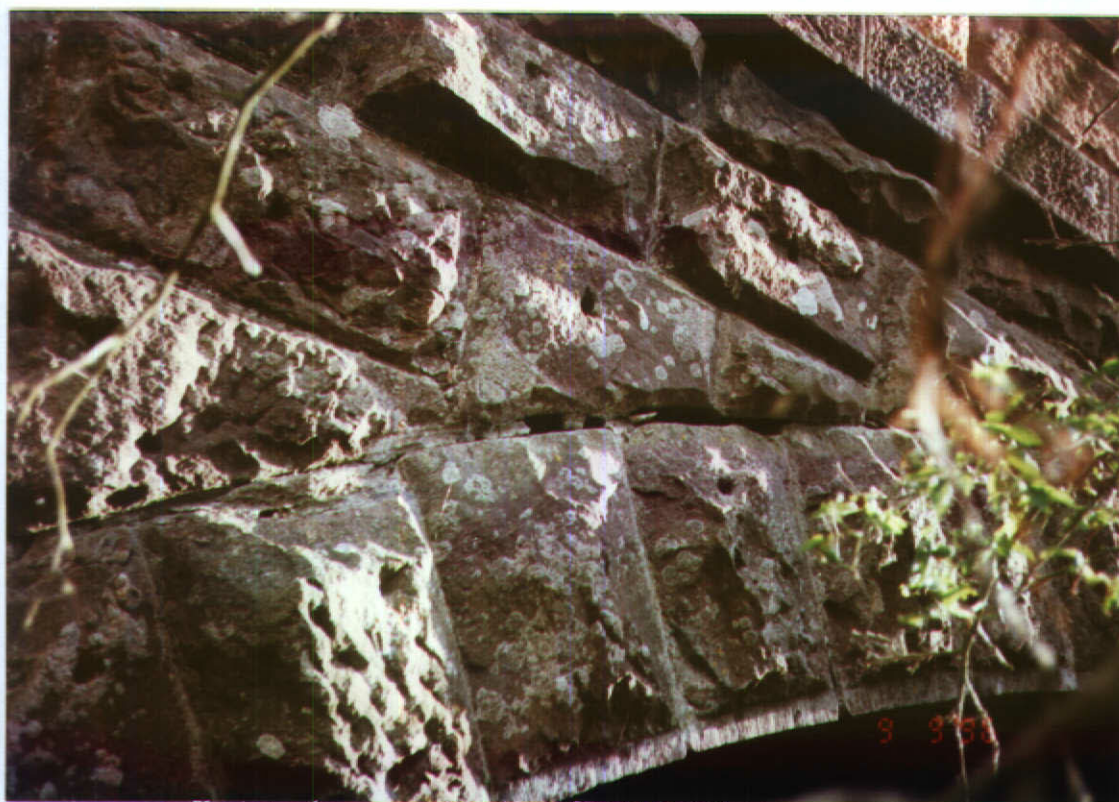
PHOTO NO. 10 – OPEN MORTAR JOINT ALONG EXTRADOS JOINT ABOVE S.W QUARTER POINT

Spandrels constructed from coursed rockfaced sandstone masonry. The alignment of the south spandrel was satisfactory with no sign of any significant lateral displacement, bulging or movement. Random cracking was evident to a number of mortar joints over the south spandrel area. Cracking of the mortar pointing to the extrados joint has occurred for the full length of the joint with the mortar missing over the 8th and 9th voussoir above the SW springing (Photo No 10).

Repoint open joints

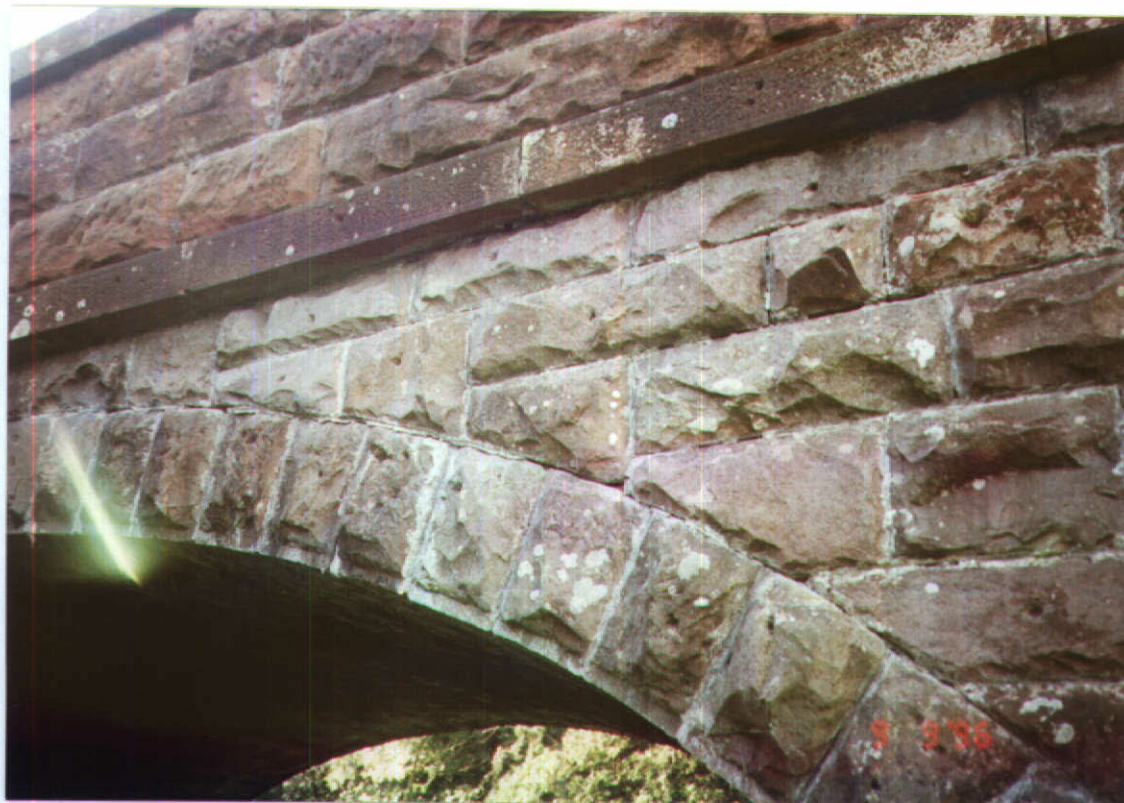
PHOTO NO. 11 – CRACKED/OPEN JOINT ALONG N.W EXTRADOS

50% of the pointing to the north spandrel extrados joint was missing, where pointing was present cracking was evident together with evidence of 2-3mm spandrel displacement (possibly longstanding). 30% of the mortar joints to the north spandrel were cracked or the pointing was spalling away from the masonry. Apart from the lateral displacement the alignment of the spandrel wall was satisfactory with no significant bulging or deformation evident.

Repoint cracked/open joints

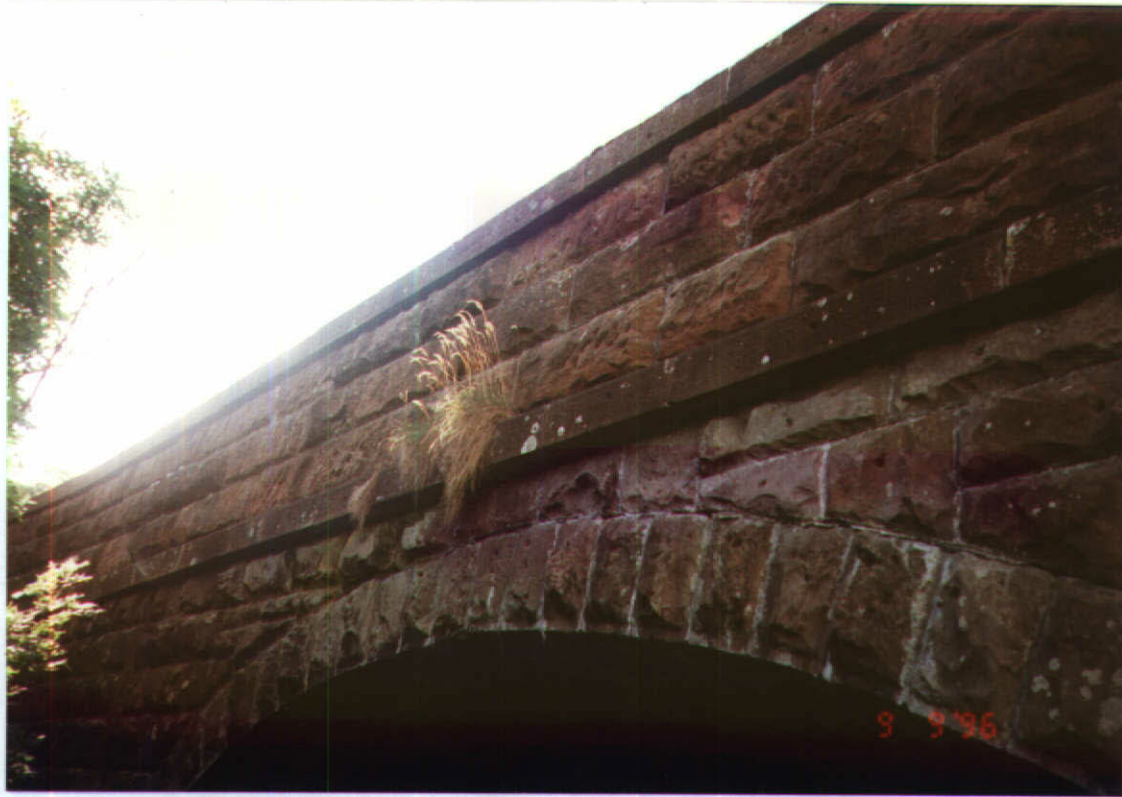
PHOTO NO. 13 – VIEW ALONG NORTH SPANDREL/STRINGCOURSE

Both stringcourses followed a satisfactory alignment with no significant deformation, the majority of the mortar pointing to the perp joints has been washed out leaving the joints open. Minor vegetation was evident along the stringcourse to the north elevation (Photo No 13).

Repoint open joints  
remove vegetation

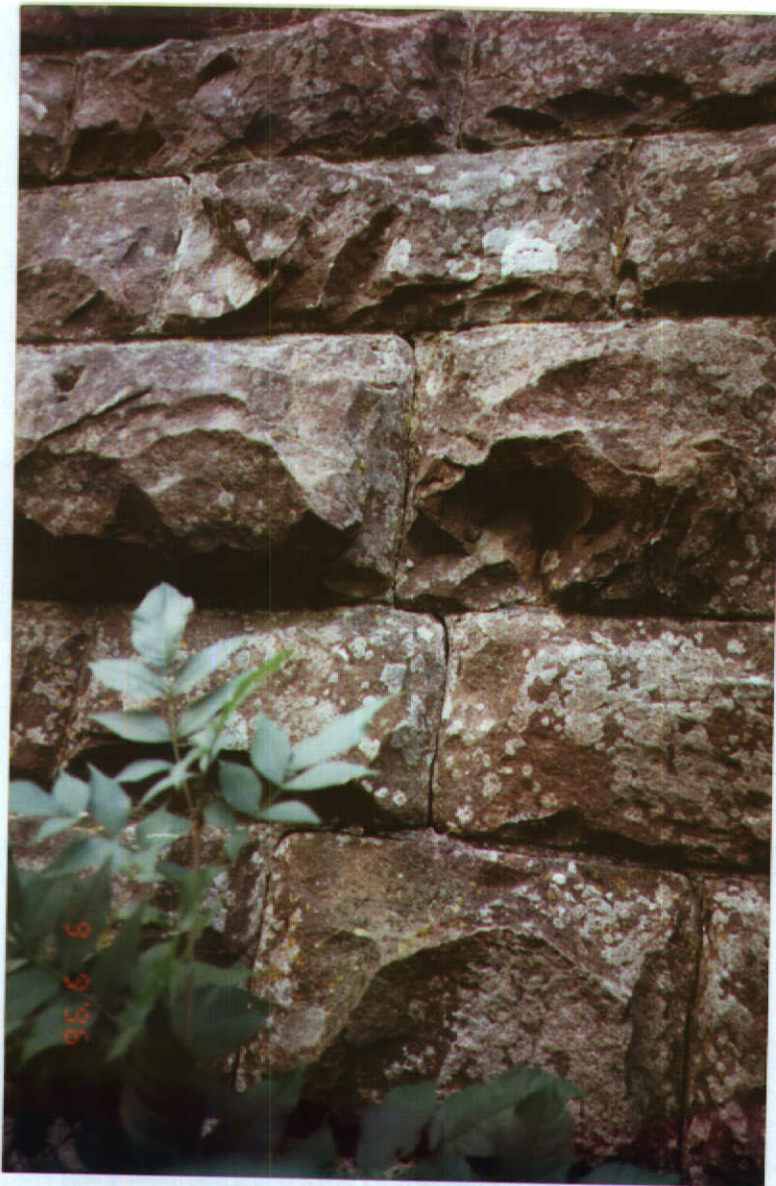
PHOTO NO. 14 - VERTICAL CRACK IN MORTAR JOINTS ON S.E WINGWALL

The SE wingwall followed a good alignment with no significant deformation rotation or movement. A small number of the mortar joints were cracked but overall the pointing to the wall was satisfactory. A longstanding predominately vertical crack 1-2mm wide ran the full height of the wall, in the mortar joints, 4m east of the east abutment (Photo No 14).

Monitor

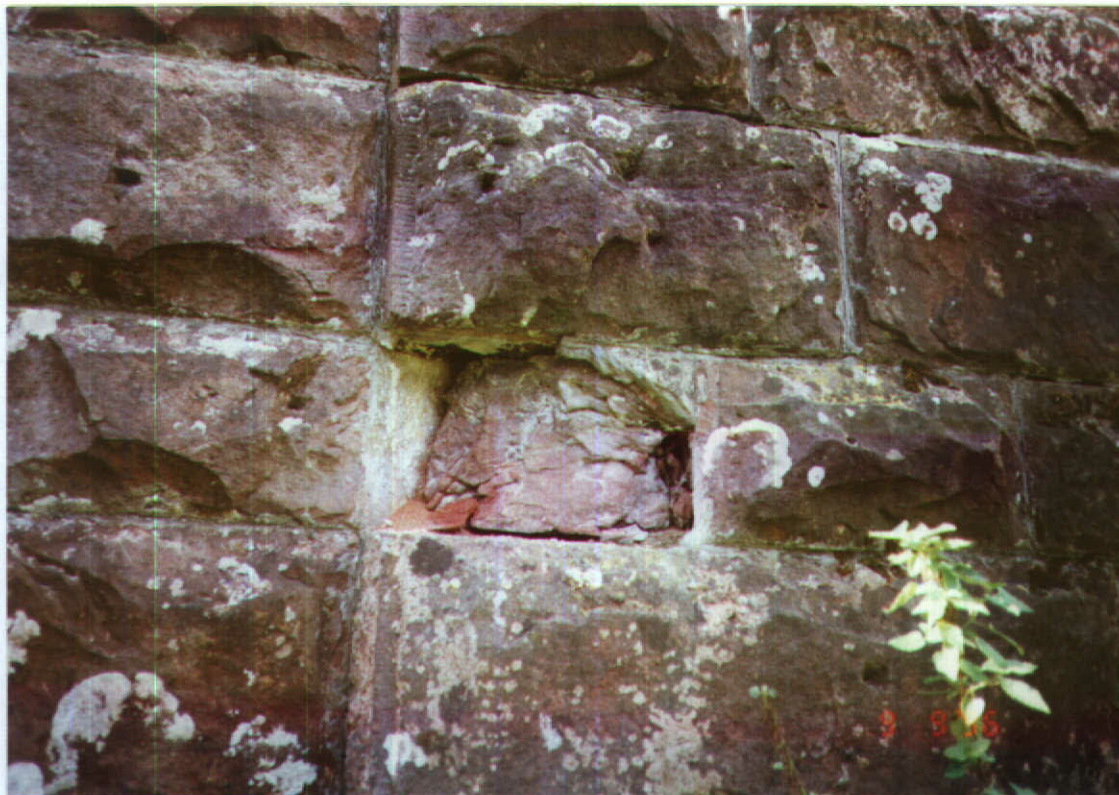
PHOTO NO. 15 – SPALLED MASONRY BLOCK IN N.W WINGWALL

The mortar was cracked or missing to 10% of the joints to the NW wingwall. 2 No masonry blocks were badly weathered with the faces spalled away adjacent to the spandrel, 1No 6 course above ground level for the full course height, 450mm in length for a depth of 100mm and 1No 3 course above ground level for the full course height, 300mm in length for a depth of 75mm (Photo No 15).

Repoint  
cracked/open  
joints  
Local masonry  
repair

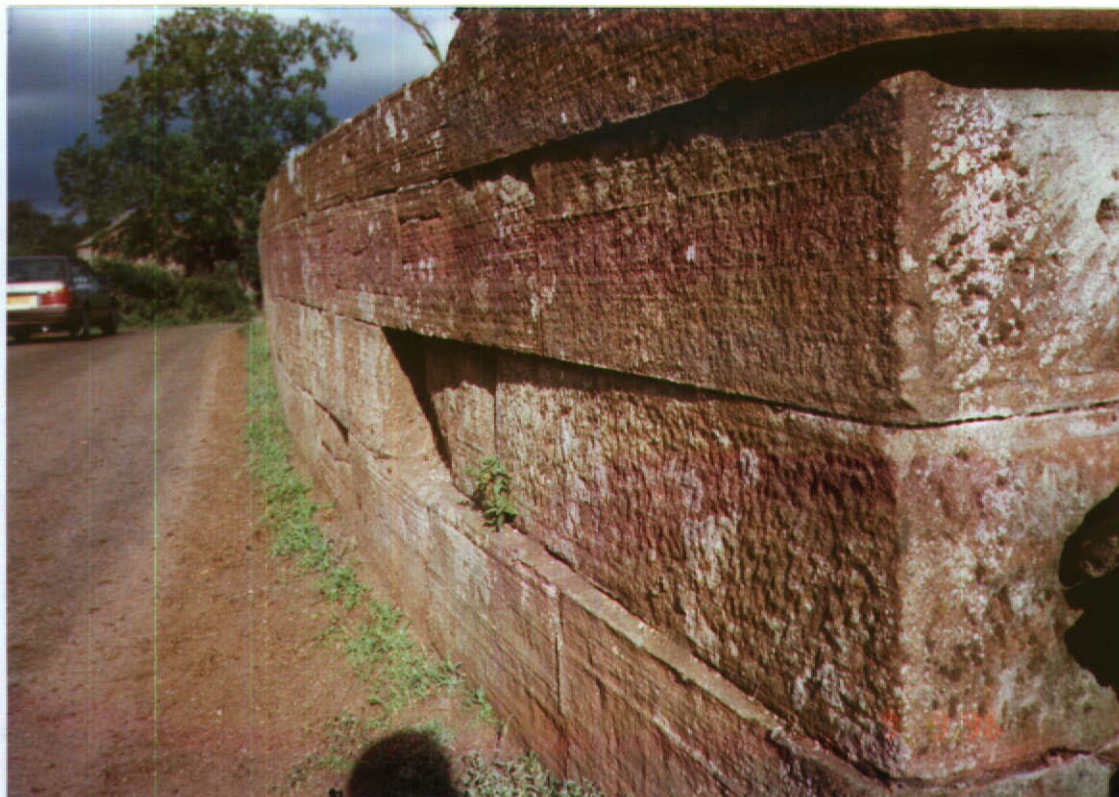
PHOTO NO. 17 – ACCIDENTAL DAMAGE AT EAST END OF NORTH PARAPET

The parapets are constructed of coursed dressed sandstone masonry with flat top sandstone copings. Accidental damage has resulted in 2No masonry blocks being displaced by up to 100mm at the east end of the north parapet, 2 courses above road level (Photo No 17). The pointing to the north parapet is at the end of its life with the majority of the joints open or cracked (Photo No 18) 30% of the mortar joints to the north parapet requiring repointing (Photo No 19). Apart from the minor accidental damage on the north parapet both parapets followed a satisfactory alignment.

Reset masonry  
blocks  
Repoint  
open/cracked  
joints

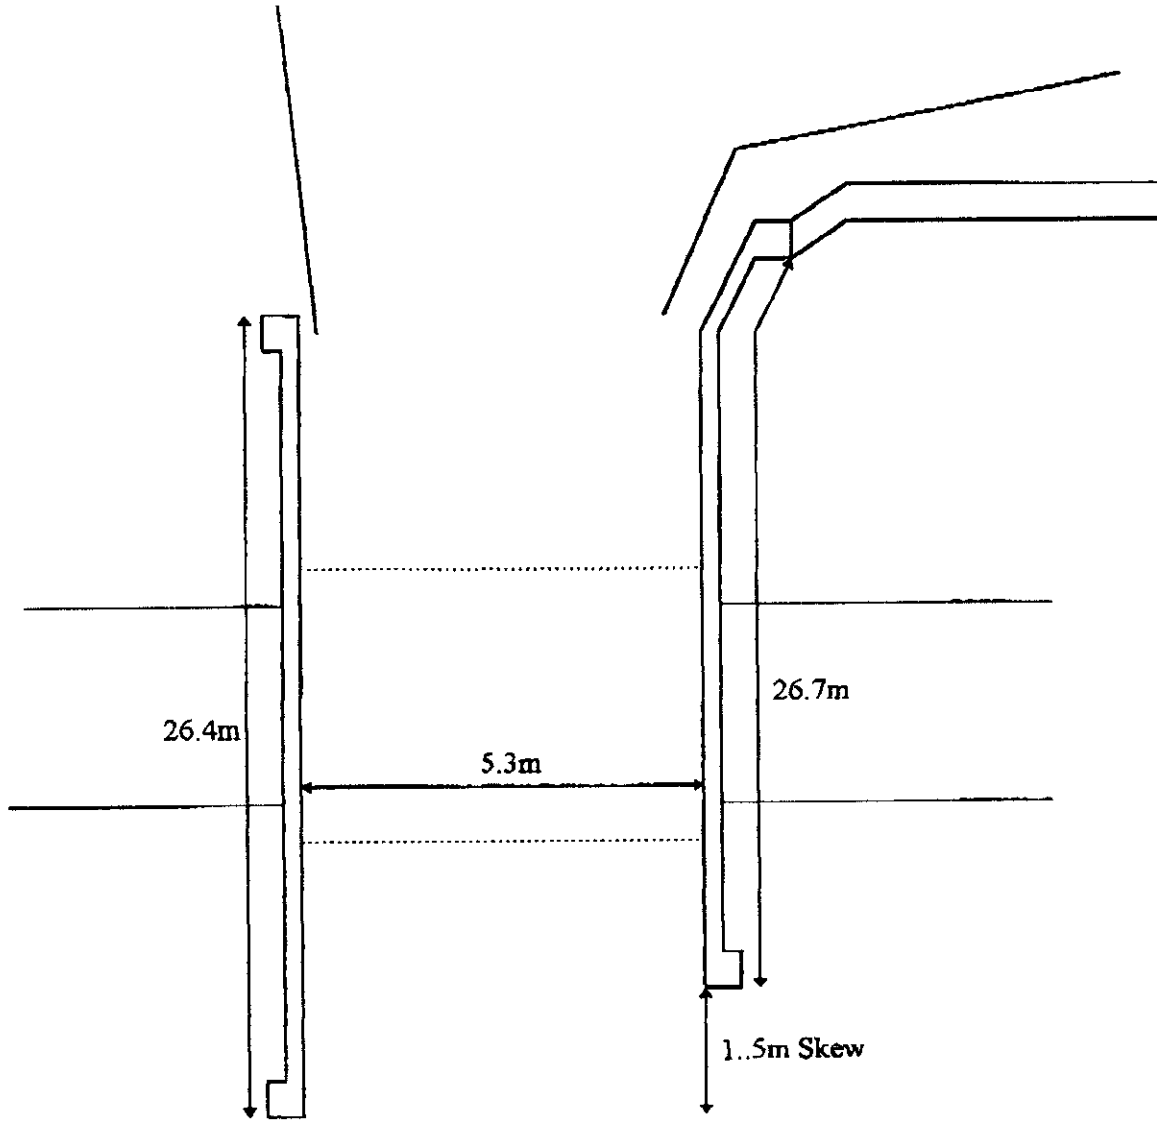
<p>Parapet Height East 1.230m Parapet Height West 1.280m Span 8.2m Abutment Length 6.300m Arch Height 4.4m Width of Parapets 470mm</p>
