Gloucestershire County Council
Rail Property Ltd Bridge Assessments

Dumpers Bridge FFD 88m 48ch
Assessment and Inspection Report
November 2003

Assessment and Inspection Report

Document Ref No TB.2116.B562.Doc.01

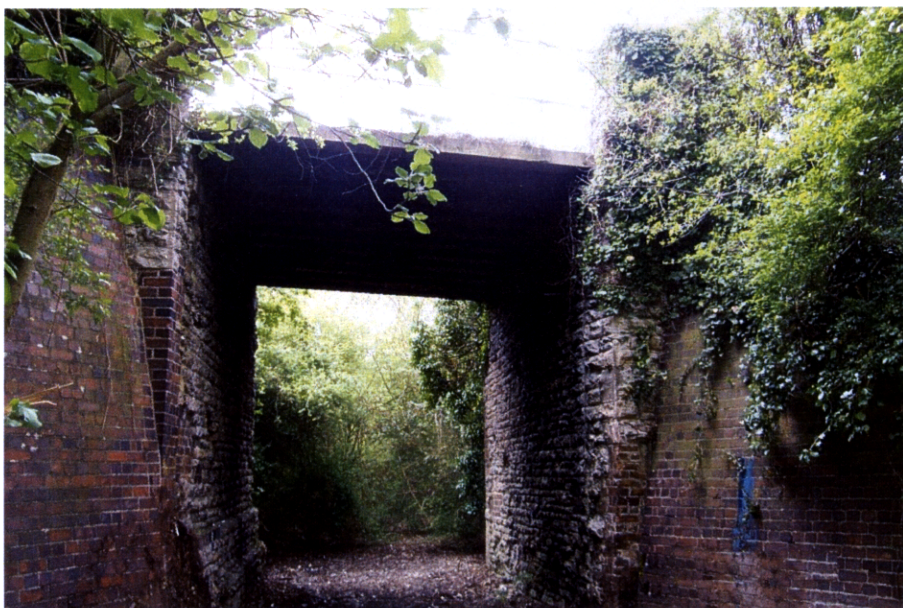
Figure 1: Dumpers Bridge

Halcrow Group Limited carried out the inspection of Dumpers Bridge (see Figure 1) on 28 May 2003. The weather was dry and sunny.

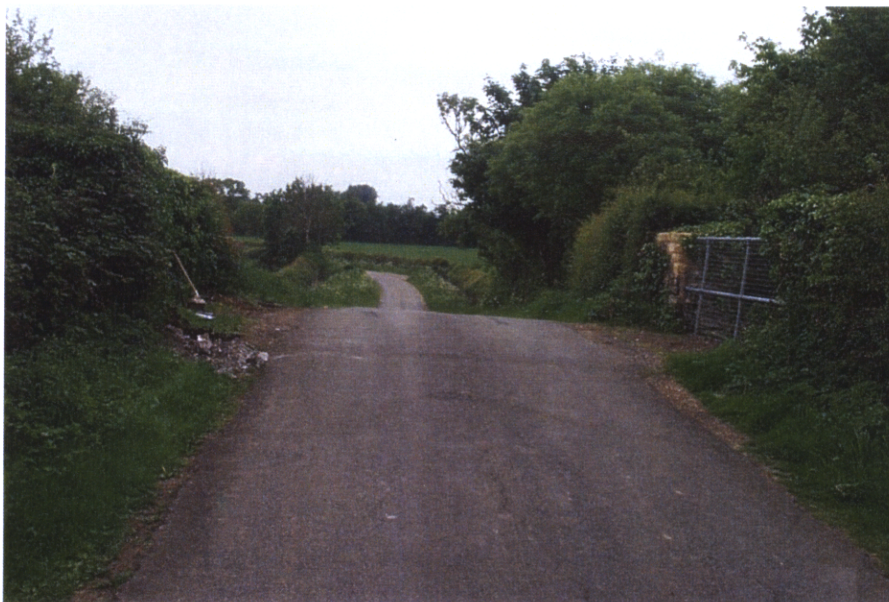
Figure 11: View from south approach

The road surface was in reasonable condition except for longitudinal and transverse cracking on both approaches. Transverse cracking on the road surface coincides with the end of the deck suggesting settlement of the fill behind each abutment. The longitudinal cracking is also considered to be a result of settlement behind the abutments. The vertical alignment of both approaches to the bridge is steep but is relatively flat over the deck, this is considered to affect the sight distance of on-coming traffic (see Figure 11).

Cracking in the carriageway on both approaches to the bridge indicates settlement of fill behind each abutment.

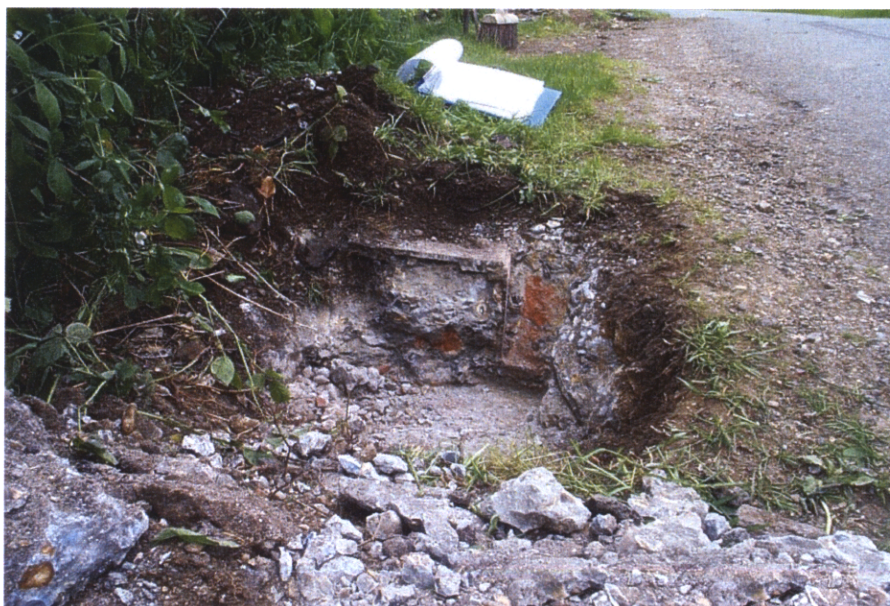
Figure 12: Trial hole exposing end of steel trough

A trial hole was excavated at each end of the bridge. The depth of cover to the top of the steel trough was approximately 175mm and from inspection the quality of concrete fill was sub standard (see Figure 12).

An intrusive investigation carried out on the top of the bridge, revealed the fill material comprised bituminous road surfacing and poorly graded concrete. It was assumed this was representative across the entire bridge deck.

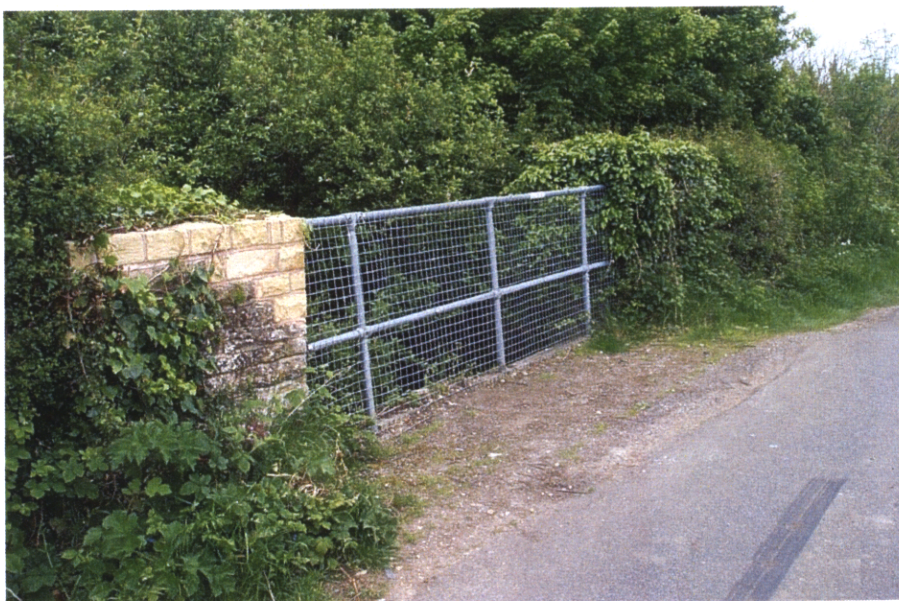
Figure 10: East parapet

The parapets comprise steel Kee-Clamp fence with mesh infill between stone pilasters. This is in good condition although it is apparent it would not meet current containment standards. Vegetation growth prevented the inspection of the pilasters (see Figure 10) except at the northeast corner, which had been repaired. Each parapet is supported on a timber edge beam, which spans between the abutments. There is no connection between the timber edge beams and the steel trough deck.

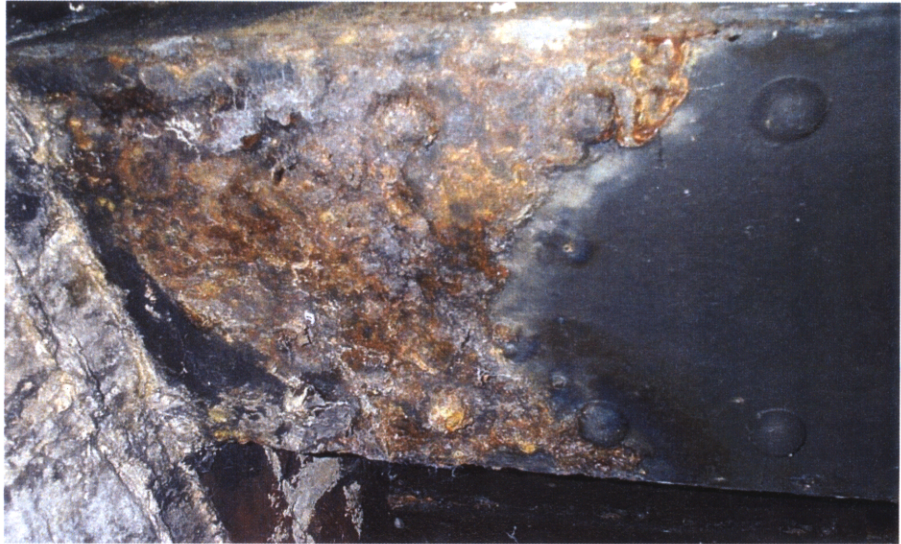
Figure 8: Severe corrosion to plate and rivets on southeast trough

Severe corrosion and section loss up to 5mm was also evident on the beam soffits towards each abutment (see Figure 8). Most of the webs were in reasonable condition except for isolated areas. In these areas the paint system had broken down and there was some surface corrosion. On the east side of the bridge the edge deck plate was severely corroded over its entire length (see Figure 9). Delamination of the plate had occurred with complete section loss in places. Exposed rivet holes at the edge of the plate were severely corroded. The edge plate on the west side was in a similar condition.

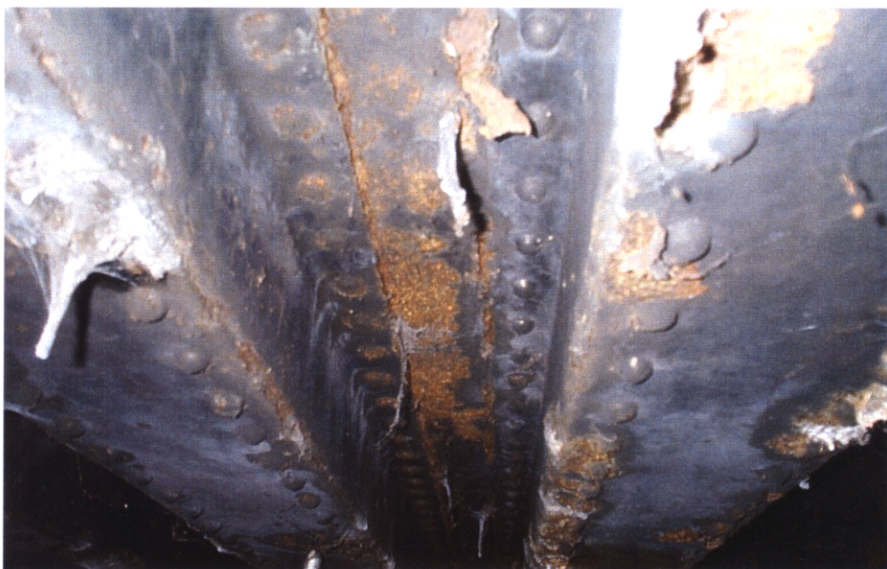
Figure 6: Break down of paintwork and surface corrosion

Corrosion was most severe at the joints between the Z-beams and the flat plates where water seepage had occurred. Section loss here was approximately 3-4mm (see Figure 6). Calcite deposits in this area indicated water seepage through the deck material and between the steel elements. The paint system had broken down on many of the rivets causing extensive surface corrosion but this is not considered to affect their overall capacity.

The steel trough deck is built up of Z-beams and flat plates, which are riveted together, refer to Drawing No. TB.2116.B562.SK02. Over the majority of the soffit the paint system was in poor condition and had broken down leaving large areas of the steel exposed (see Figure 6).

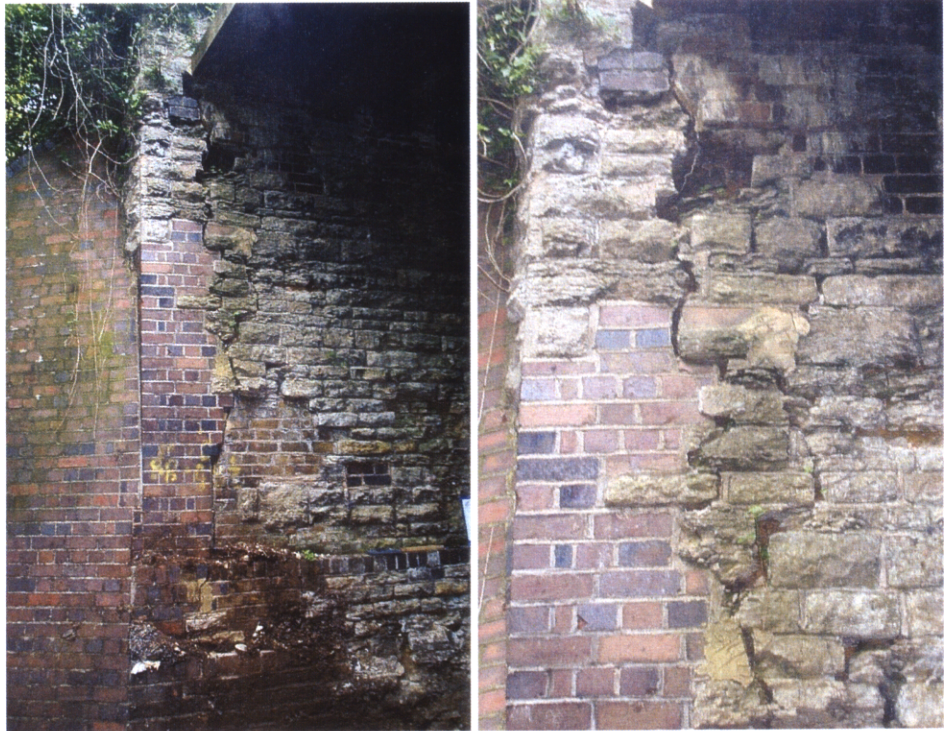
Figure 5a: Cracking on south abutment

On the south abutment, there was a significant full height vertical crack at the east end (see Figure 5a). This is assumed to be the result of settlement and rotation at the interface with the southeast wingwall. It appears the crack has been monitored since 1979 and that movement has taken place since (see Figure 5b). Repairs to the stonework had been carried out using brick, but there were areas of missing masonry generally in the region of the crack. Spalling up to a depth of 100mm of the stone had occurred in localised areas.

A qualitative assessment of the abutments and wingwalls was carried out in accordance with BD21/01. Vertical cracking in the south abutment is considered to be the result of rotation of the abutment due to settlement in the southwest corner of the bridge. Cracking of the northwest and southwest wingwalls is also believed to be as a result of settlement. These cracks are not considered to affect the load capacity of the structure significantly.

Generally the structure was in a poor condition. Cracking on the south abutment, northwest and southwest wingwalls is considered to be the result of settlement and rotation of the wingwall foundations.

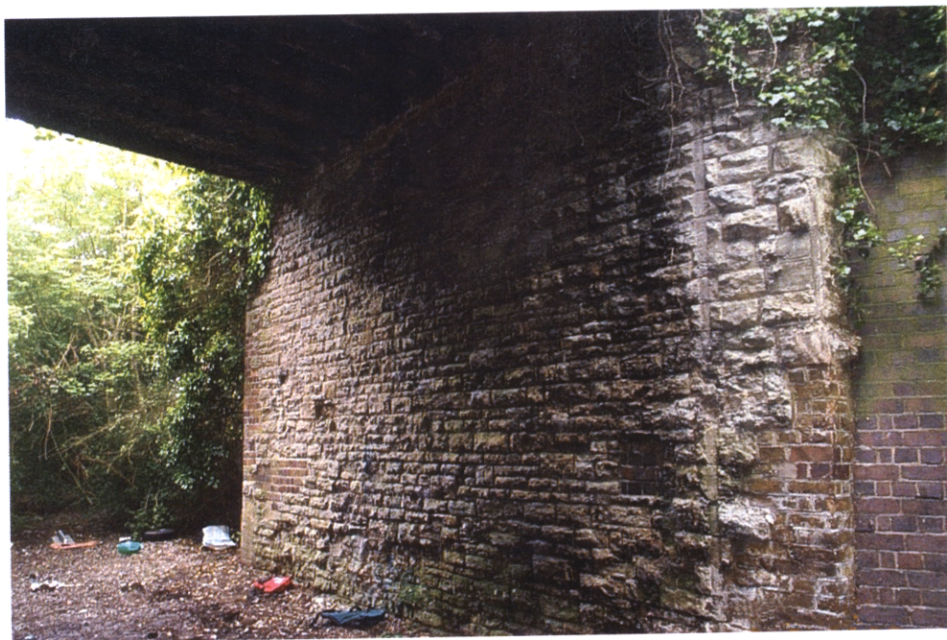
Figure 4: View of north abutment.

Both abutments were constructed of stone but some localised areas have been repaired in brick (see Figure 4). Stonework was generally in good condition except for some localised spalling. Mortar joints were approximately 10mm wide with 5mm mortar loss on average. Vegetation growth covered the top corners of the abutment.

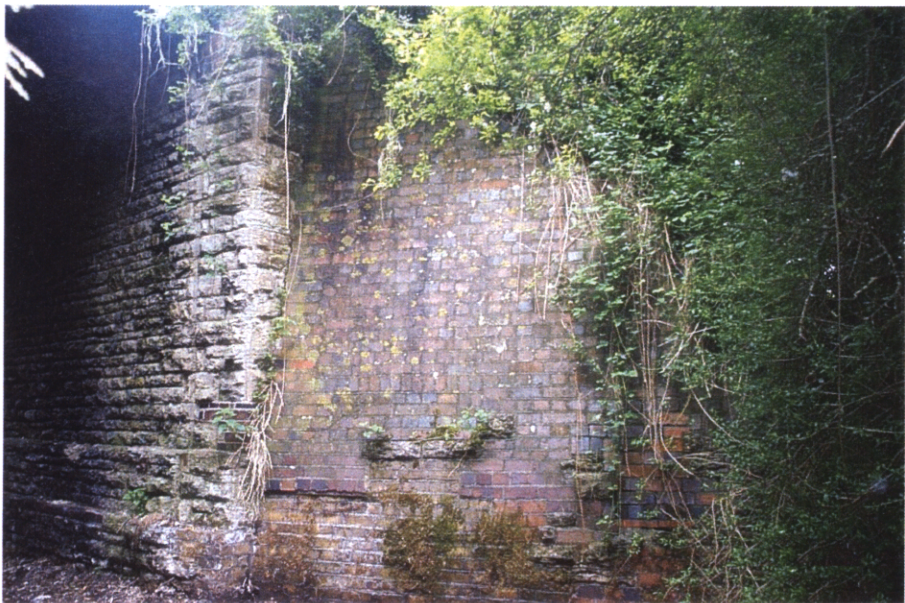
Figure 2: Southwest wingwall

All visible parts of the wingwalls were in reasonable condition with some localised areas of mortar loss. Large areas were covered in vegetation (see Figure 2), particularly along the coping stones. This growth had caused localised spalling of

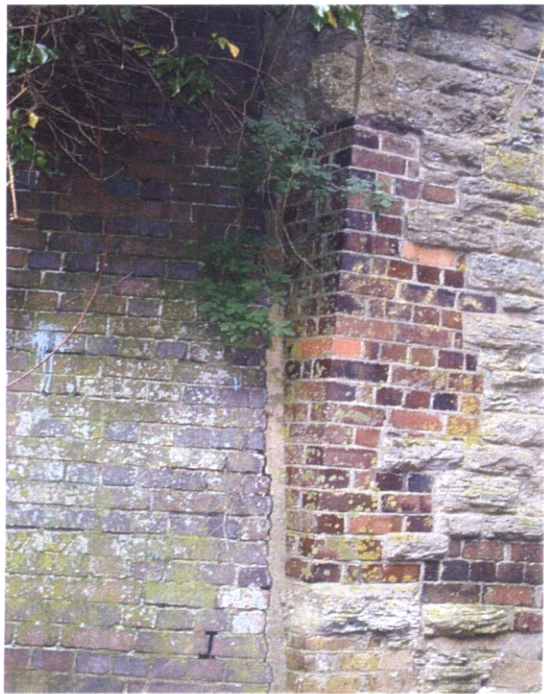
Figure 3: Cracking between north abutment and northwest wingwall

the brickwork and cracking in the coping stones. Cracking at the intersection of the southwest and northwest wingwalls with the abutment (see Figure 3) is considered to be the result of rotation and settlement of the wingwalls.

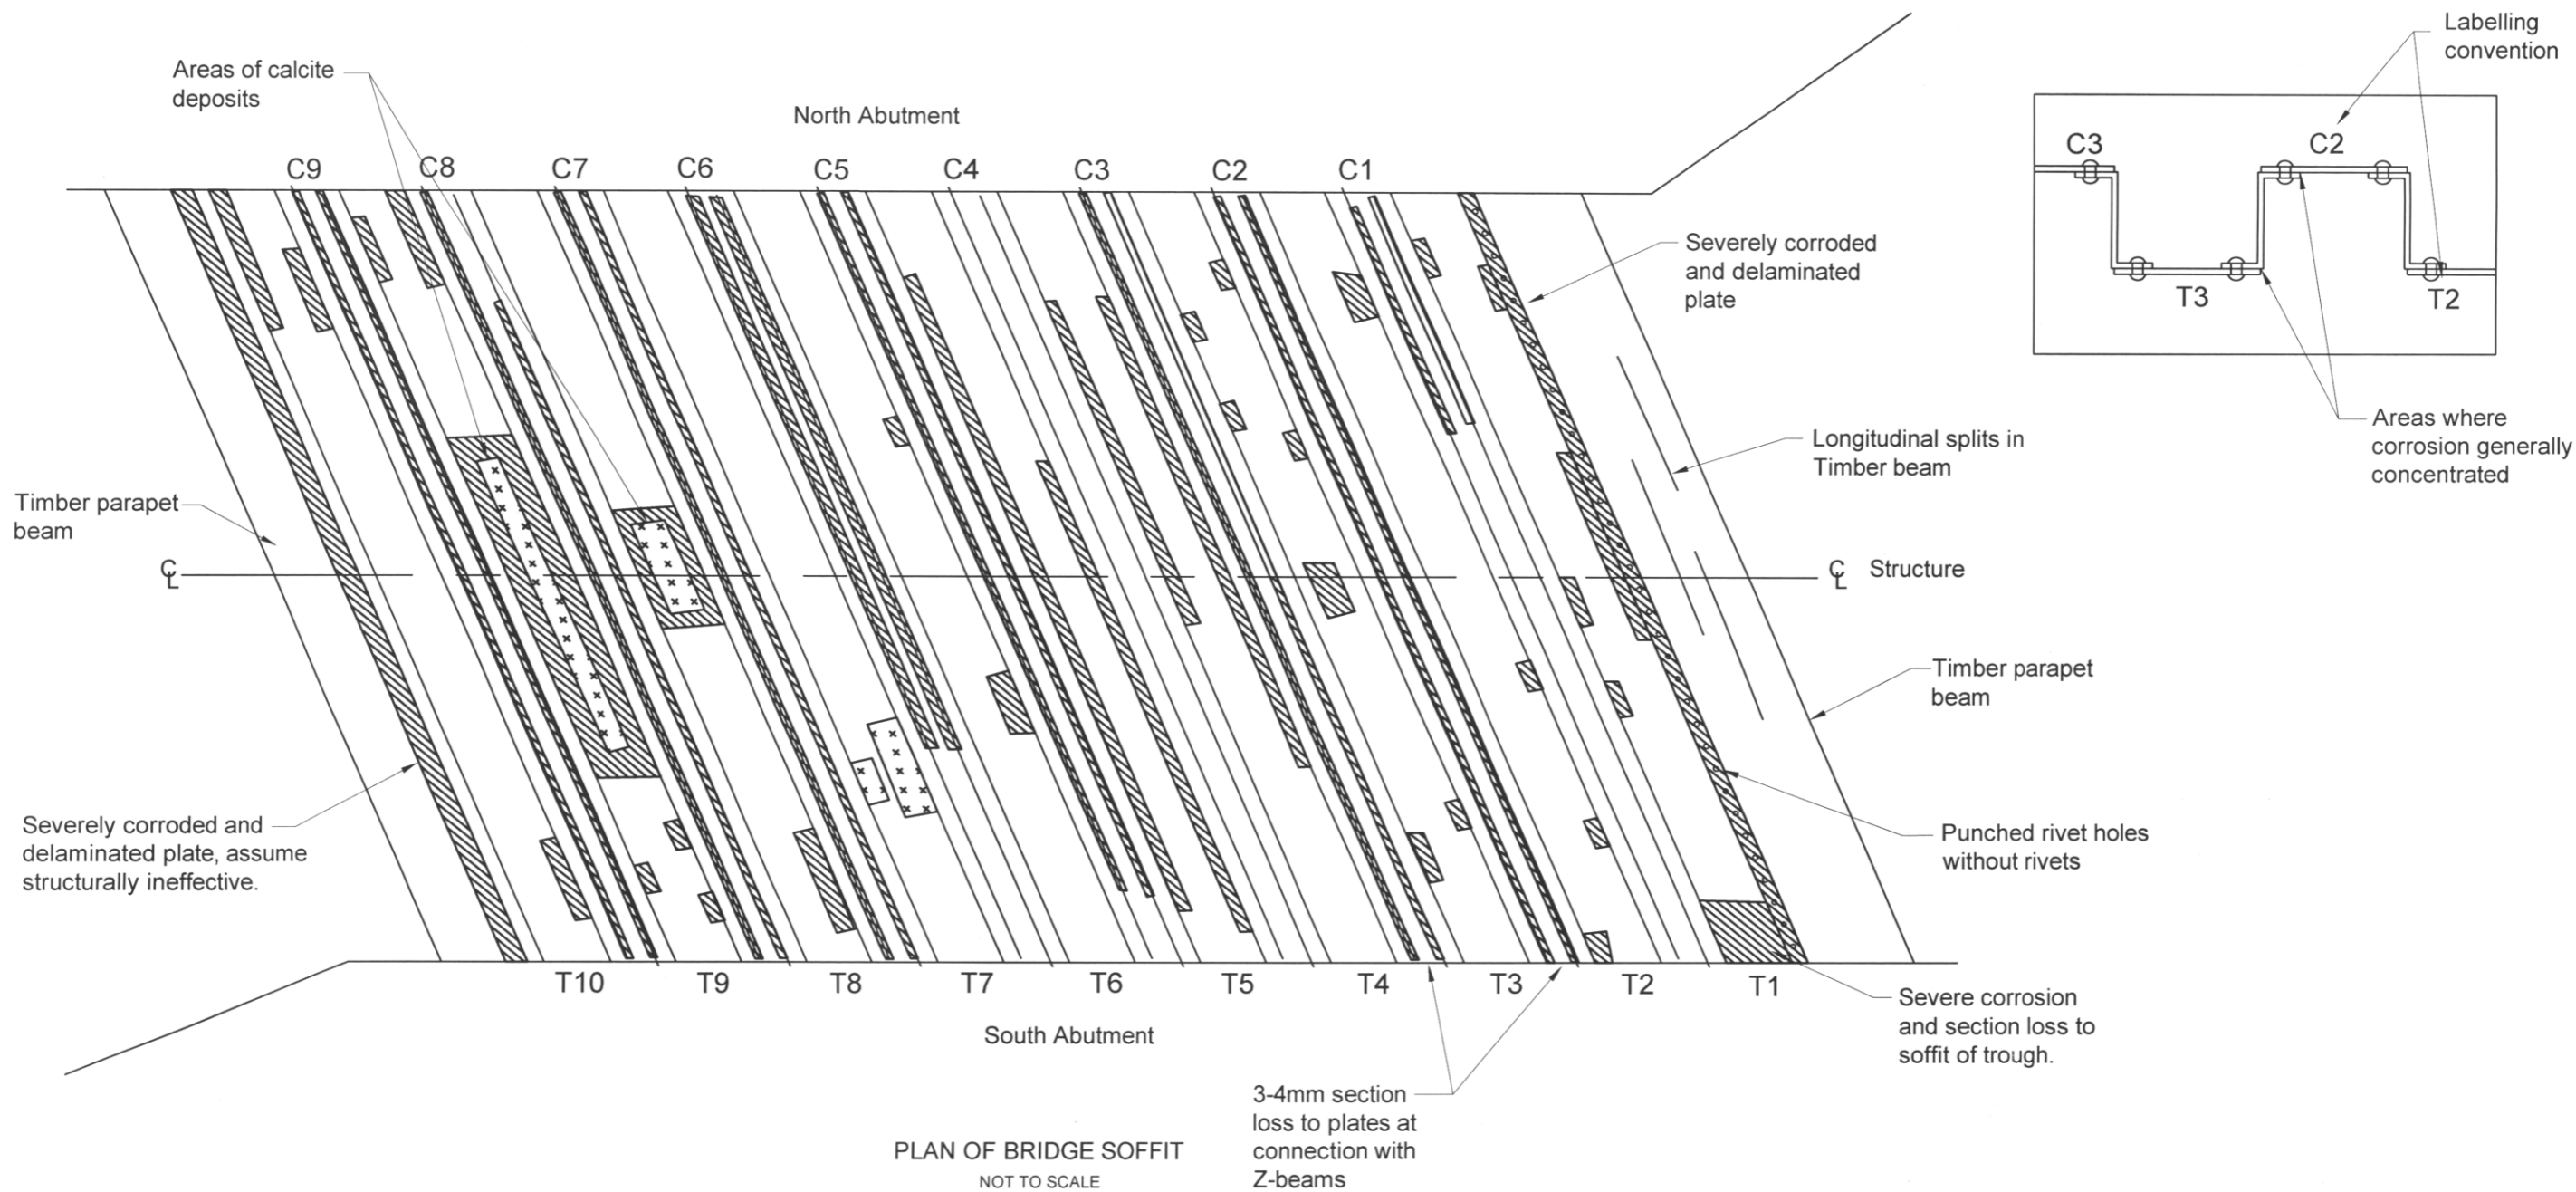
Main recorded defects are shown on Drawing No TB.2116.B562.SK02.

Areas of significant corrosion of steel,

Significant calcite deposits

Water seepage through the deck is widespread, causing the break down of paint, corrosion and section loss. Areas of reduced sections due to corrosion and delamination of the trough deck were considered in the assessment as detailed on Drawing No. TB.2116.B562.SK02.

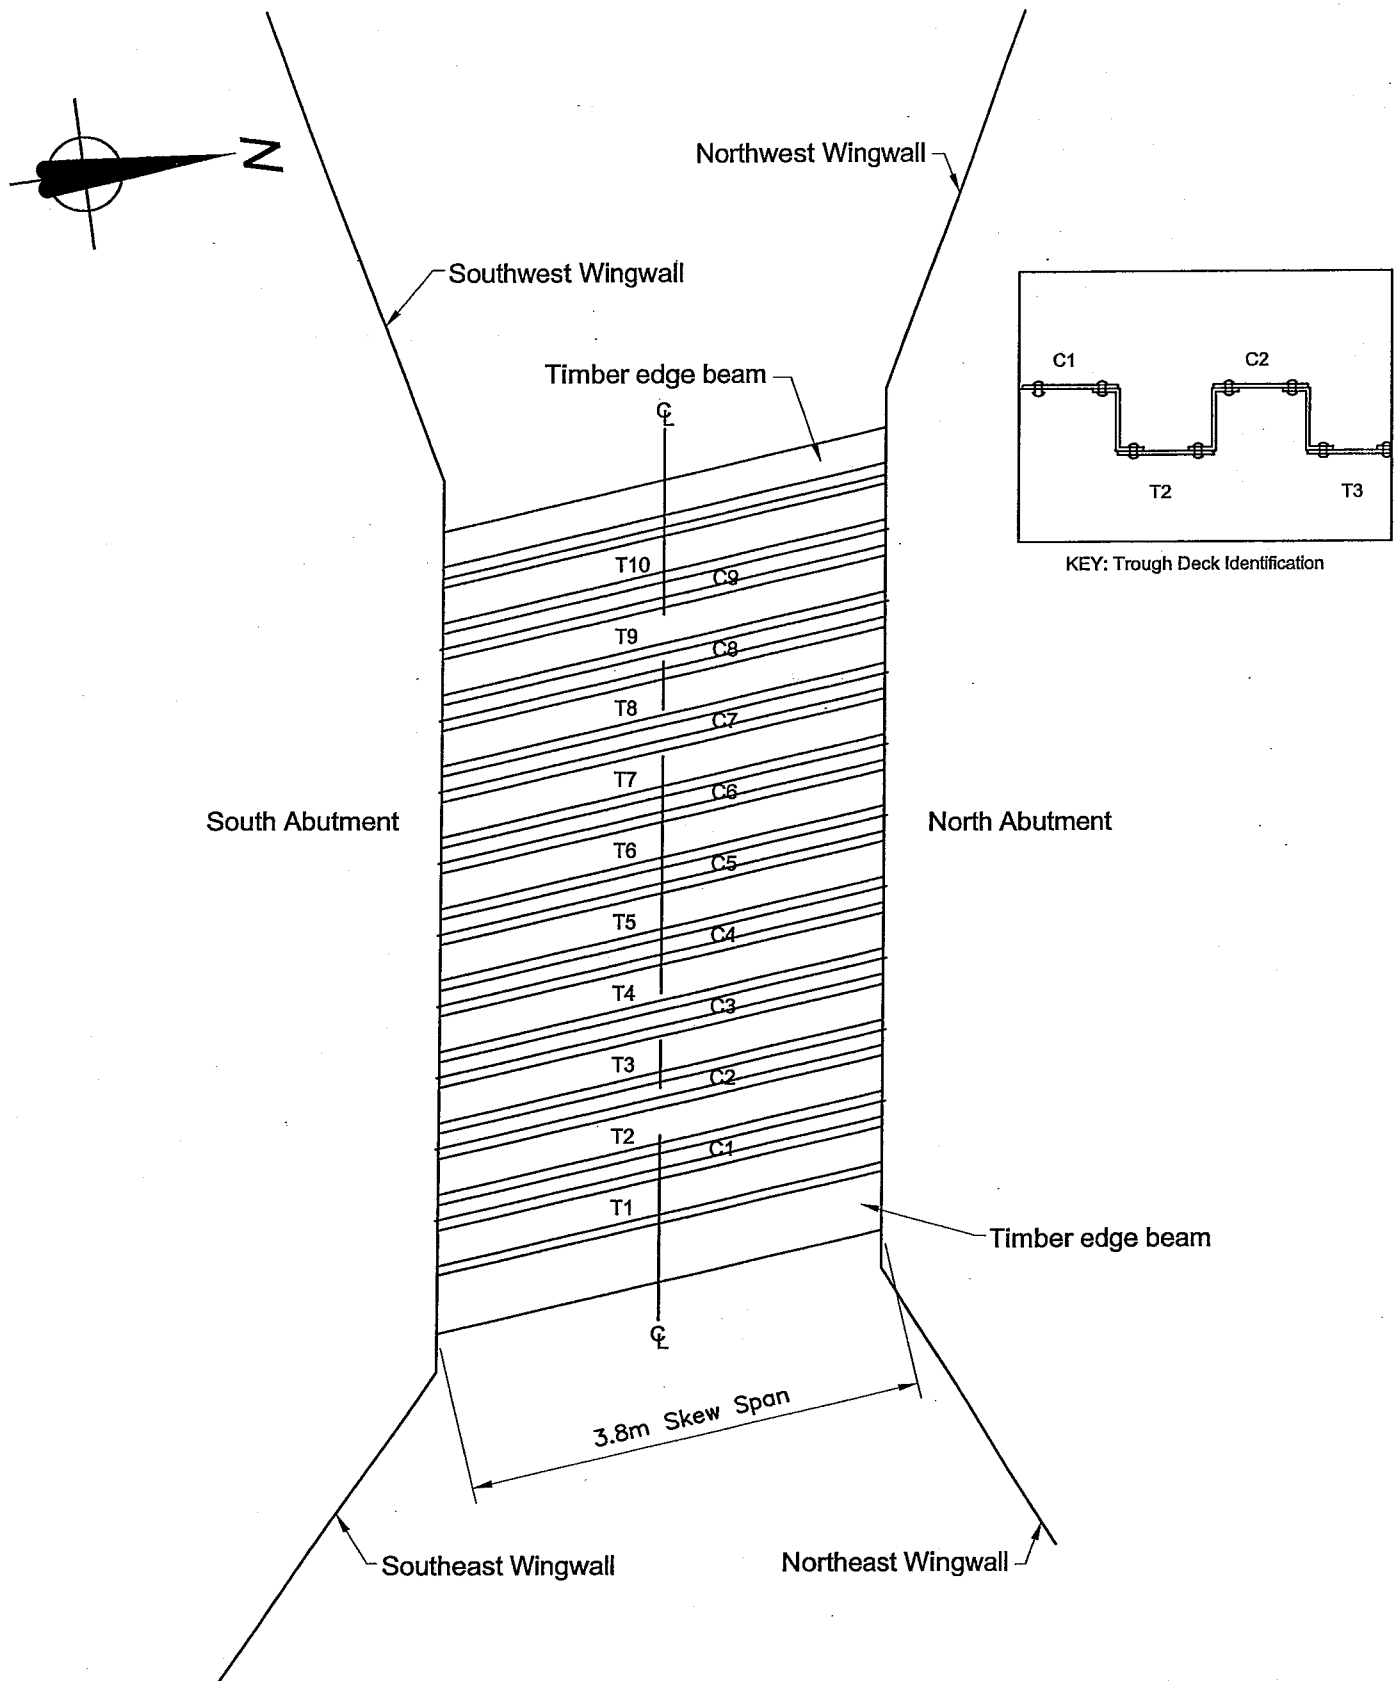
Plan View of Bridge Soffit

Dumpees Bridge consists of a steel trough deck which spans between stone abutments. The wingwalls are constructed of brick. Kee Clamp parapets with wire mesh infill are supported on timber beams. The vertical alignment over the bridge is significant and axle lift-off is possible. The trough deck is encased in concrete over the abutments but the poor composition of this concrete and lack of fill material above the troughing dictates that the deck should be analysed as being simply supported.

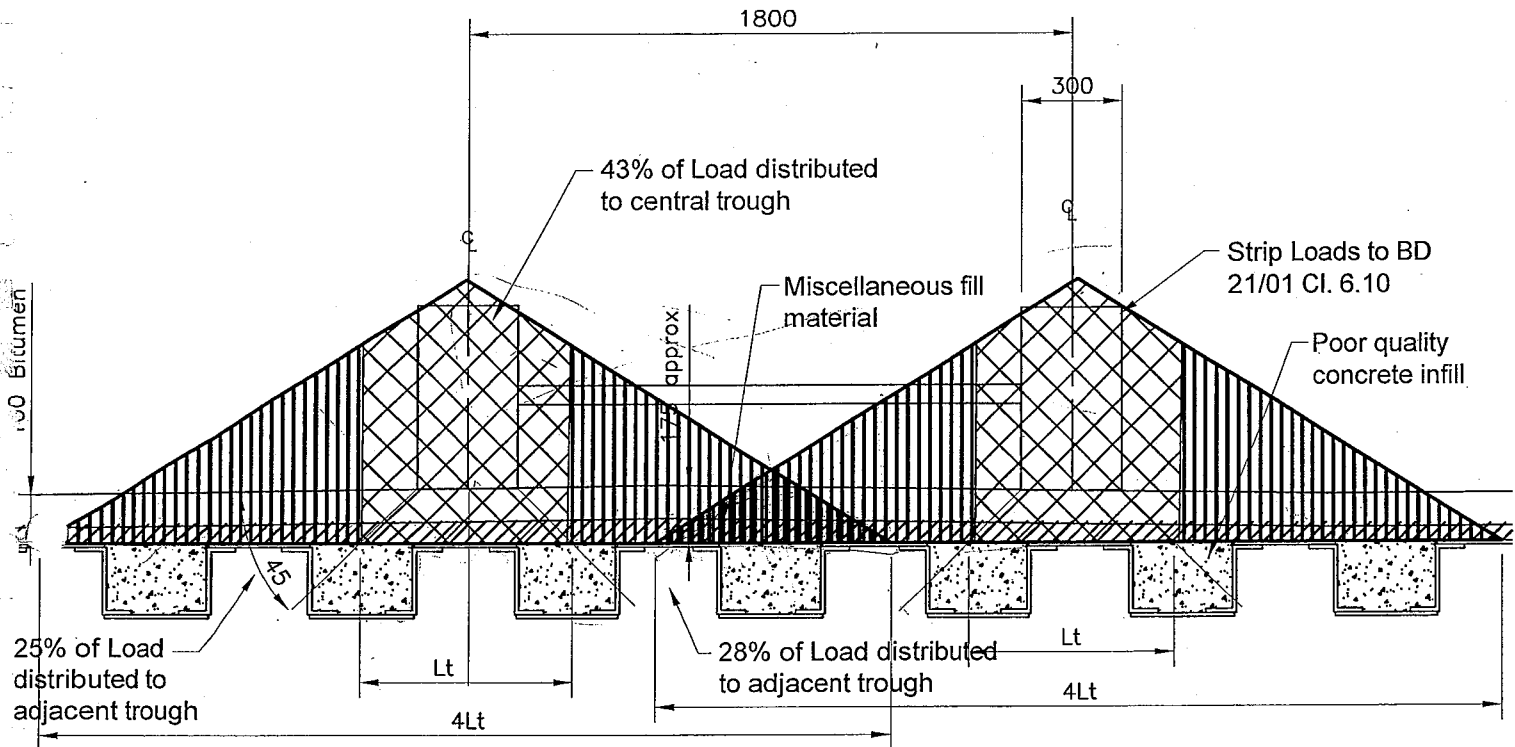
Dispersal of Strip Loads to Trough Deck

Load can be assumed to be carried by width of
troughing = $4L_t$ provided it is adequately connected.

From AutoCAD drawing on pg 5.3, percentage of
loading affecting trough under consideration.

Central trough $\rightarrow 43\%$

Adjacent troughs $\rightarrow 25, 28\%$

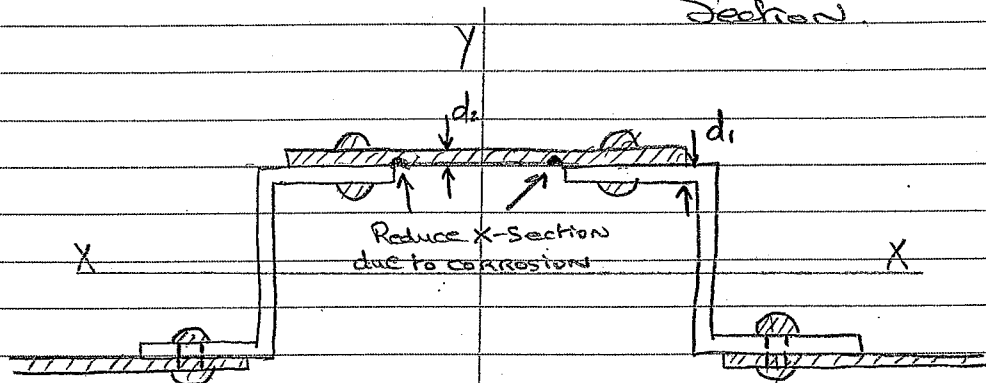
Section Properties of Double Z-beam Section

Reduce Depth of top & bottom plates due to corrosion, $d_2 = 8\text{mm}$
 Section loss around some rivets is localised & not considered in the assessment.

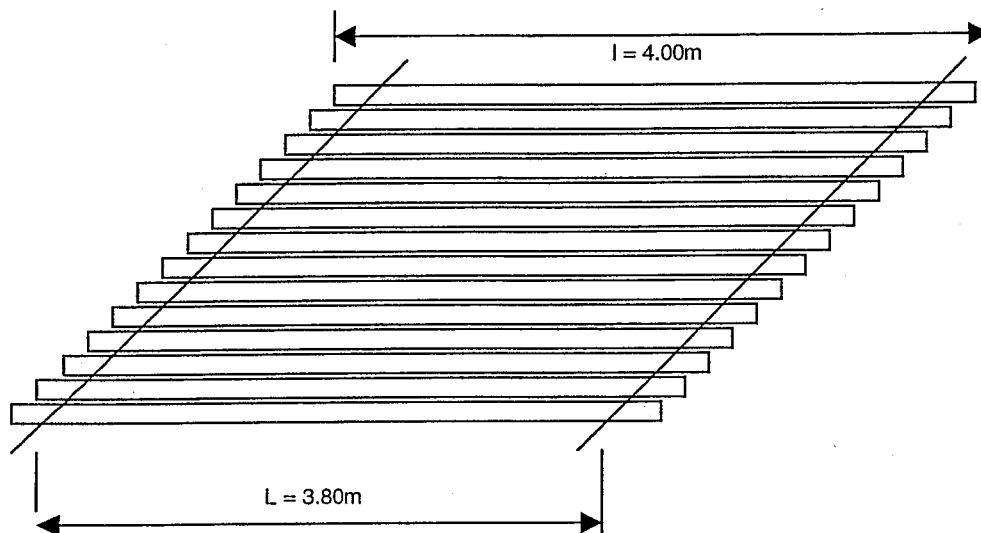
APPROVAL IN PRINCIPLE FOR ASSESSMENT**Diagram Showing the Idealised Structure**

Span between points of support (I):	4.00m
Clear Span between abutments (L):	3.80m
Characteristic yield stress of steel:	230N/mm^2
