**Assessment Report**  
**60045644-026-AR-01**

Bridge Name: **Melkington**  
BRB Ref: KLO/29  
NCC Bridge No.: A698/01RY

Northumberland County Council  
April 2009

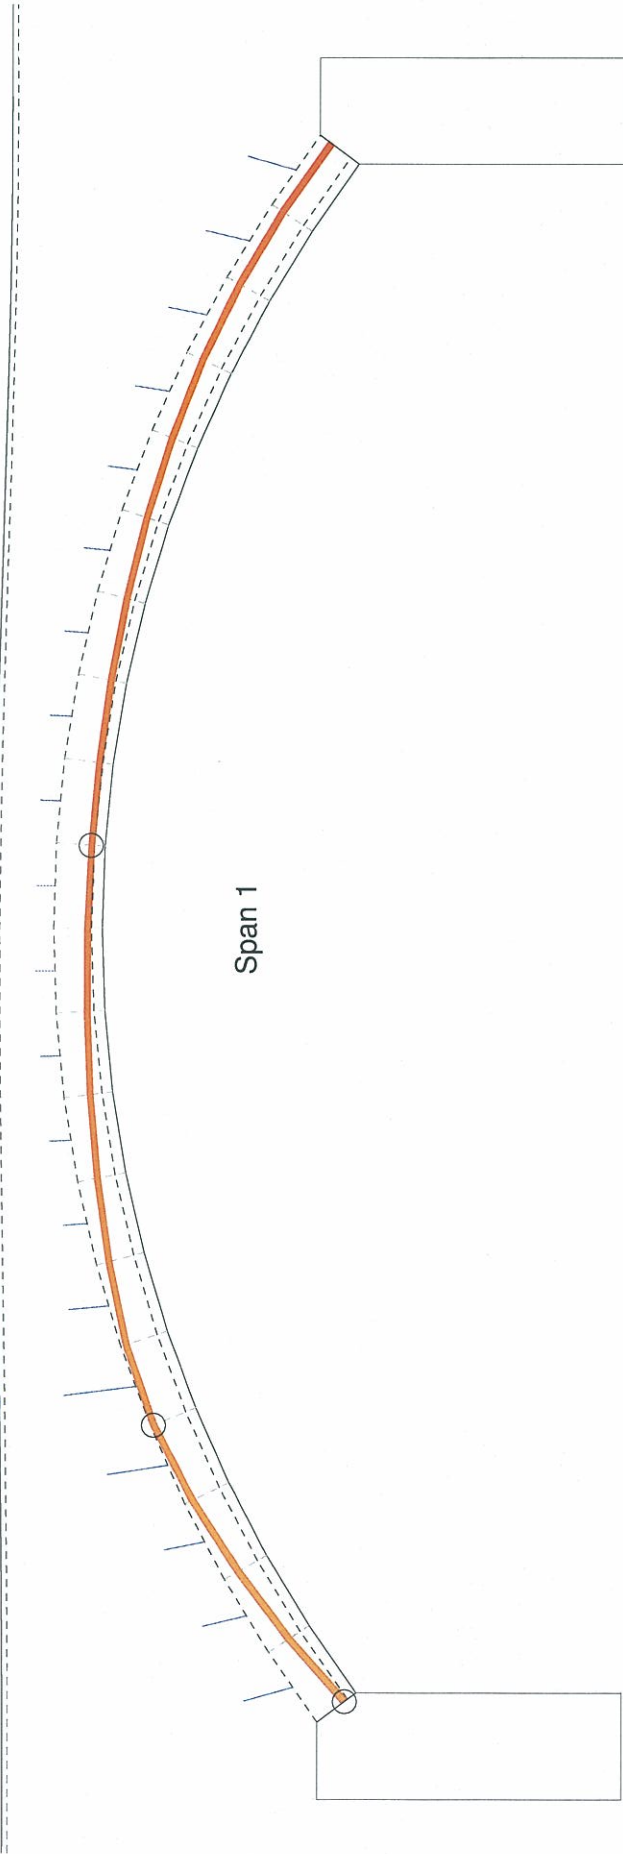
FE 2 Single Axle with Impact @ 2726 [mm]

The ARCHIE-M analysis found the bridge to have a capacity of 3 tonnes plus a Group 2 Fire Engine and was found to be able to accommodate 5 units of HB. The capacity of the arch would increase to 13 tonnes and 10 units of HB if the arch was re-pointed. Any further increase in capacity would require extensive strengthening work to be carried out as the capacity of the arch is largely limited by its relatively flat profile.

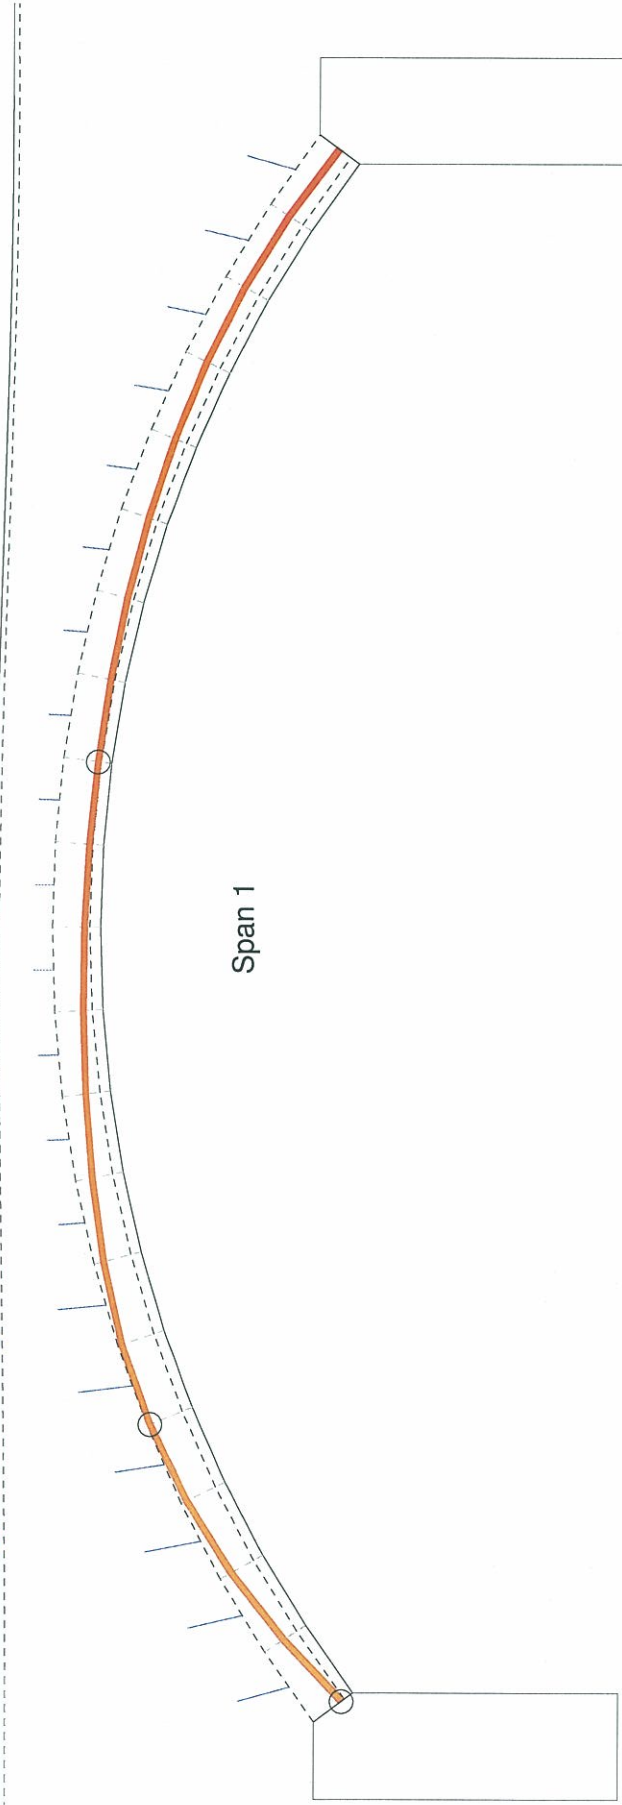
5 Units @ 3259 [mm]

The ARCHIE-M assessment found the arch barrel to be capable of accommodating a Group 2 Fire Engine and 5 units of HB.

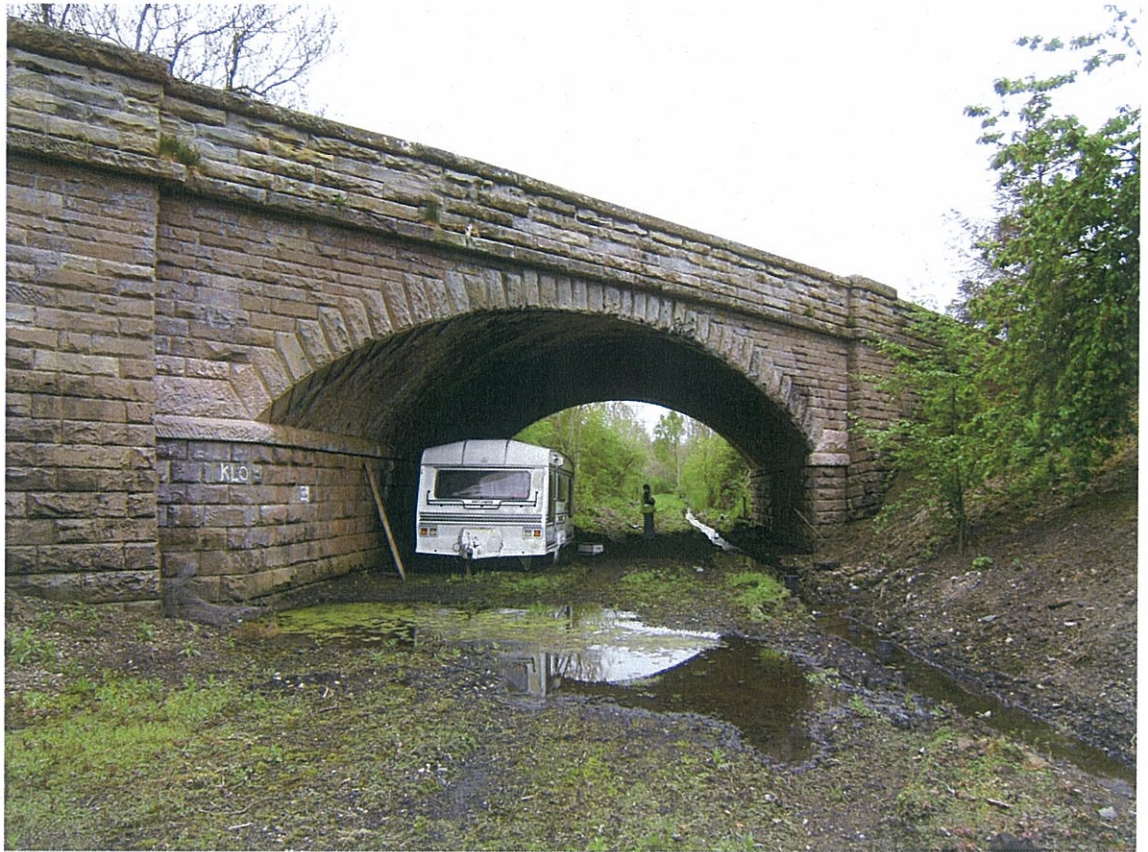
Photo 1. North Elevation

The inspection found the parapet and spandrel walls to be in good condition.

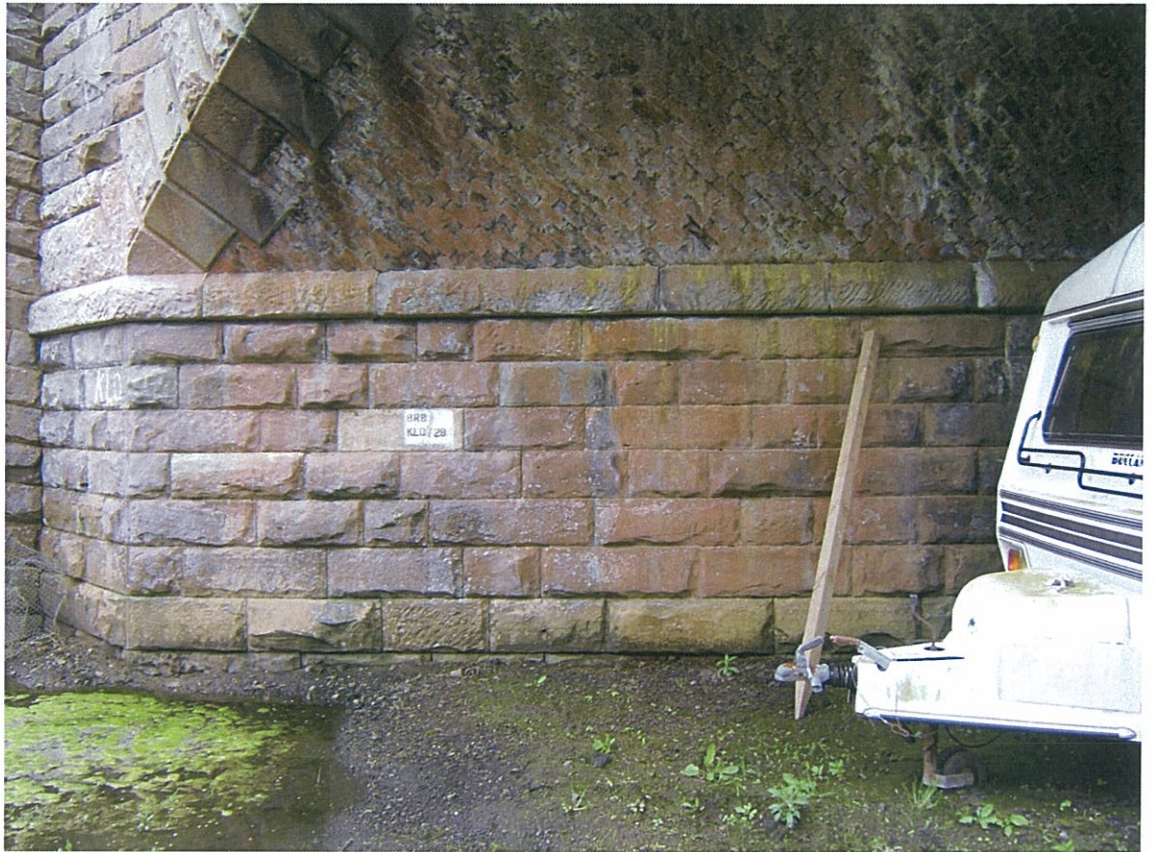
Photo 3. East Abutment

The abutments and wing walls were found to be largely in good condition with joints and stones intact and in good shape.

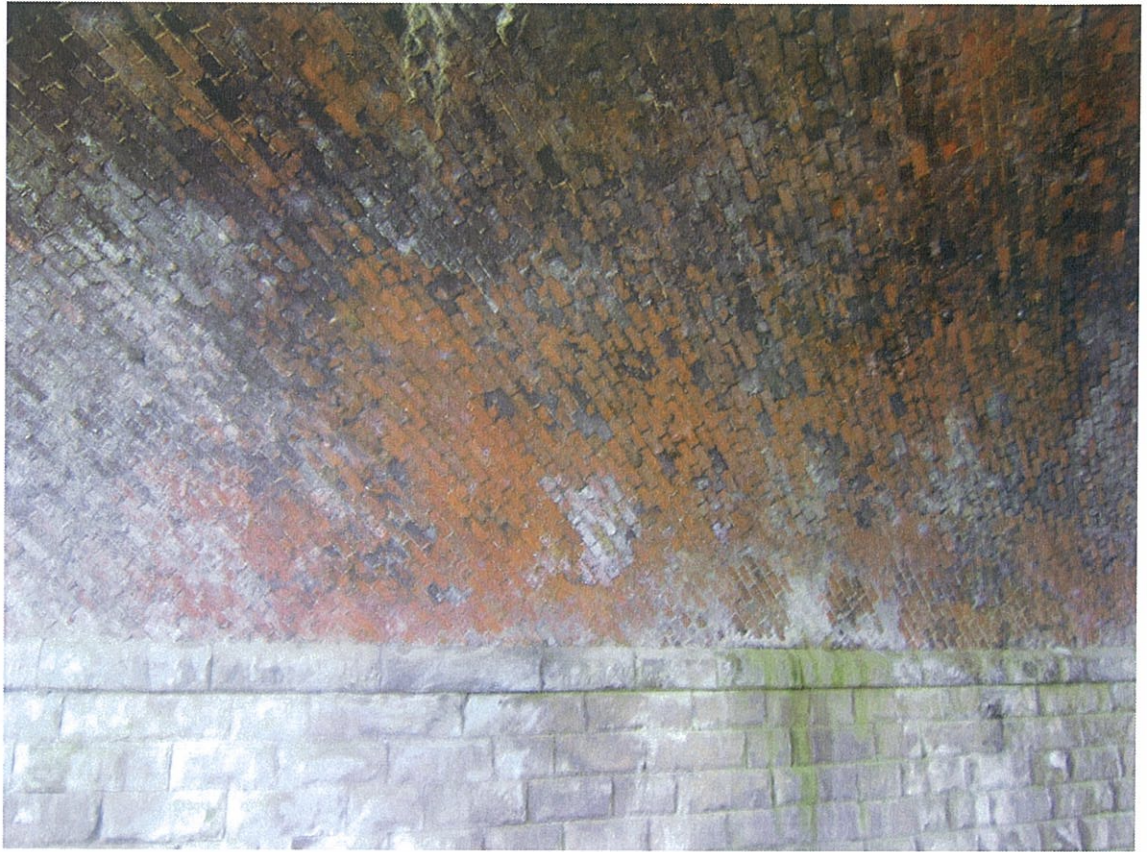
Photo 5. Soffit Typical

The inspection found the arch barrel to be in fair shape with the mortar in the joints missing to a depth of 100mm in some places. Extensive salt and calcareous deposits were noted to the arch barrel, particularly beneath the verges.

The structure has been assessed to a **Group 2 Fire Engine** and **5 units of HB**, hence a weight restriction of 3t is recommended. The arch barrel should be re-pointed in order to increase the capacity of the bridge to 13 tonnes and 10 units of HB however any further increase in capacity would require extensive strengthening works to be carried out.

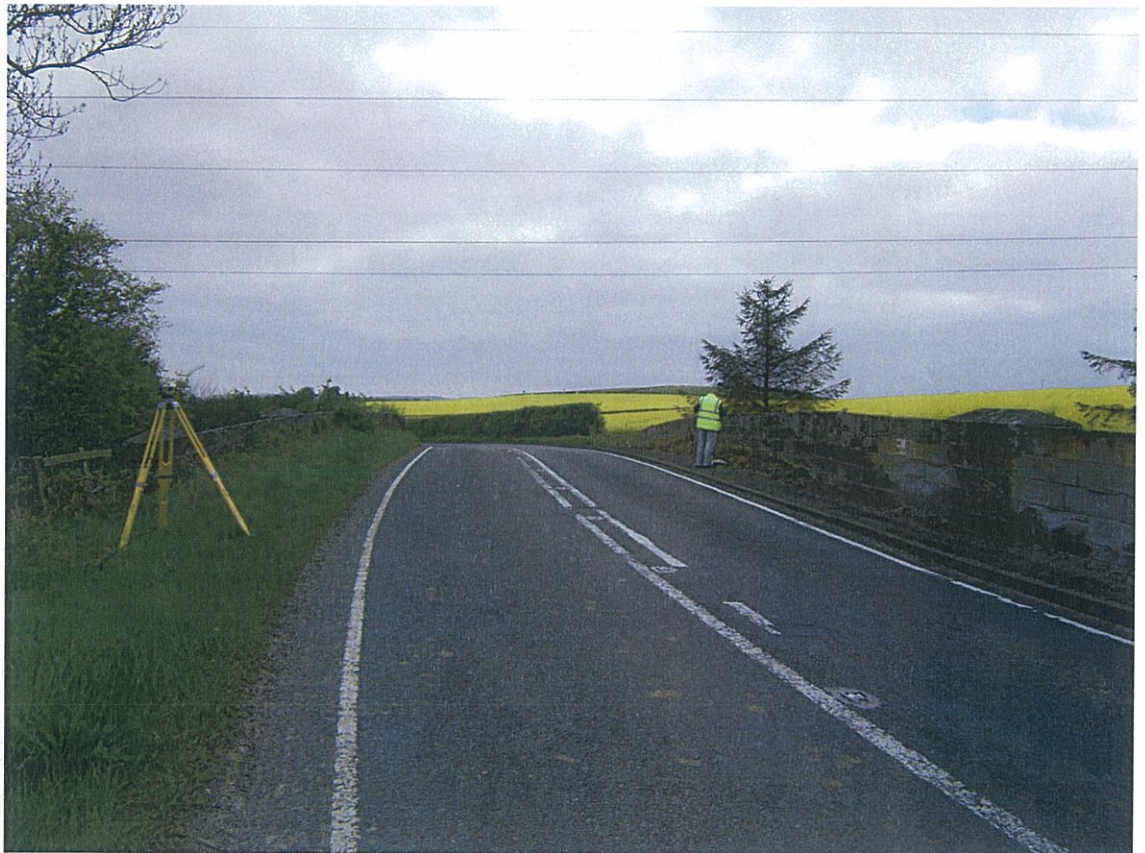
Photo 6. Bridge deck surface

The road surface was in generally good condition with only minor surface break up to the edge of the carriageway.

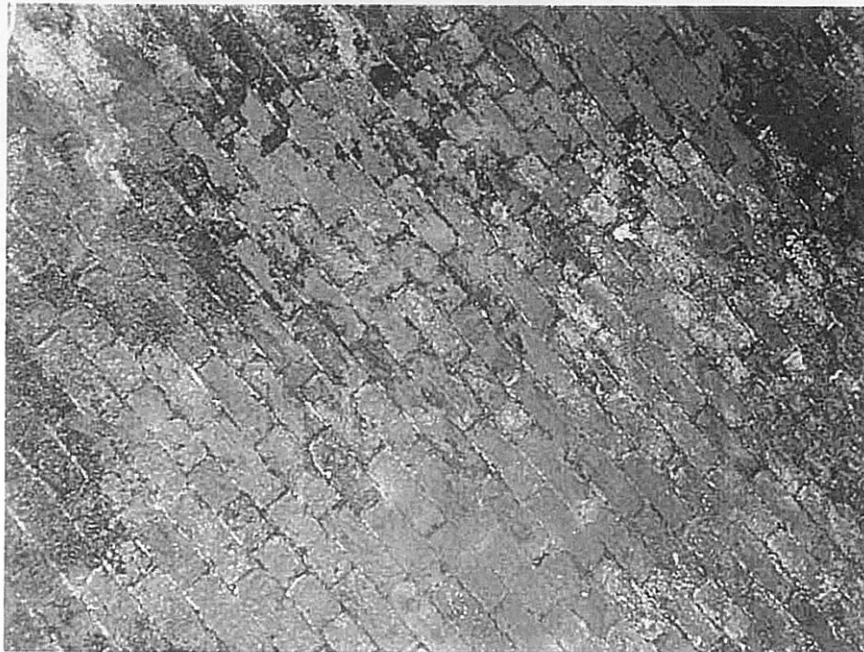
Arch Barrel

The bridge was generally in a fair condition. The bricks were laid with 6 to 12.5mm joints. The arch barrel was 457mm (18") deep at the crown (as drg No CD/2252/5/3/1). There was water ingress underneath the verges with calcareous deposits. There was evidence of spalled bricks, however due to extensive soot deposits it was difficult to establish the extent. The depth of mortar missing was estimated at up to 100mm in various locations.
