**ASSESSMENT OF HIGHWAY STRUCTURES
PACKAGE No 25 (COUNTY)
PRINCIPAL BRIDGE INSPECTION**

**BLUNTISHAM RAILWAY BRIDGE
BRIDGE NUMBER 365743**

INSPECTION DATE: SEPTEMBER 1995

BC6272/704/R1 Rev 1

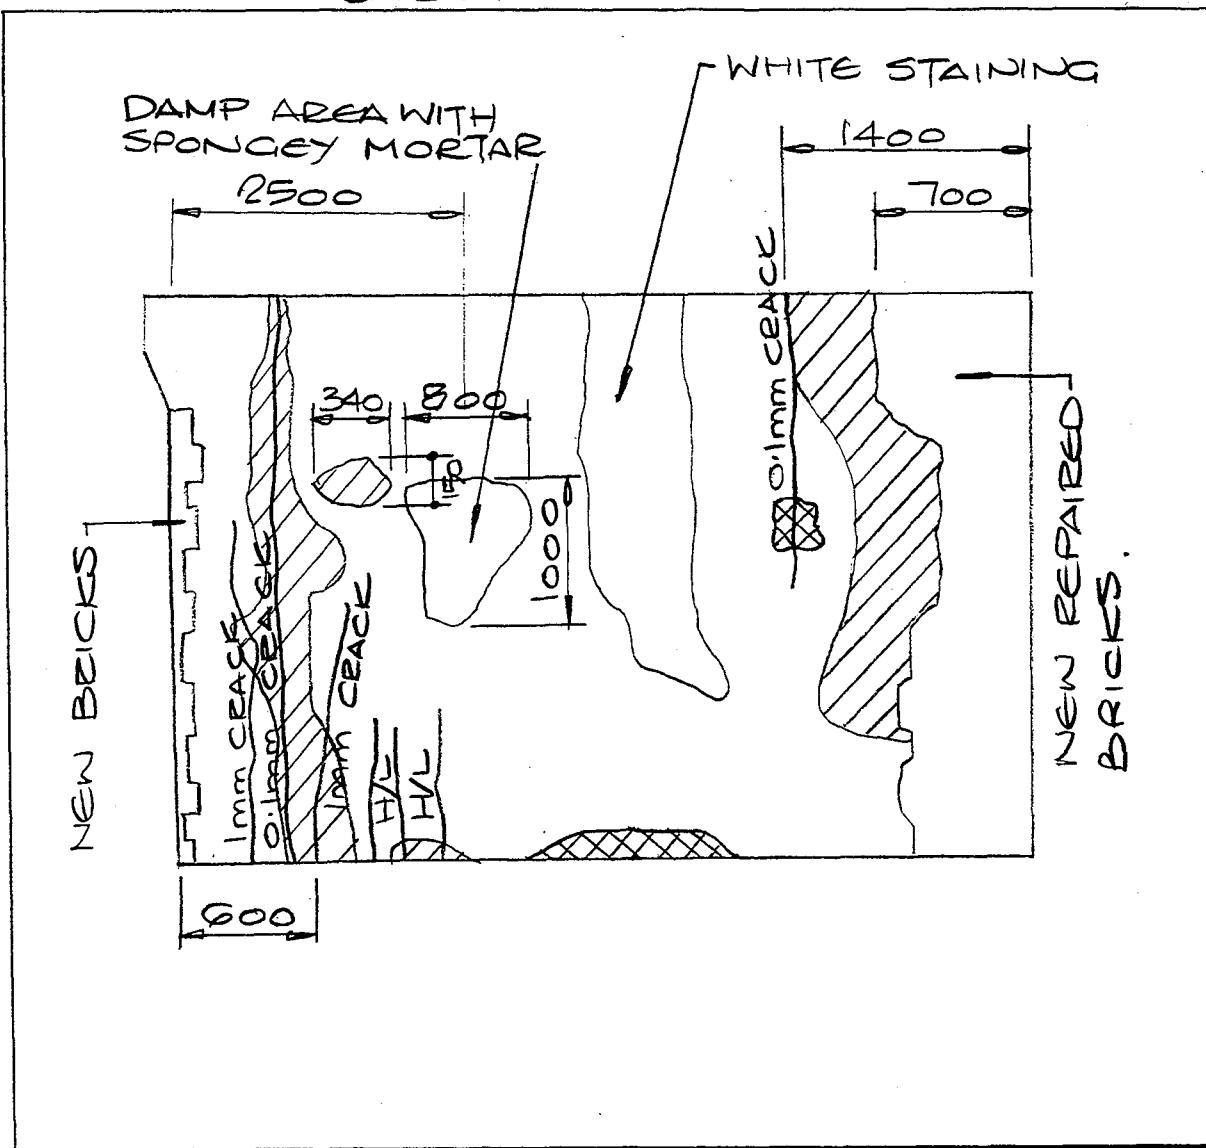
DETAIL OF NORTH ABUTMENT
SHEET 1 OF 11

Several vertical cracks ranging from 0.1 mm to 1 mm wide, 600 mm away from the west end of the north abutment. There is also a single vertical crack from the top of the east end of the north abutment. This is 0.1 mm wide.

Extensive areas of spalling on both abutments, varying from minor to deep spalling.

Priority: Medium
Action: Repair crack in mortar joint by repointing.
Estimated Cost: £300

Action: Brickwork repair - remove spalled brickwork and replace.

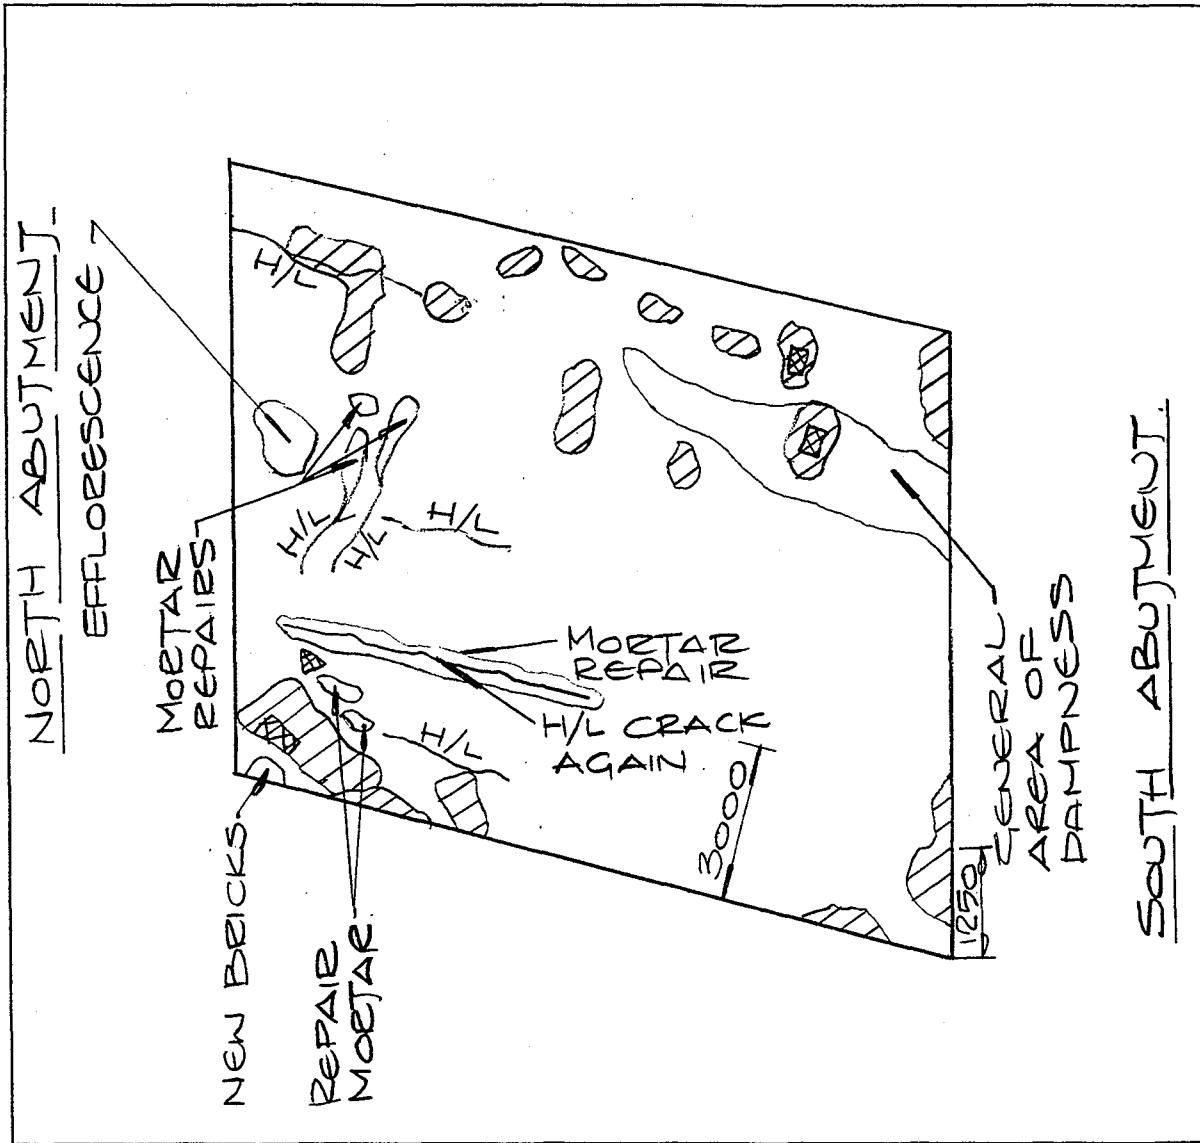
DETAIL OF SOFFIT OF BARREL
SHEET 3 OF 11

SOOT ON BARREL SO DIFFICULT TO SEE DEFECTS.

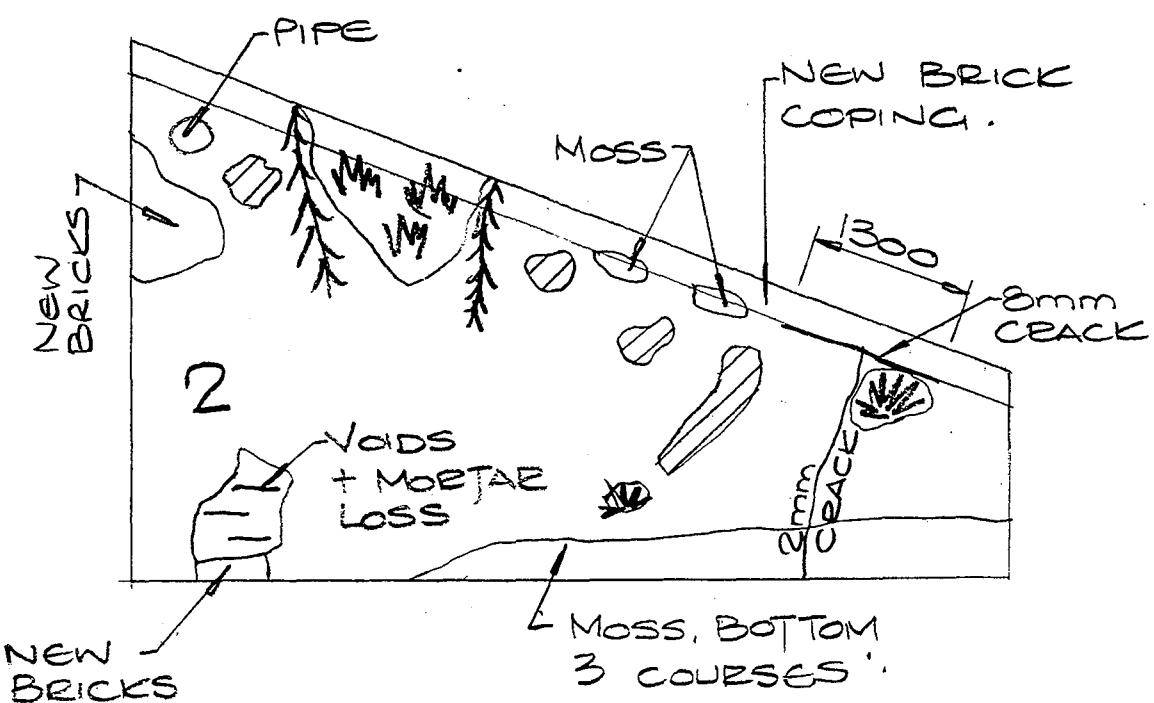
DETAIL OF NORTH EAST WING WALL
SHEET 4 OF 11

MANY OF THE JOINTS ARE MOSSY.

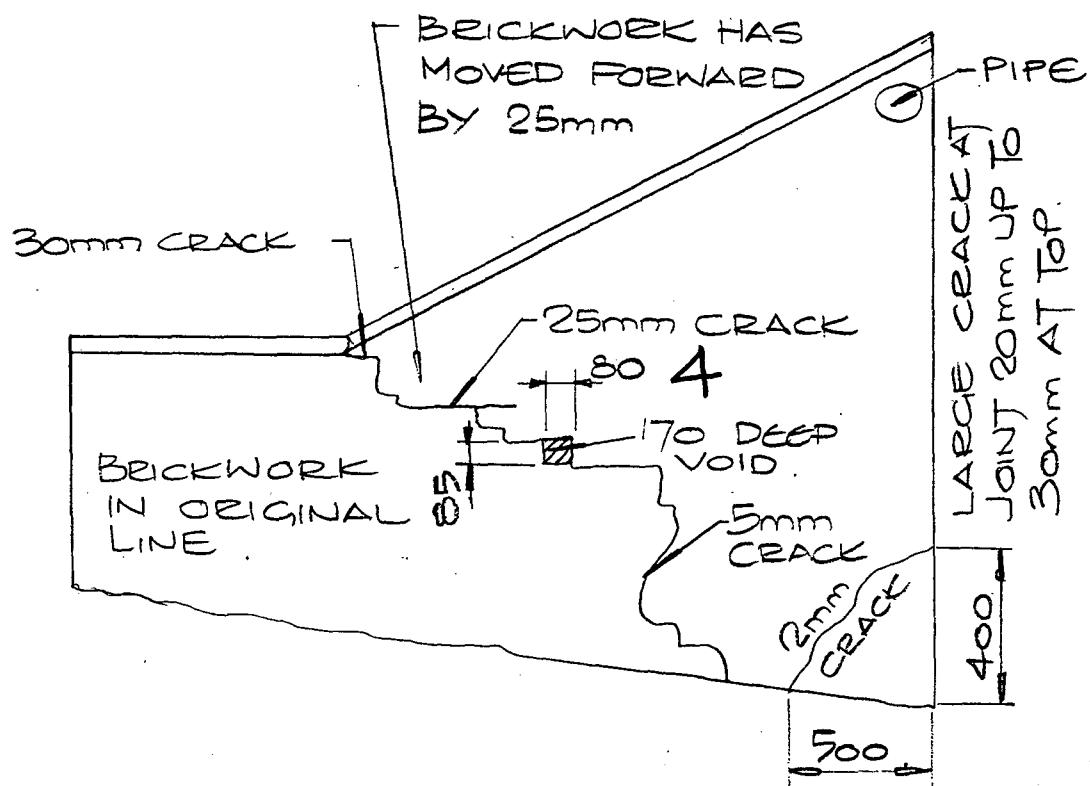
DETAIL OF ..NORTH WEST WING WALL
SHEET 5 OF 11

Large crack running diagonally from the direction change at the top edge of the wingwall, down to the bottom corner, nearest the abutment. The crack varies in width from 30 mm at the top to 5 mm at the bottom. Approximately half way along, there is a 170 mm deep void where a brick is missing. There is a full height wide vertical crack where the wingwall has moved away from the buttress. There is also a 2 mm diagonal crack at the bottom corner of the wingwall nearest the abutment.

See 6A.1. These cracks were caused by movement of the wingwall. The top section has moved forwards by 25 mm from the bottom section which is on its original line.

Priority: Medium
Action: Repair and strengthen wingwall.
Estimated Cost: £20,000

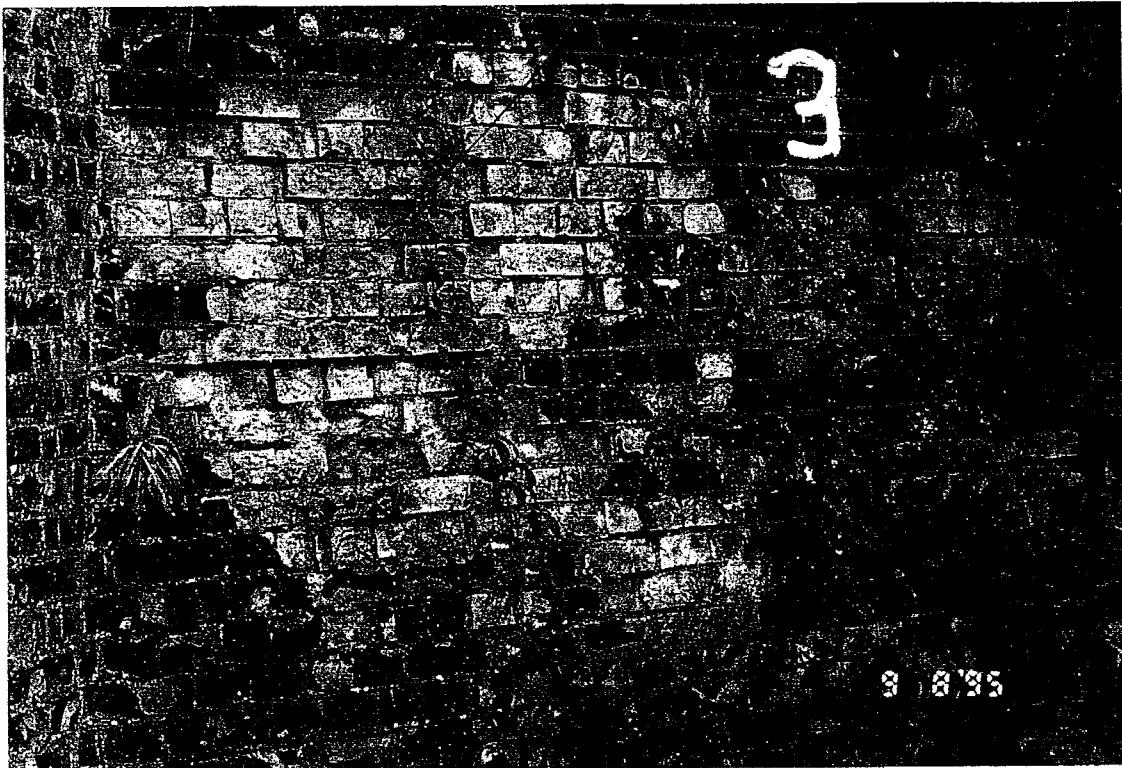
F14/2 - Spalling and vegetation on south west wingwall.

Large areas of spalling, up to half a brick deep in places on the wingwall.

Action: Brickwork repair - remove spalled brickwork and replace.
