Highways Agency, Historical Railways Estate Major Works Programme 2012 - 2015

BD21 ASSESSMENT REPORT

Crawley Hall Bridge,
Crawleyside, County Durham

BRIDGE REF: ASS/2

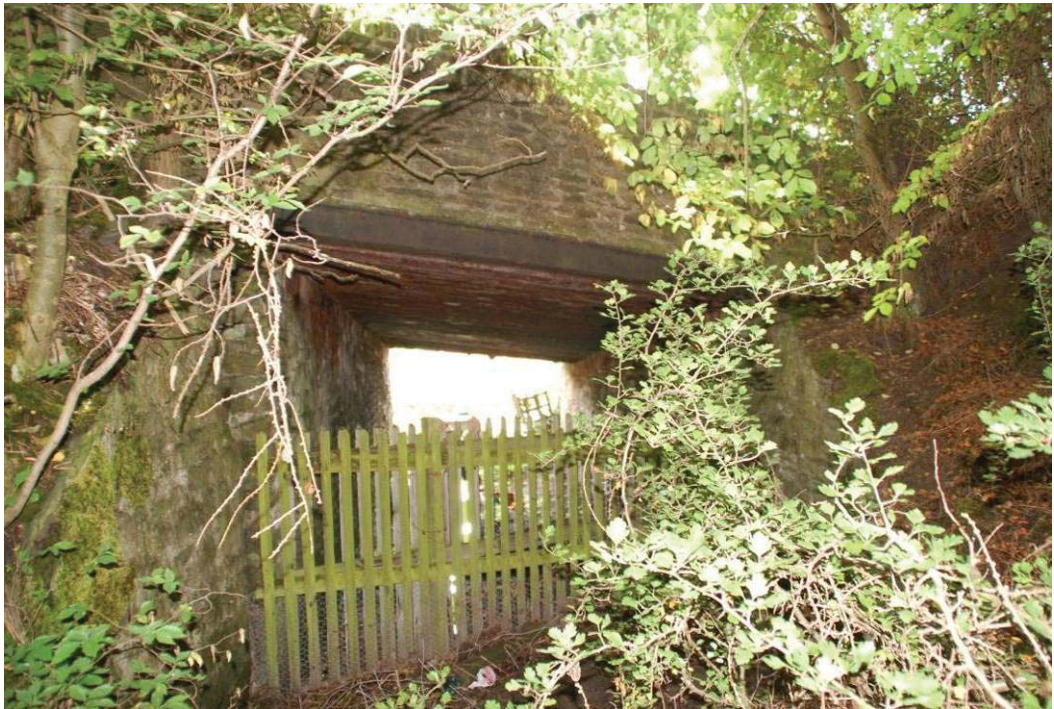
1. North elevation

On the north parapet the joints are generally well filled with light weathering to the inside face. Where the east end of the parapet meets the extension wall there is a large stepped fracture through the joints. On the outside face there are deep open joints to the stonework and loose stones. There is light weathering to both the inside and outer faces.

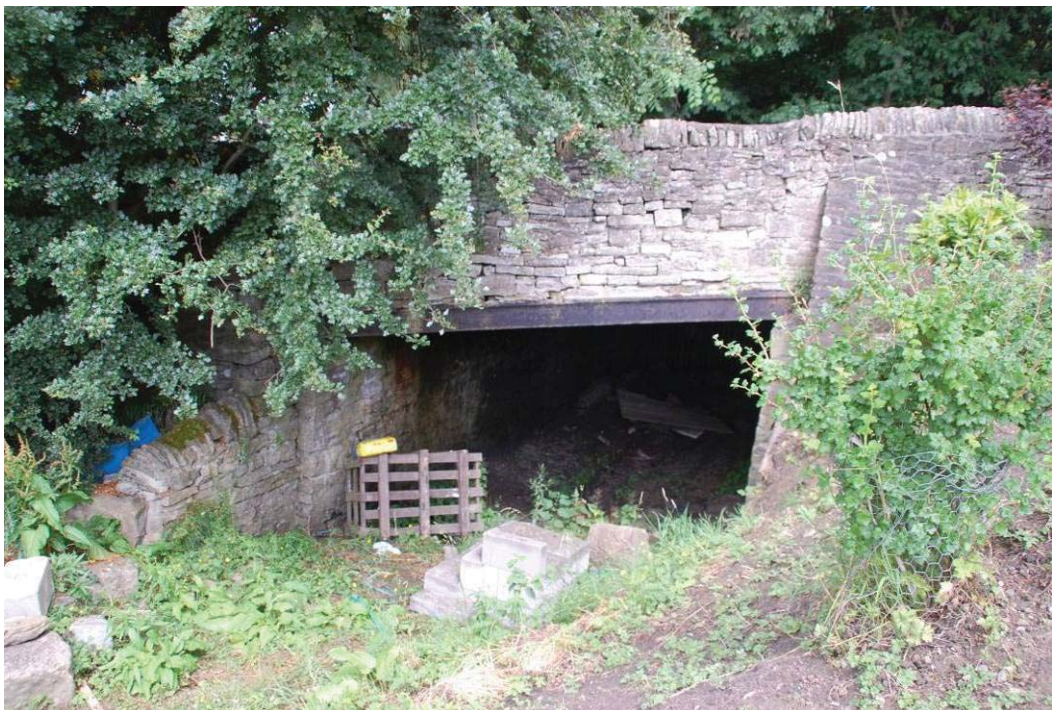
2. South elevation

The parapets are in fair to poor condition. The south parapet has had repairs to the coping stones and the joints are generally well filled in the top 500mm. Below that, the joints are open to the deck level on the inner face. On the outer face there are deep open joints to the coursed stonework and loose stones. There is light weathering to both the inside and outer faces (Photograph 17 and 21).

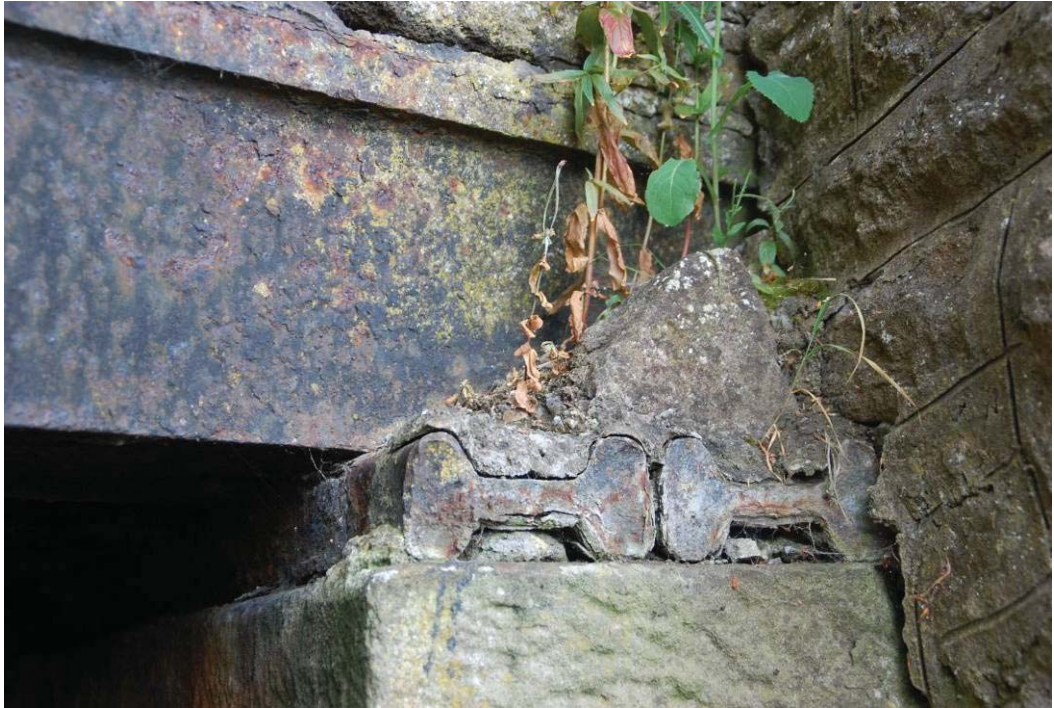
3. South East Bearing Point

There is heavy corrosion and de-lamination to the west abutment bearing rails. A sample of the first bearing rail was taken and revealed de-lamination and loss of section of up to 4mm on all faces (Photograph 5). The east abutment bearing at the south face was in a fair condition; the paint system was still intact on the end face with up to 1mm of section loss across the exposed west face.

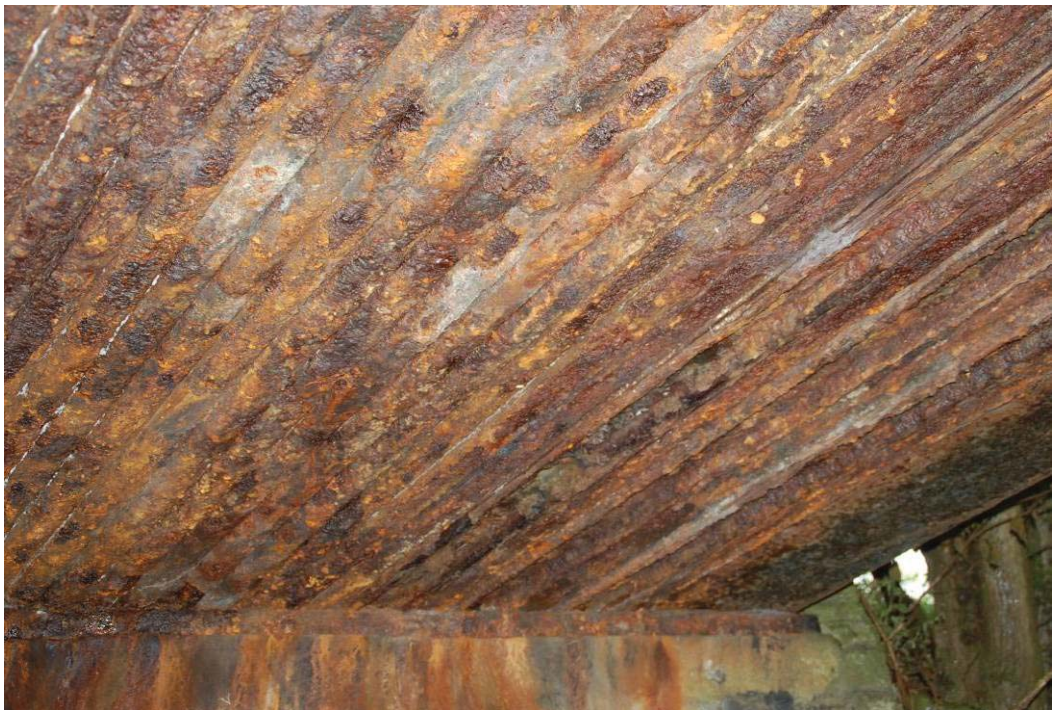
6. Underside of Longitudinal Rails Facing West Abutment

The longitudinal rails are heavily corroded on the bottom flanges with damp staining noted along the length of the span. The paint system has completely failed across the span except for localised sections towards the centre of the deck and east support area where it remains intact. There is heavy damp staining and build up of leachate along the length of the span; stalactites up to 60mm in length were noted towards the west support area (Photograph 6). Up to 5mm section loss to the bottom flange of the rail was noted across the span. The north and south edges of the rail construction were exposed; up to 5mm section loss was evident along the faces (Photograph 11).

If the bridge is to be retained, it is recommended that the deck is re-waterproofed to eliminate seepage. Corrosion protection to the old rails is probably impractical. Repairs to the abutments are also recommended.

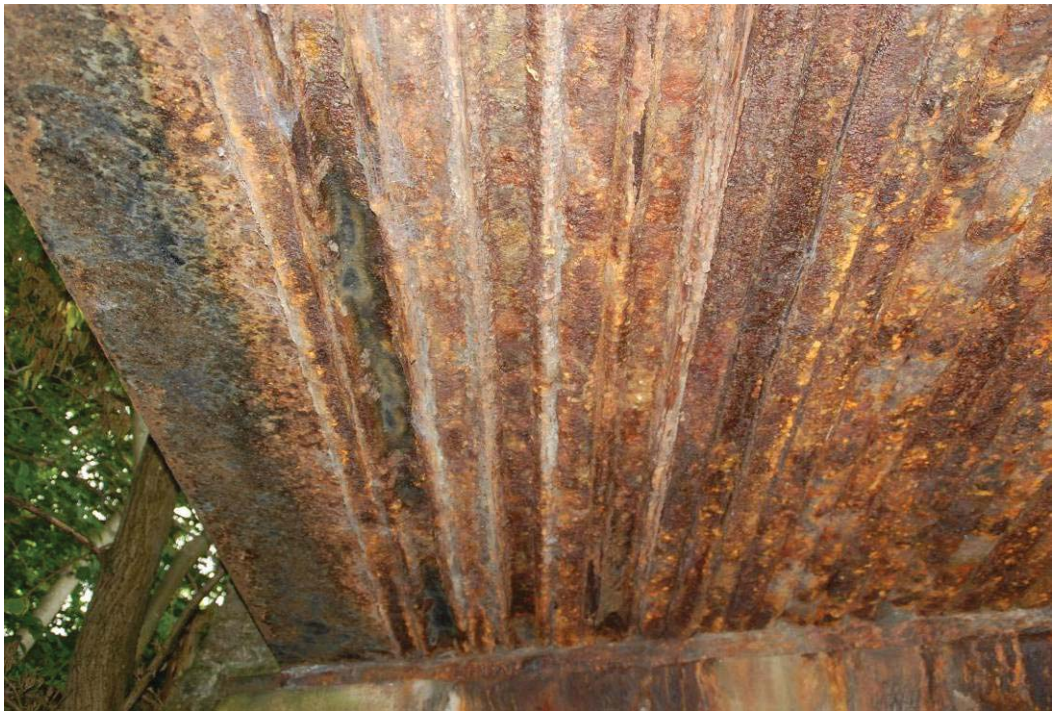
8. Horizontally Laid Rails and South Edge Beam Facing West Abutment

There are cast iron trough type edge girders that form the support for the bridge parapets. Under the footways some of the rails are laid horizontally. At the south footway a section of rail deck appears to have been removed to accommodate a service pipe. The gap has been covered with a steel plate.

The south edge girder is in fair condition. The paint system is failing on the outer face and has completely failed on the bottom face. Pitting was noted on the outside face and the bottom flange has deep pitting corrosion evident along the full length with up to 2mm loss of thickness (Photograph 4 and 5).

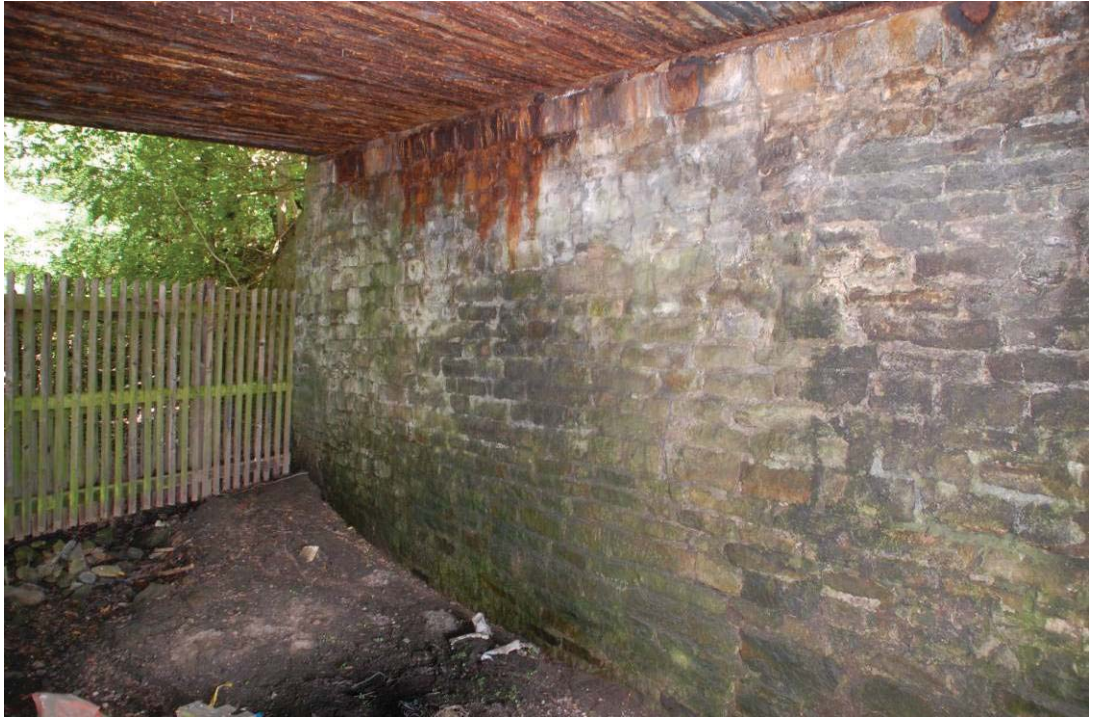
13. East Abutment

The east abutment is in whole in fair condition, damp staining and rust from the supported rails is evident along the top 700mm across the width of the abutment. Towards the north end of the abutment there is leachate staining over the full height of the abutment. There are deep open joints across the face of the abutment with several vertical fractures; there is a joint fracture open to 5mm, starting from the base of the service pipe approximately 1100mm from the south face, extending vertically down to ground level. There are several spalled stones with loss up to 90mm deep associated with the fracture. At the centre of the abutment there is a gap between the bearing stones 30mm wide. There is a fracture open to 5mm extending from the gap through the joints down to ground level. There is a 2.5m² area of bulging approximately 1000mm from the north end surrounded by deep open joints. There is a 6.5m² damp area from ground level approximately 2000mm from the north face.

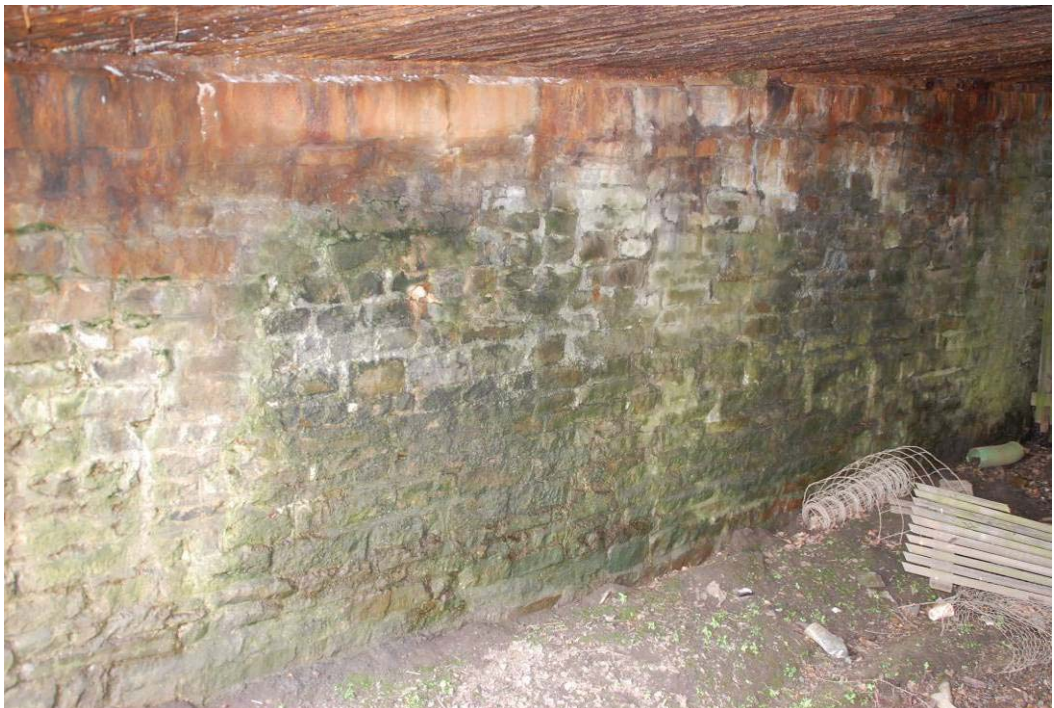
14. West Abutment

The west abutment is in fair condition, damp staining, rust and leachate deposits were noted across the width of the abutment from the bearing points 1000mm in length. There is an area of deep outward bulging 1m², 1000mm from the south face. There is a fracture extending vertically through the joints though the bulging stonework open to 30mm (Photograph 15). There is a fracture open to 3mm from the base of the service pipe extending vertically 1000mm through the joints. At the centre of the abutment there is a fracture extending vertically 1100mm through the joints and below the bearing stones there is a horizontal open to 3mm fracture through the joint 900mm in length. There are localised areas of open joints to 50mm deep. There is a 3.5m wide band of damp extending the full height at the centre of

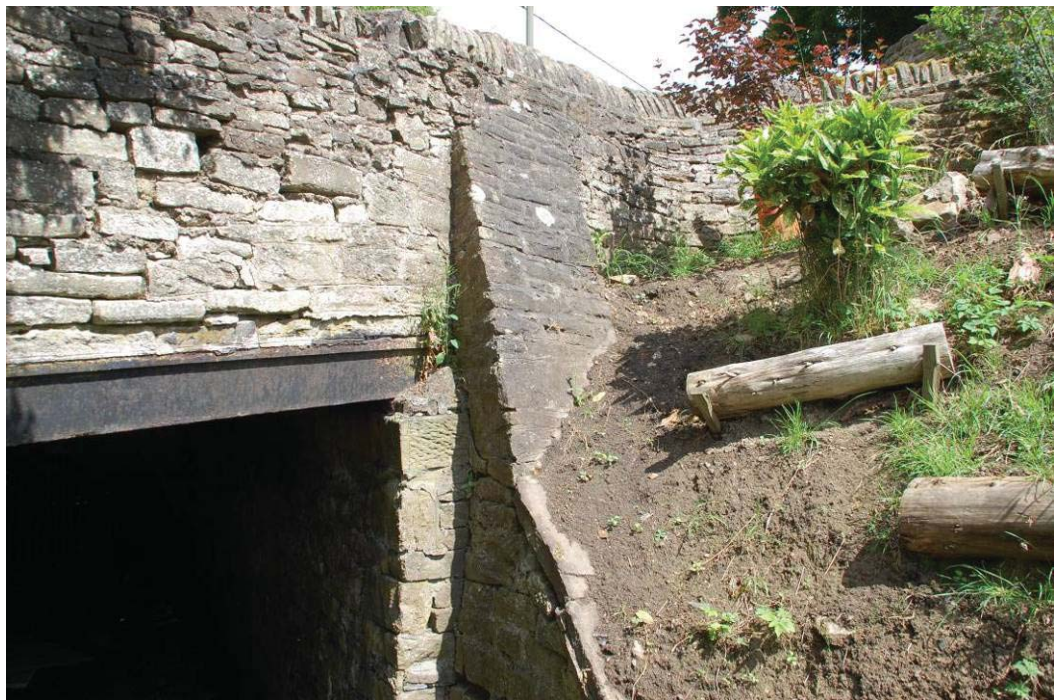
17. South East Wing Wall

The stone extension walls beyond the parapets are generally in fair condition. They are lightly spalled with localised areas of recessed mortar joints in the same fashion as the parapets with intermittent vegetation growth.

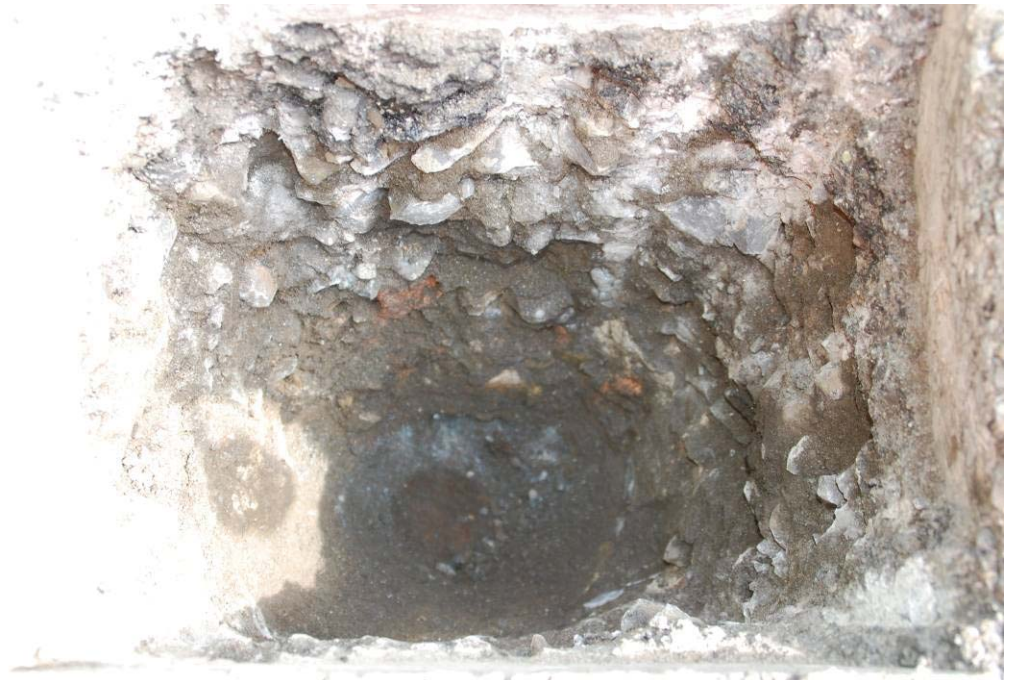
22. Trial Pit in Carriageway Exposing the Top of the Longitudinal Rails

Structural Soils Ltd. excavated a trial pit in the carriageway, north of the deck centre line at midspan exposing the top of the longitudinal rails.
