HRE Assessment Programme

Highways England - Historical Railways Estate

AYH/1, Limekiln Road, South Ayrshire

BD21/01 Assessment and Inspection Report

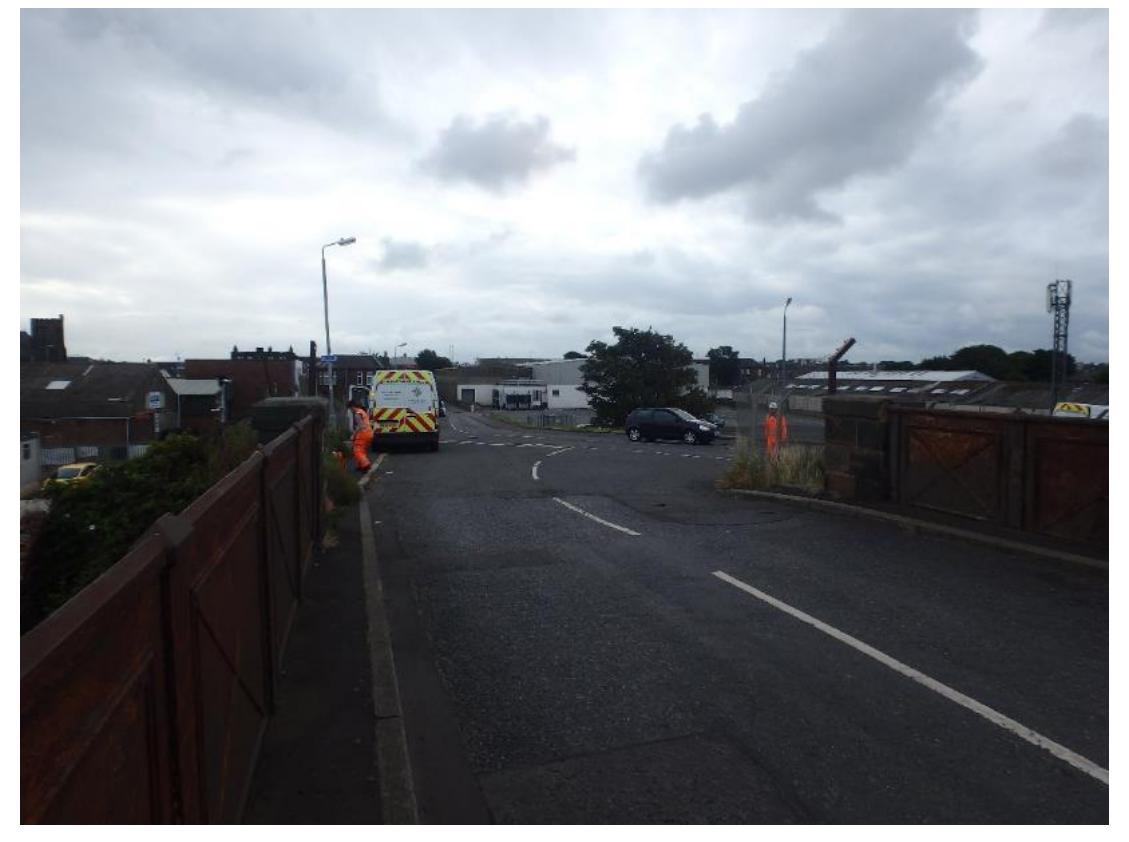
2) View of carriageway approach looking west

The road surface above the structure is in fair condition with no signs of settlement or tracking. There was evidence of previous inspection pits at midspan and at each of supports. (Photographs 2, 3 and 4). Road surface category for assessment is taken as "poor". There was occasional use of the bridge by HGVs during the inspection. The AAHHGVF for this assessment is taken as 'low'.

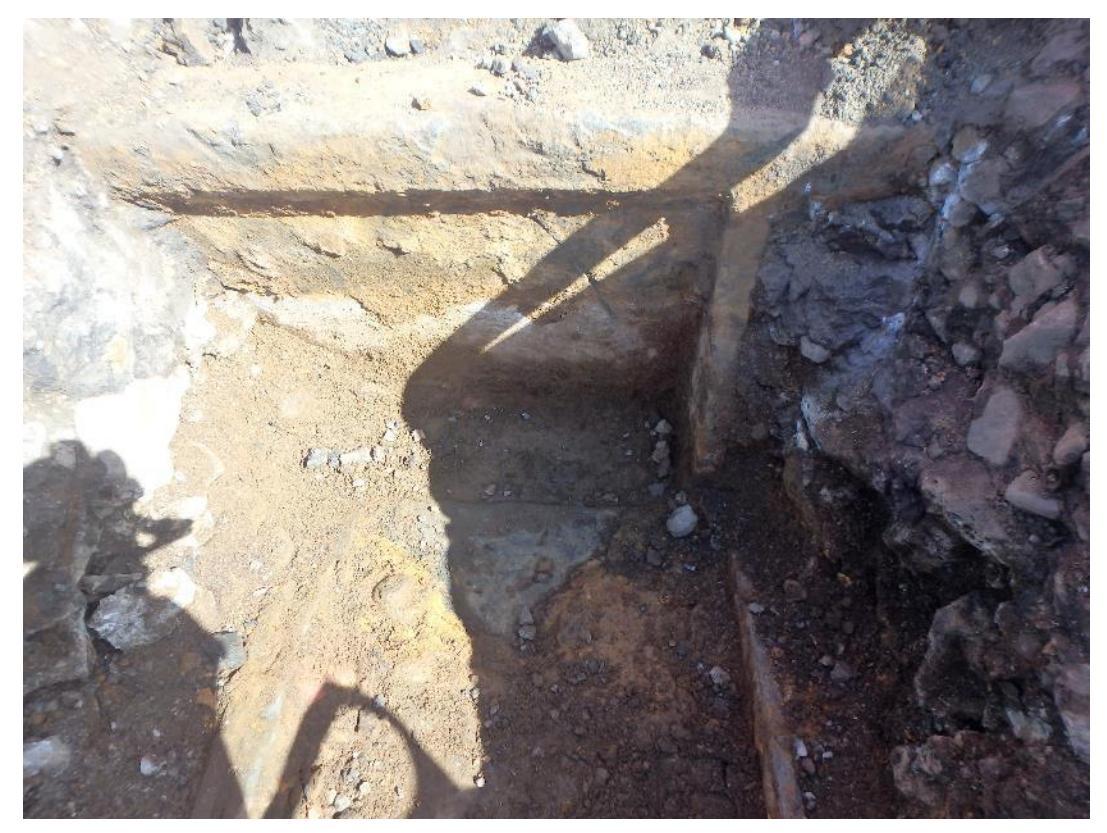
22) Trial pit at midspan showing top side of hogging plate
