Major Works Programme 2009 - 2012

BE4 ASSESSMENT & INSPECTION REPORT

**Stubbs Road, Walden Stubbs,
North Yorkshire**

BRIDGE REF: HBR3/123

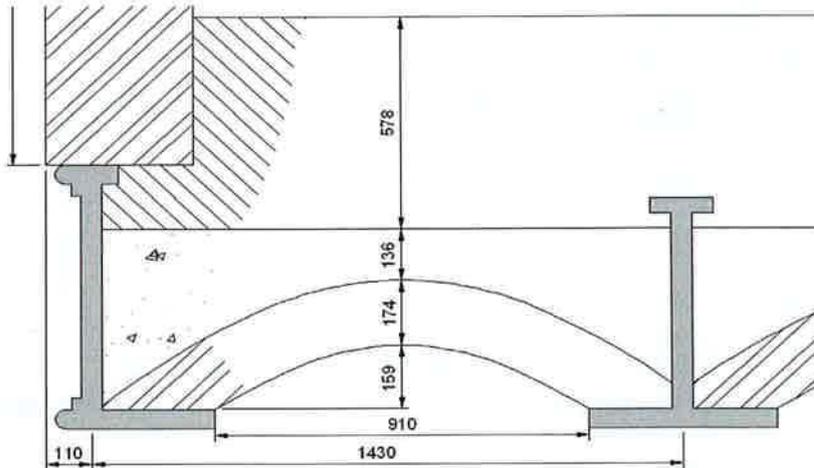
9. Jack Arch Assessment

The jack arches fail according to the advice of the Bridgeguard Current Information Sheet No. 22 with regards to the strength of the ties in the edge bays. The current tie arrangements provide approximately 50% of the required 260mm²/m specific area. Approximately 50% of the original 1" diameter has been lost to corrosion.

**Consider Jack arch between edge girder and adjacent internal girder due to larger span*

**Review of the adequacy of the jack arches and tie-rods will be based upon the empirical method described in Bridgeguard 3 Current Information Sheet No 22 (Pro-forma for the empirical assessment of brick, masonry and concrete jack arches and associated ties.)*

Install additional ties straps in outer bays to meet specific area requirements in order to ensure stability of the edge girders and edge jack arches.
