Southill Road Railway Bridge

No. HIB27

Assessment Report

ASSESSMENT OF BRB BRIDGES IN BEDFORDSHIRE
SOUTHILL ROAD RAILWAY BRIDGE (HIB27)
AMENDED ASSESSMENT

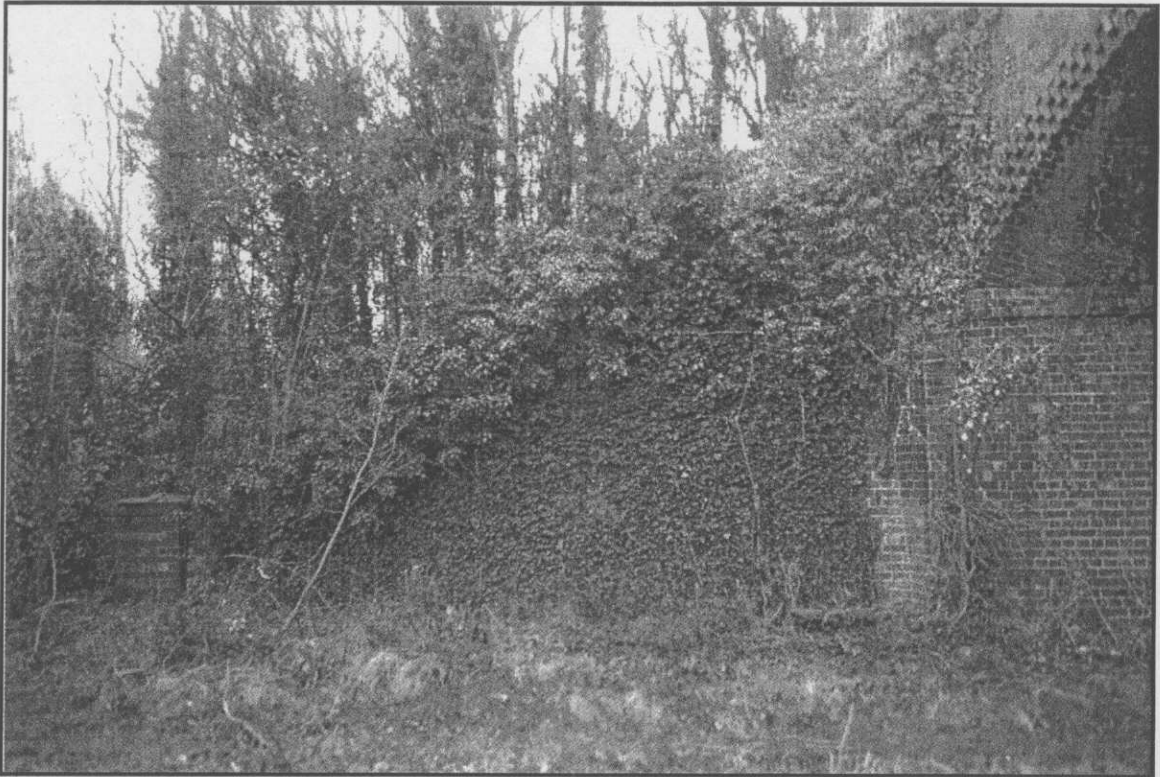
Plate 8
Southwest wingwall

2.06.3 The southwest wingwall has a diagonal hairline crack emanating from the abutment joint at springing level running down towards the base. There is a horizontal crack at half height 2mm wide from the centre to the copings. The central area is bulging and hollow sounding (see plate 8).

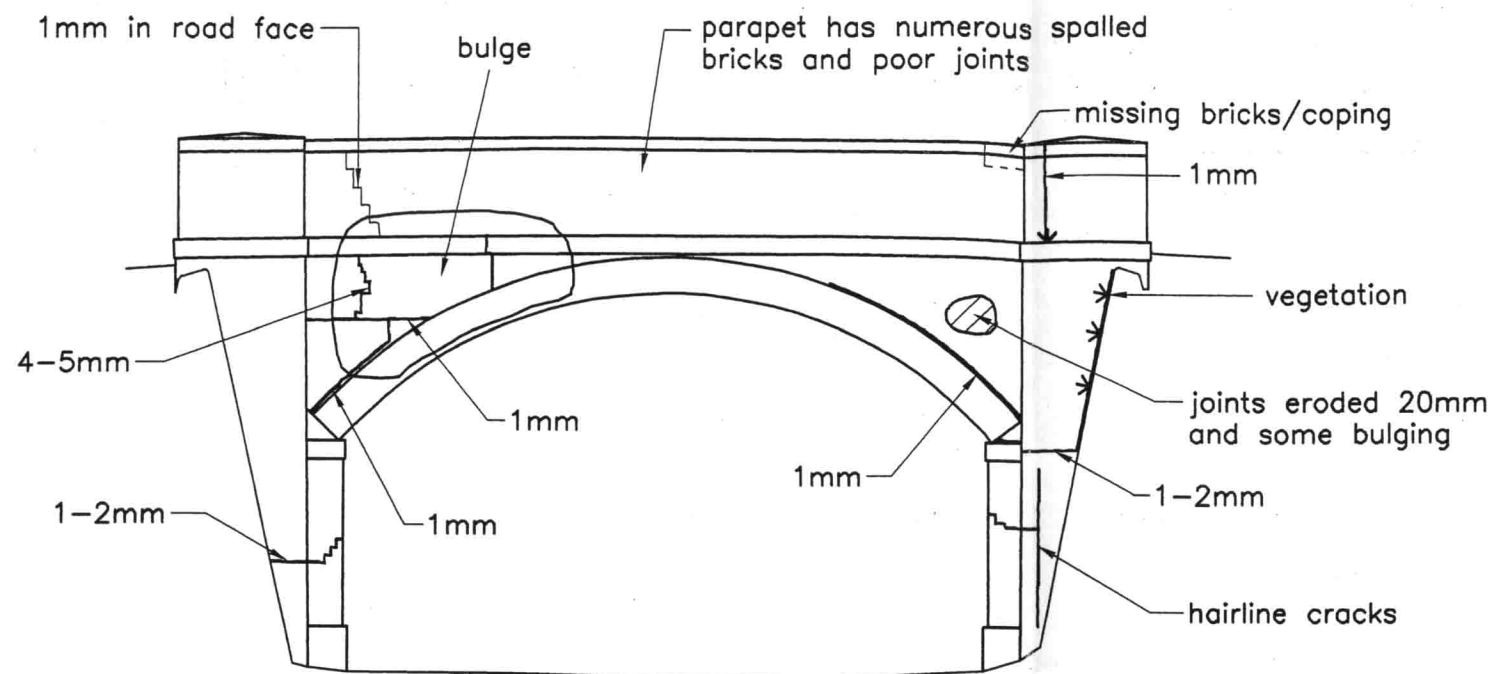
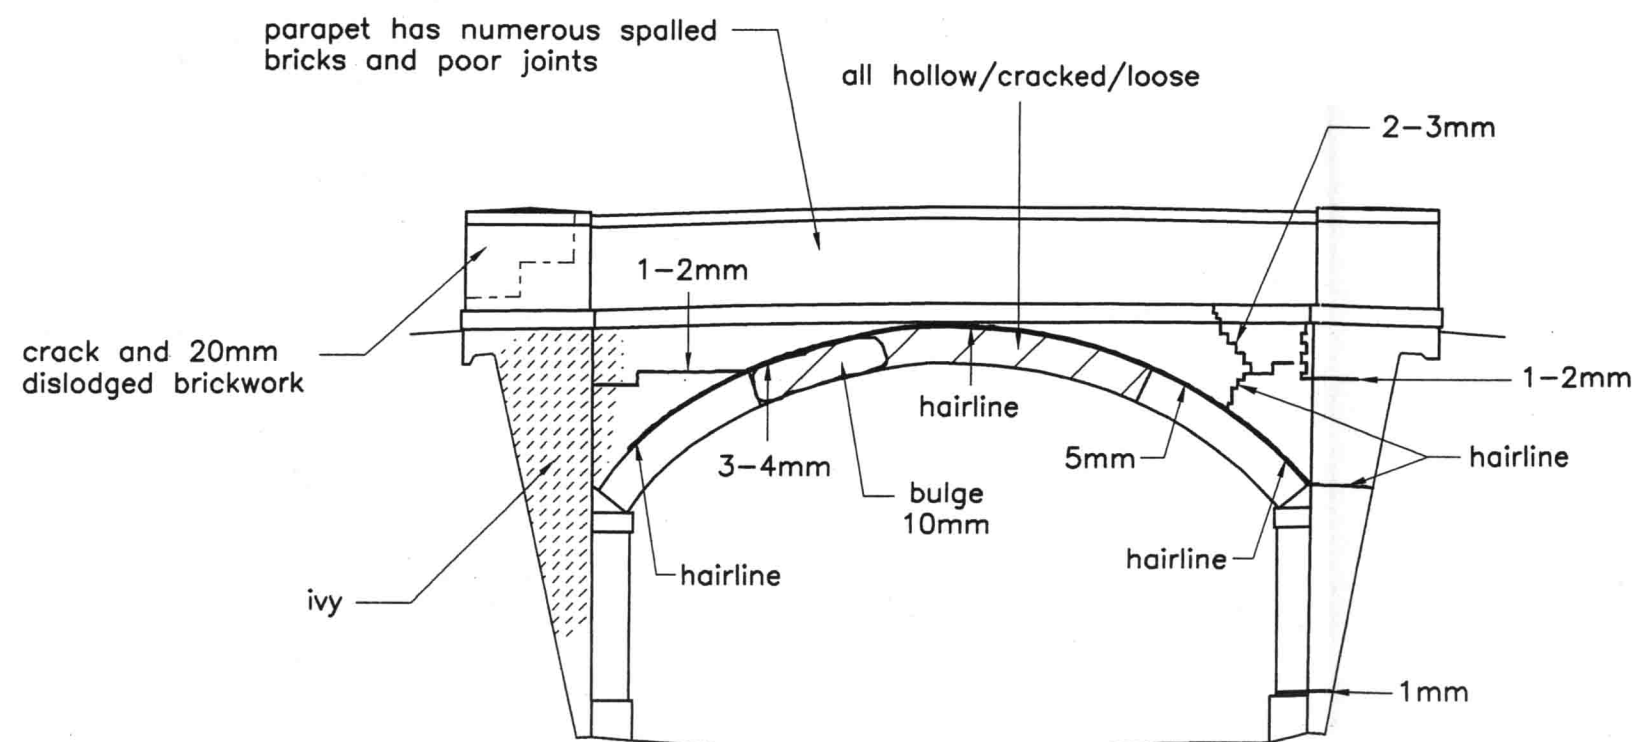
Drawing No.	HIB27/06	Date	APRIL 2002
Scale	1:100	Drawn	SR
		Checked	PDB
		Approved	<i>[Signature]</i>

There are a number of defects such as areas of poor joints, surface spalling, hollow brickwork, bulging and cracks to both south-east and south-west wingwalls. Whilst there is no evidence of failure of the walls due to rotation or forward movement, the above mentioned defects do give cause of concern. The walls are accordingly considered to be inadequate by inspection until such time as the defects are repaired, and the walls proven adequate by calculation. As the thicknesses of the walls and dimensions of their foundations, and ground conditions are unknown, an extensive site investigation would need to be carried out prior to any proposed analytical assessment.

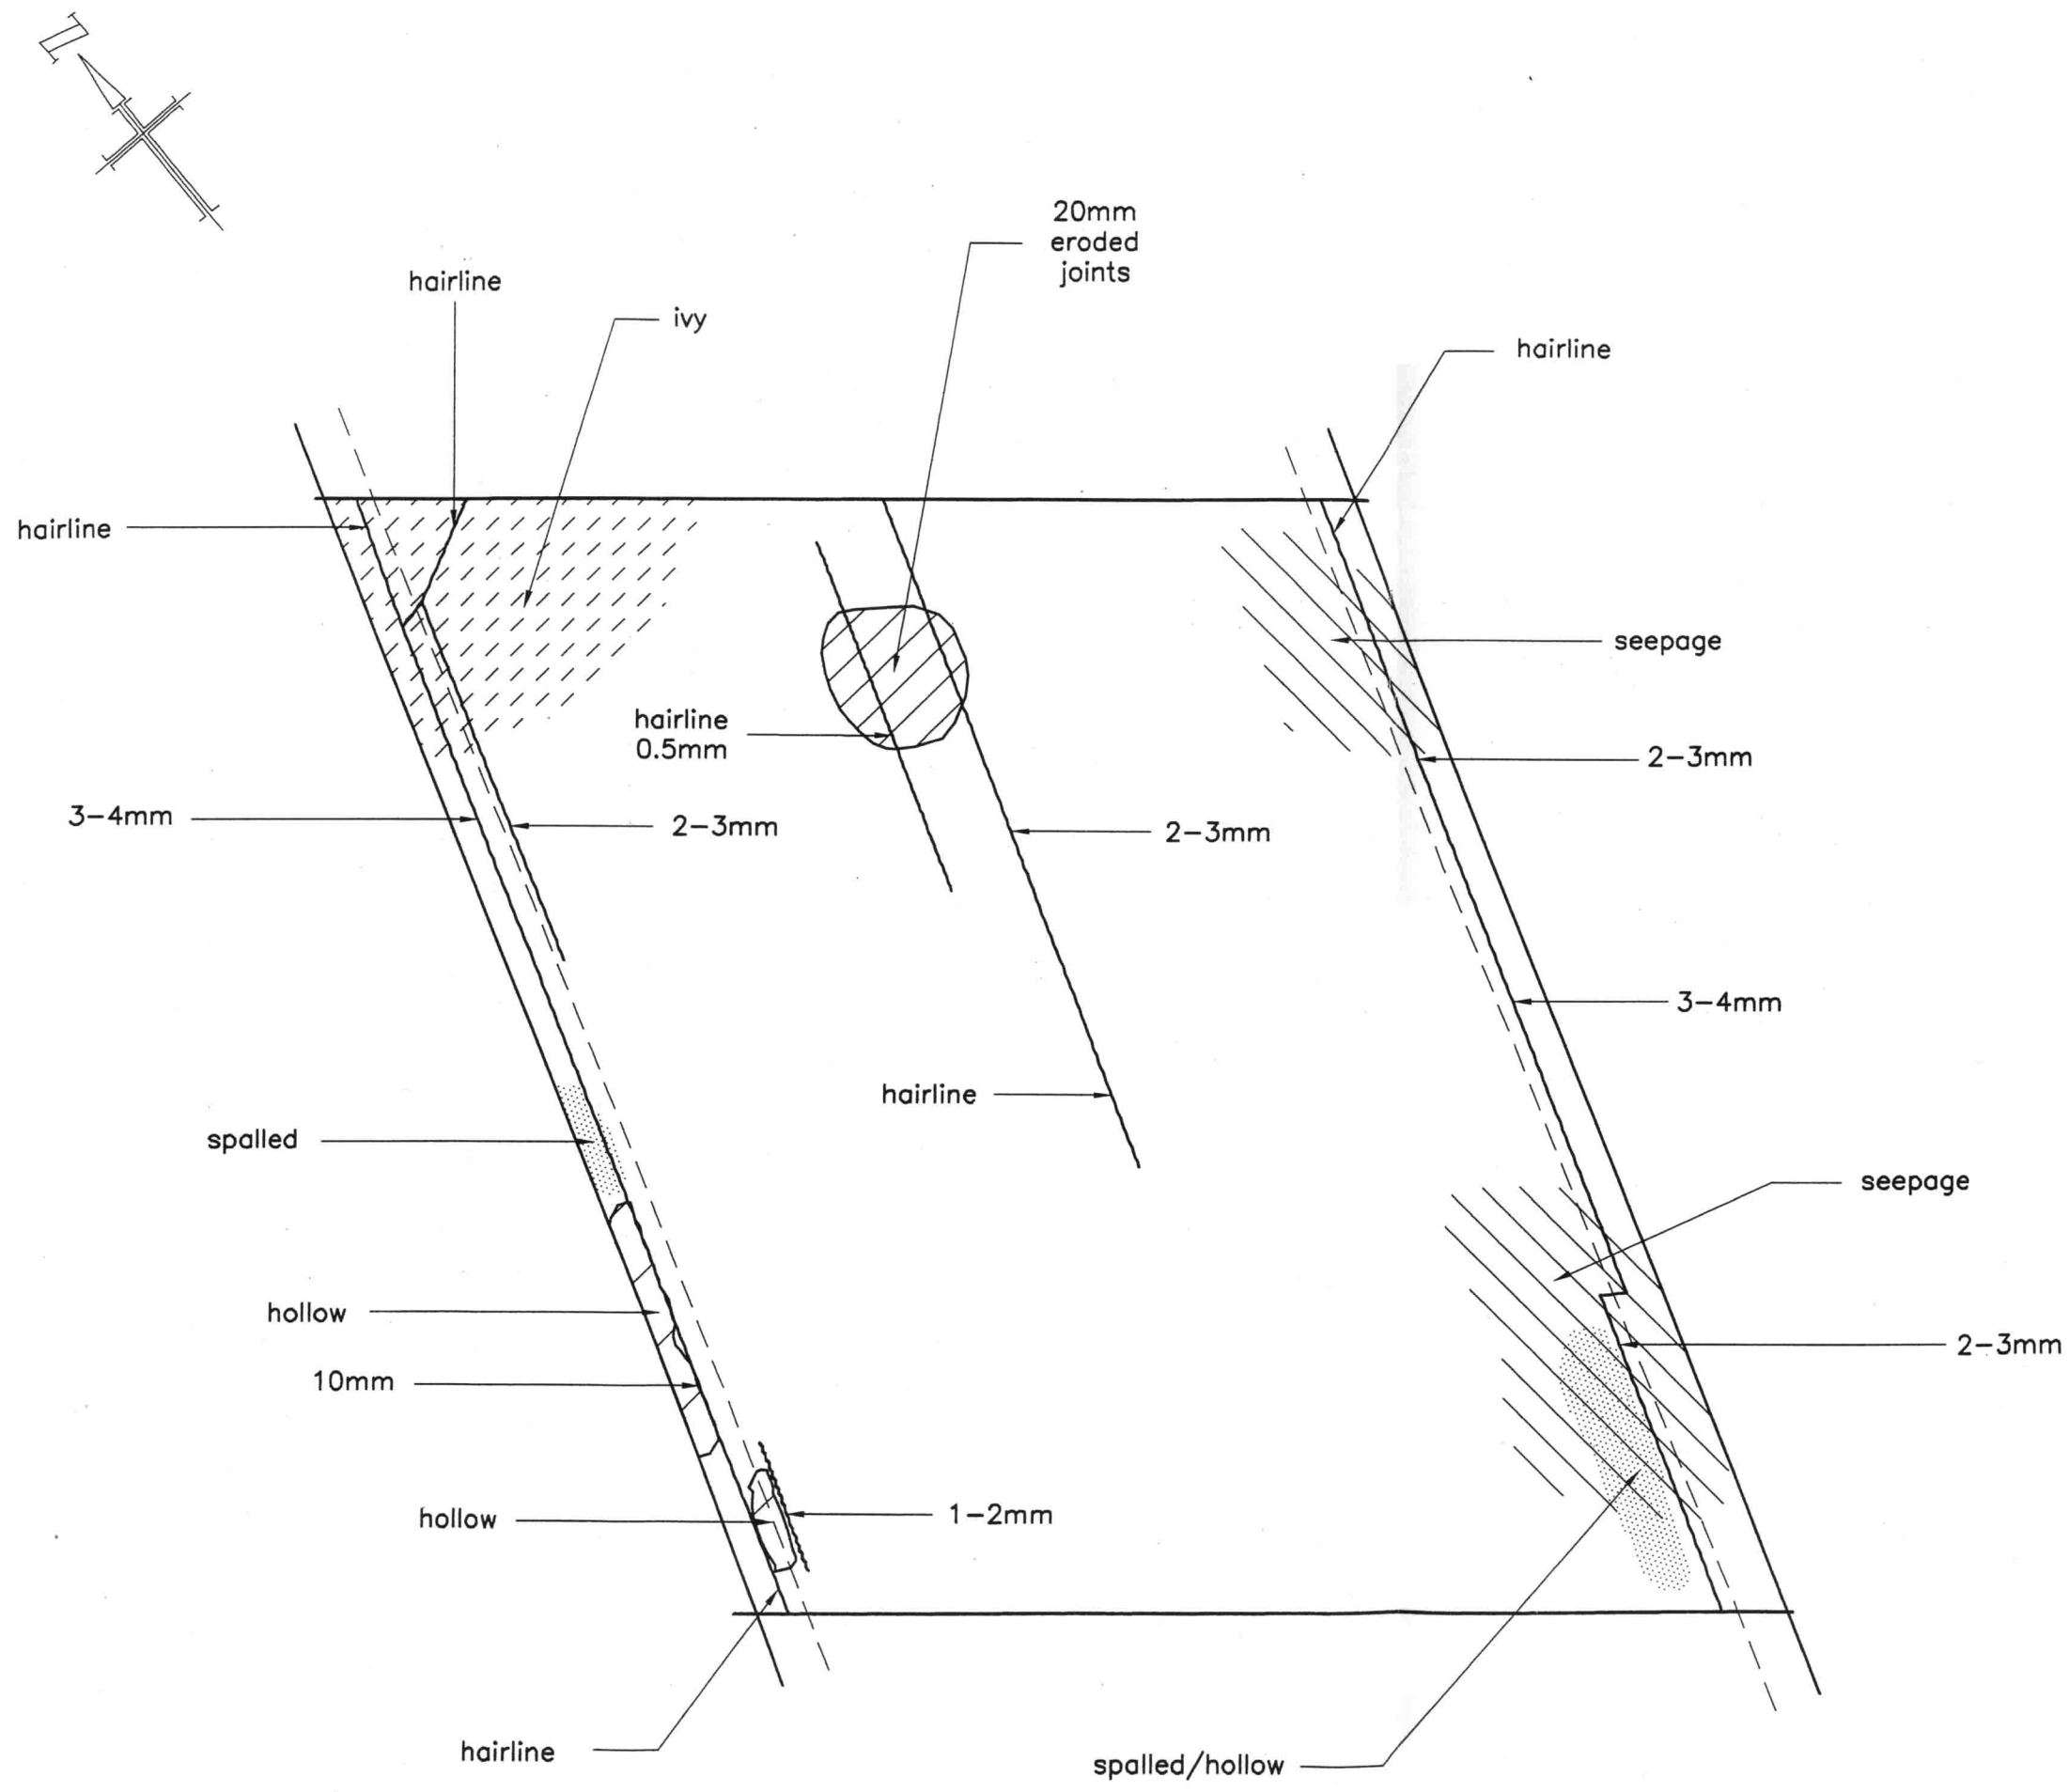
The inspection has identified that there is longitudinal cracking, seepage deposit and areas of hollow sounding brickwork in the arch intrados. Therefore a barrel with thickness of 3 rings has been used in the assessment as it is assumed the lower (fourth) ring is ineffective due to ring separation.

Drawing Number		HIB27/07	
Notes			
	seepage		
	hollow		
	spalled		
	eroded joints		
	ivy		
Do not scale this drawing			
Rev	Date	Checked	
Babtie			
Client	BEDFORDSHIRE COUNTY COUNCIL		
Project	ASSESSMENT OF BRITISH RAIL PROPERTY BOARD STRUCTURES		
Title	SOUTHILL ROAD RAILWAY BRIDGE U147 CARDINGTON ARCH DEFECTS		
Drawing No.	HIB27/07		
Scale	1:50	Date	APRIL 2002
Drawn	SR	Checked	PDS
Approved			
Copyright reserved Babtie Group Ltd Box 272, The Merton Centre, 45 St.Peters Street, Bedford MK40 2ZY

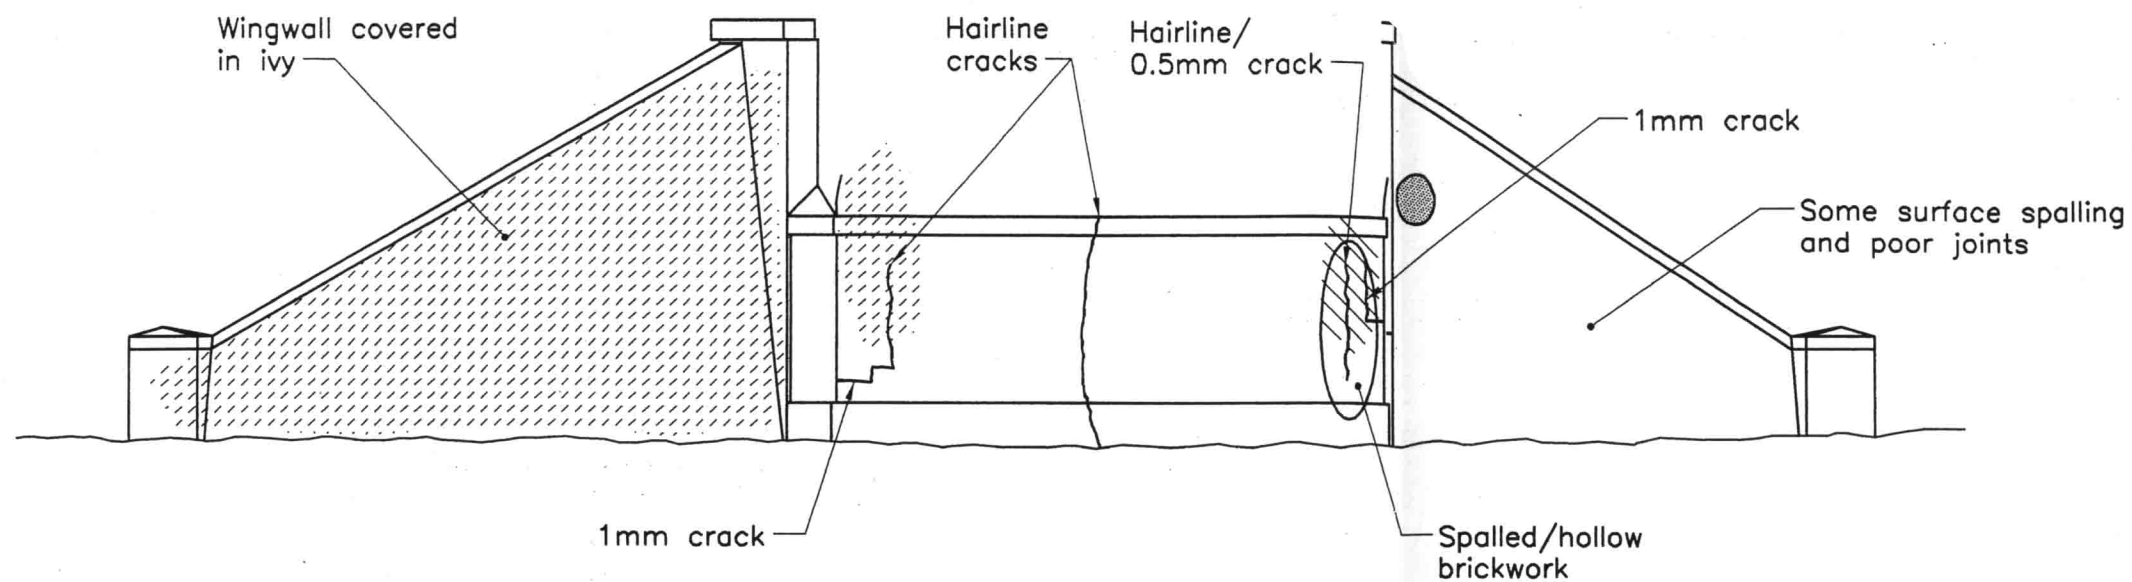
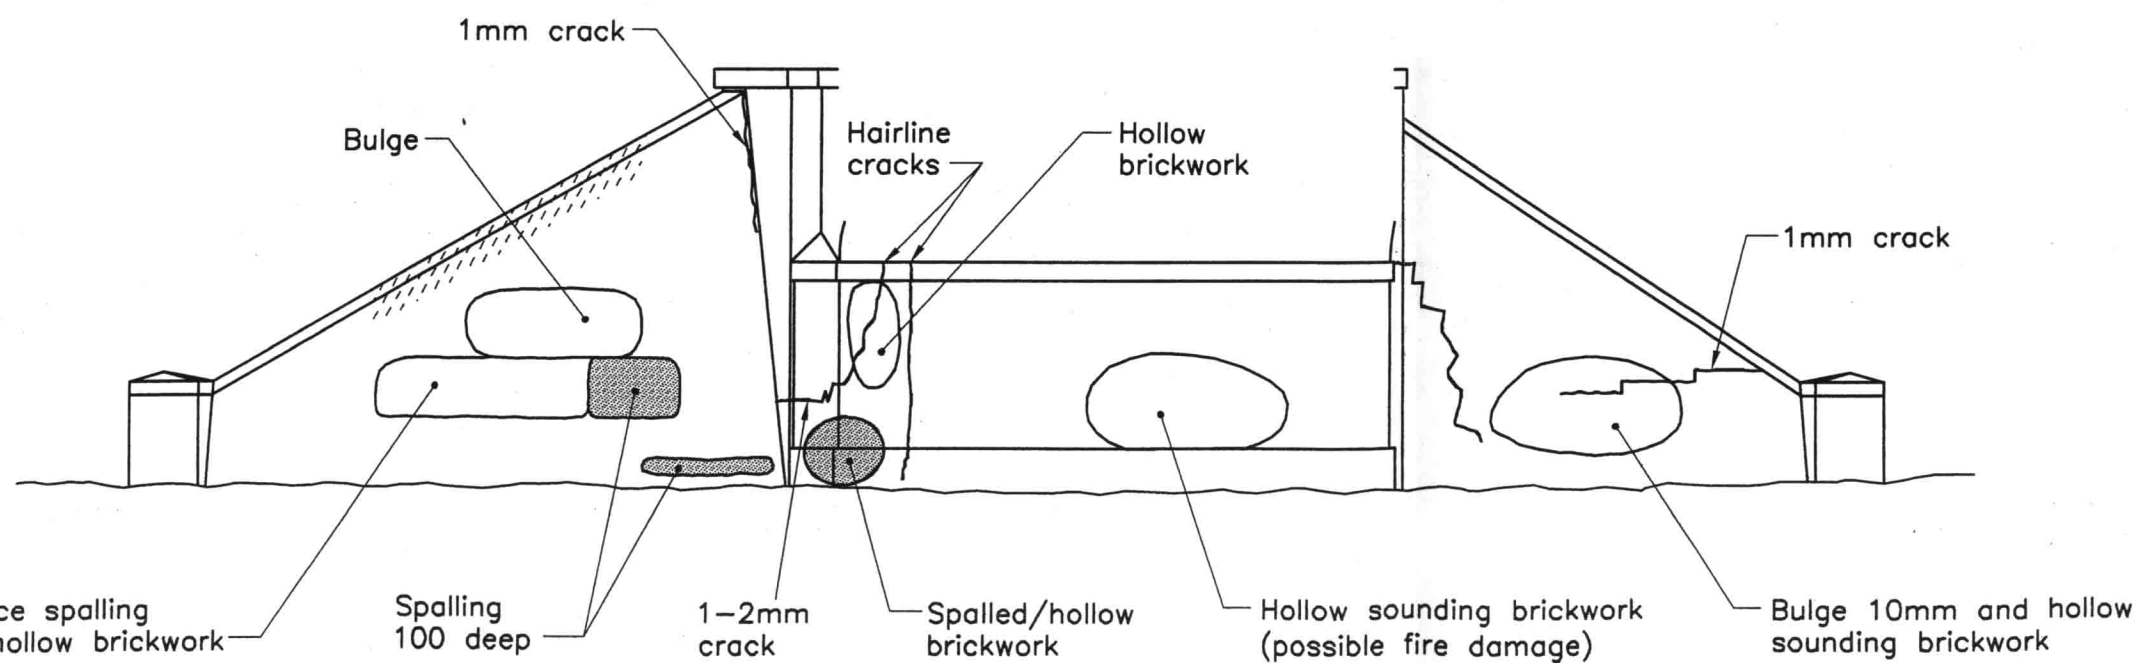
Drawing No.	HIB27/08				
Scale	1:100	Date	APRIL 2002		
Drawn	SR	Checked	PDB	Approved

The abutments and the walls were assessed visually during the assessment inspection in accordance with Chapter 8 of BD 21/01. There are a number of hairline cracks in both north and south abutment walls, which may appear to be due to movement/settlement of foundations. However it is considered that the condition factor of 0.6 has taken this into account in the assessment of the arch.
