**BE4 ASSESSMENT AND INSPECTION REPORT**

**Mill Tack Road Bridge  
Nr Turriff, Aberdeenshire**

**BRIDGE REF: IMD/433**

**December 2010**

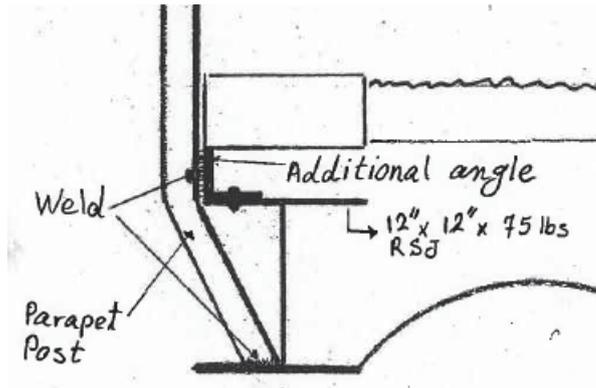
Edge girder details

The parapets are timber palings supported on the vertical metal angles that are welded to the edge girders.
