**BRB (Residuary) Ltd
Major Works Programme 2004/2007**

**VAR9-1220 BE4 ASSESSMENT
PROGRAMME**

**ASSESSMENT AND INSPECTION
REPORT**

BRIDGE REF: NPB 719

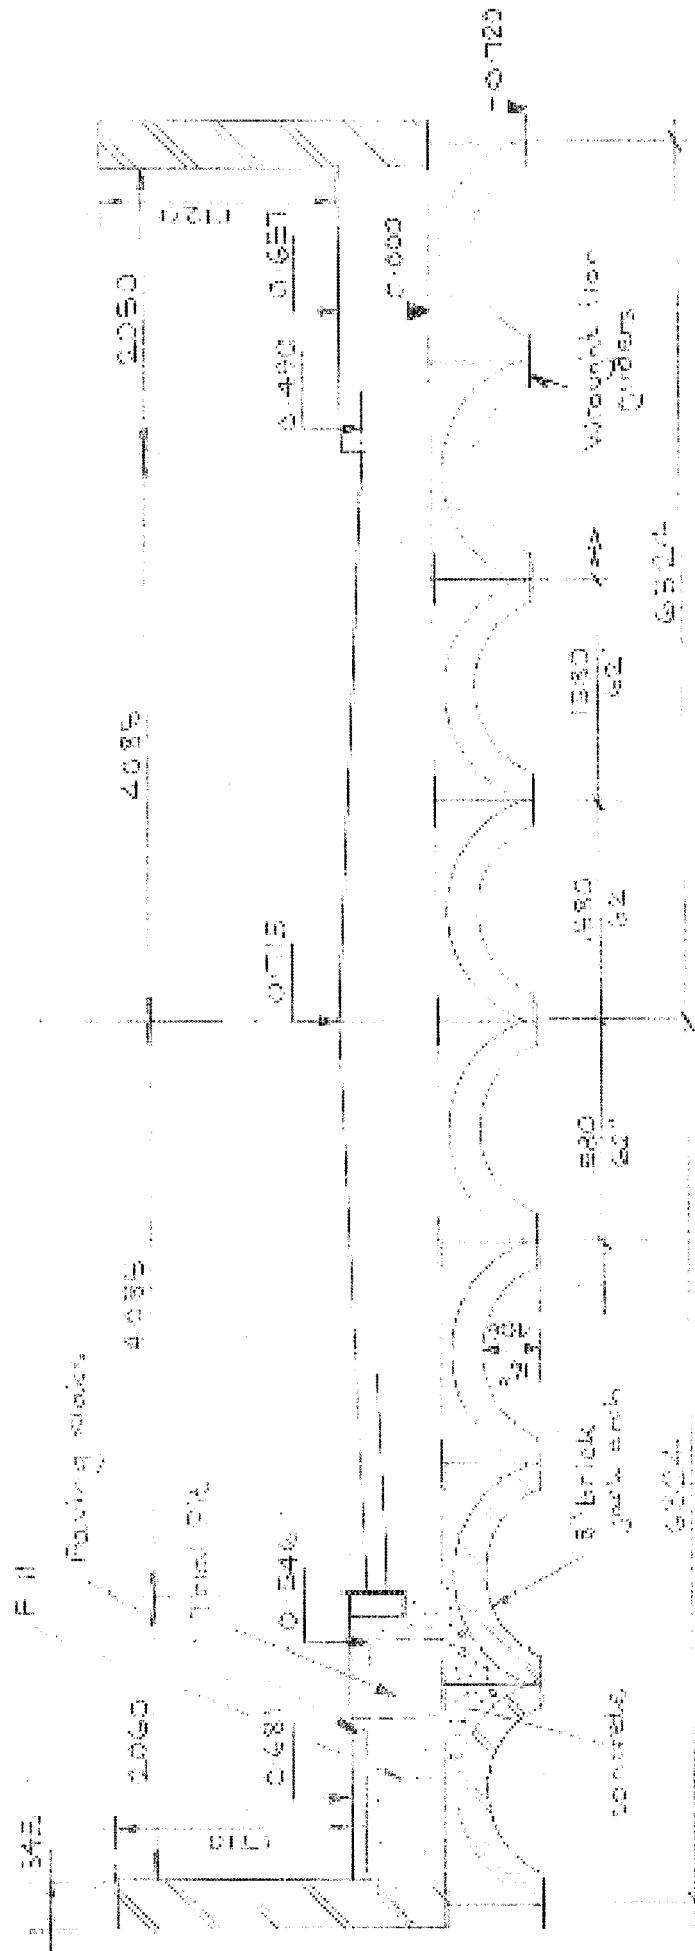
BE4 Survey - Jan. 2005
Figure 1

The structure comprises nine spanning wrought iron riveted plate girders with brick jack arch construction between the girders. All girders have the same construction, with 27" web depth, 14" flange width and $3\frac{1}{2} \times 3\frac{1}{2} \times \frac{1}{2}$ " angles. The central section of the girders has two $\frac{1}{2}$ " flange plates top and bottom reducing to one plate at 2'-6" from the support. The deck is square to the abutments with clear span measured at 25'-3" (7.71m). Girder spacing is 62" (1580mm). (Figures 1 and 2: Appendix F.)

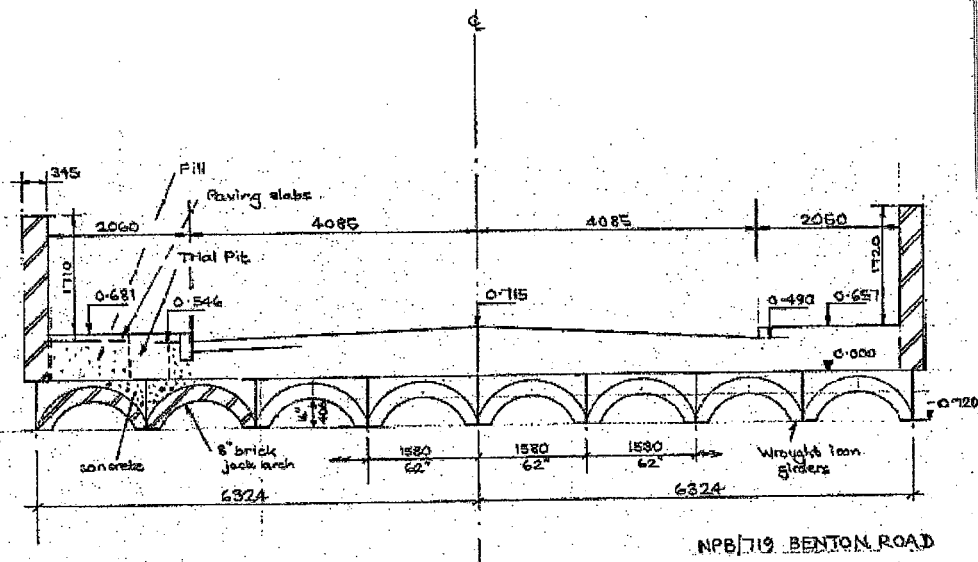
NPB/719 BENTON ROAD
CROSS-SECTION
BE4 Survey - Jan. 2005
Figure 1

Both external girders are not loaded with traffic loading. The pedestrian pavements are wider than the spanning of the Jack arches, hence the external girders should be assessed only for dead loading.
