## SMB/2062 CS454 Assessment and Inspection Report

### Braughing, Puckeridge, East Hertfordshire

National Highways – Historical Railways Estate  
VAR9/7070

HRE Assessment Programme

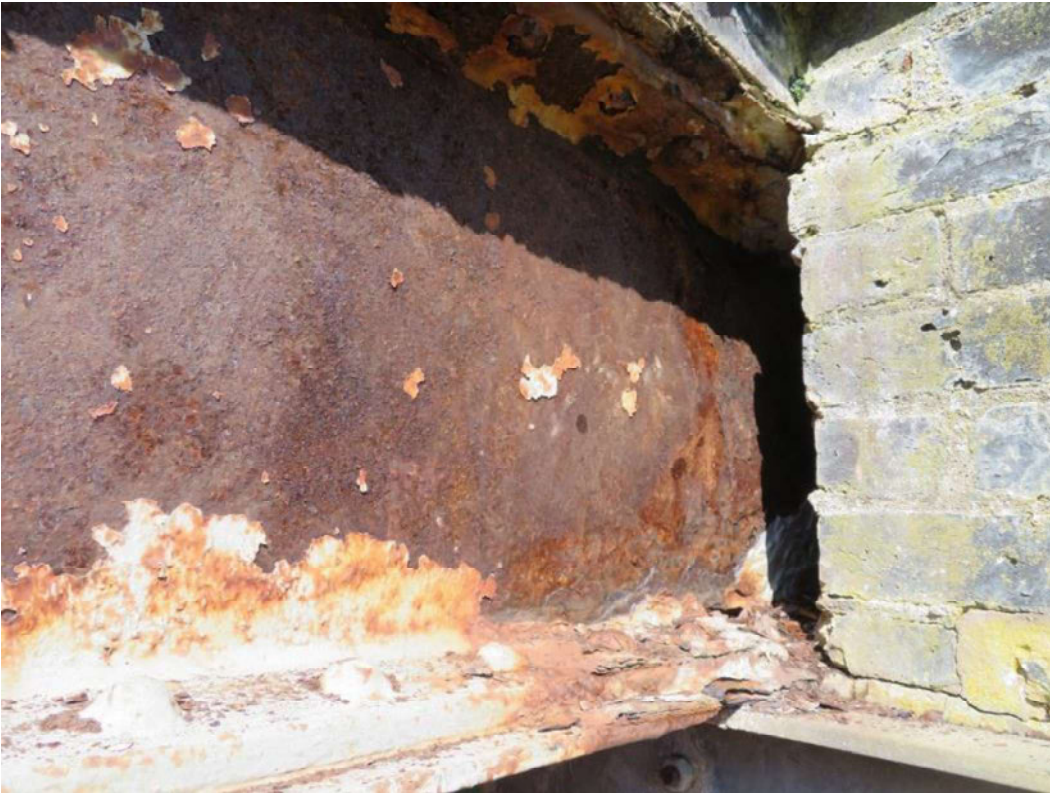
Photograph 19. North Edge Girder at East Support - Web

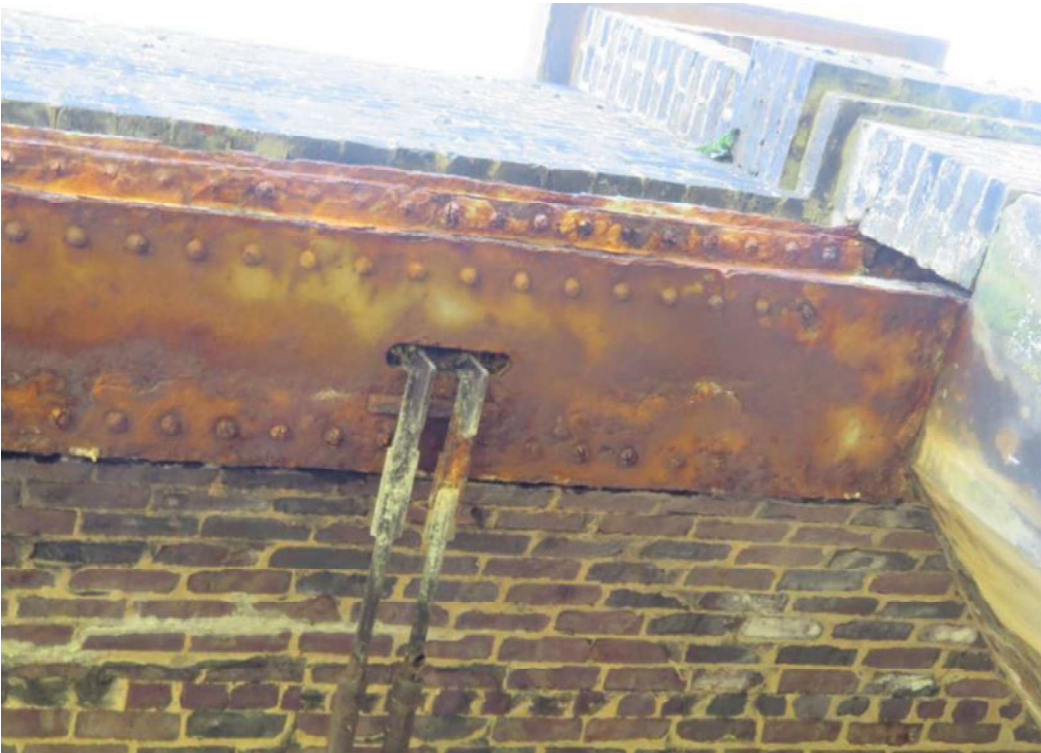
At support, there is total section loss of the bottom flange plate over a width of 38mm. Elsewhere there is 1mm of corrosion across the exposed faces of the girder.

Photograph 20. North Edge Girder at East Support – Underside of bottom flange plate

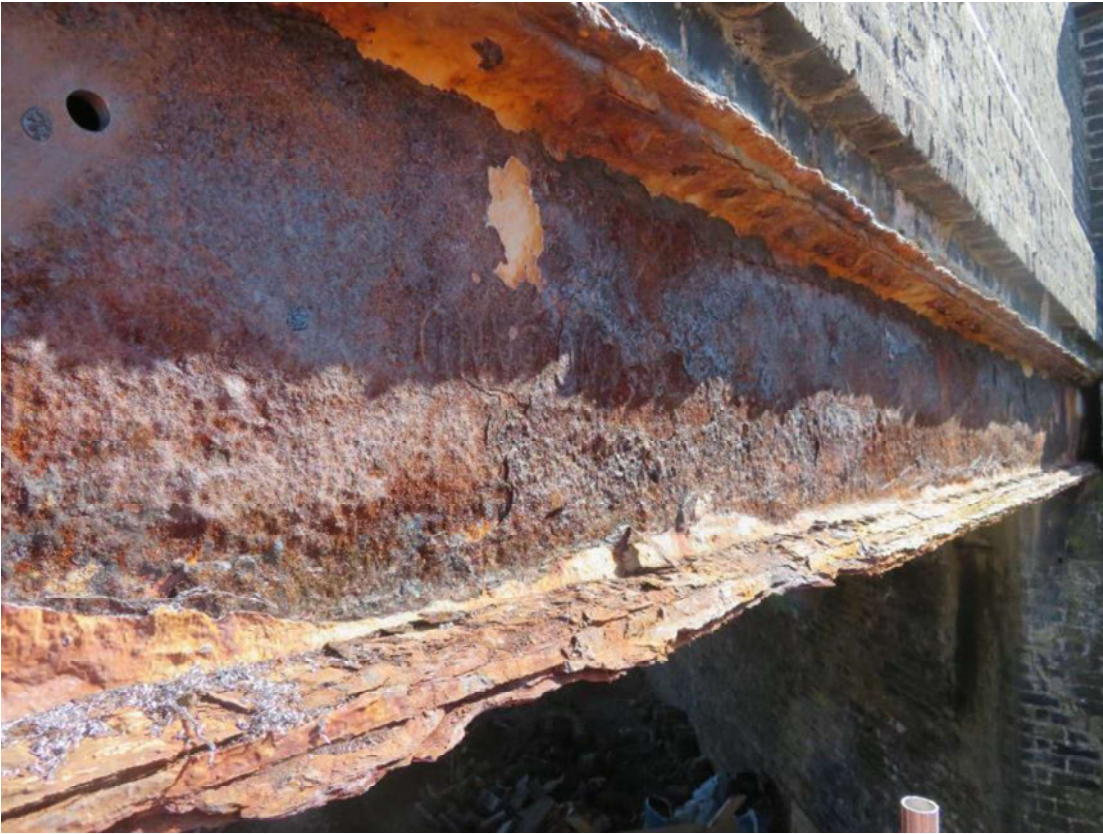
On the external RSJ, the web has become severely corroded, and the corrosion is concentrated toward the base of the web. UTG measurements indicate that the web thickness has reduced to a residual thickness of 7mm from the mid-depth of the girder to the base. There is total section loss of the bottom flange plate over a width of 38mm. Elsewhere, the girder has sustained up to 2mm of corrosion on the exposed faces of the girder. There was also 1mm of pitting and corrosion to the internal faces of the double joist compound girder.

Photograph 21. North Edge Girder at Midspan – External face and web

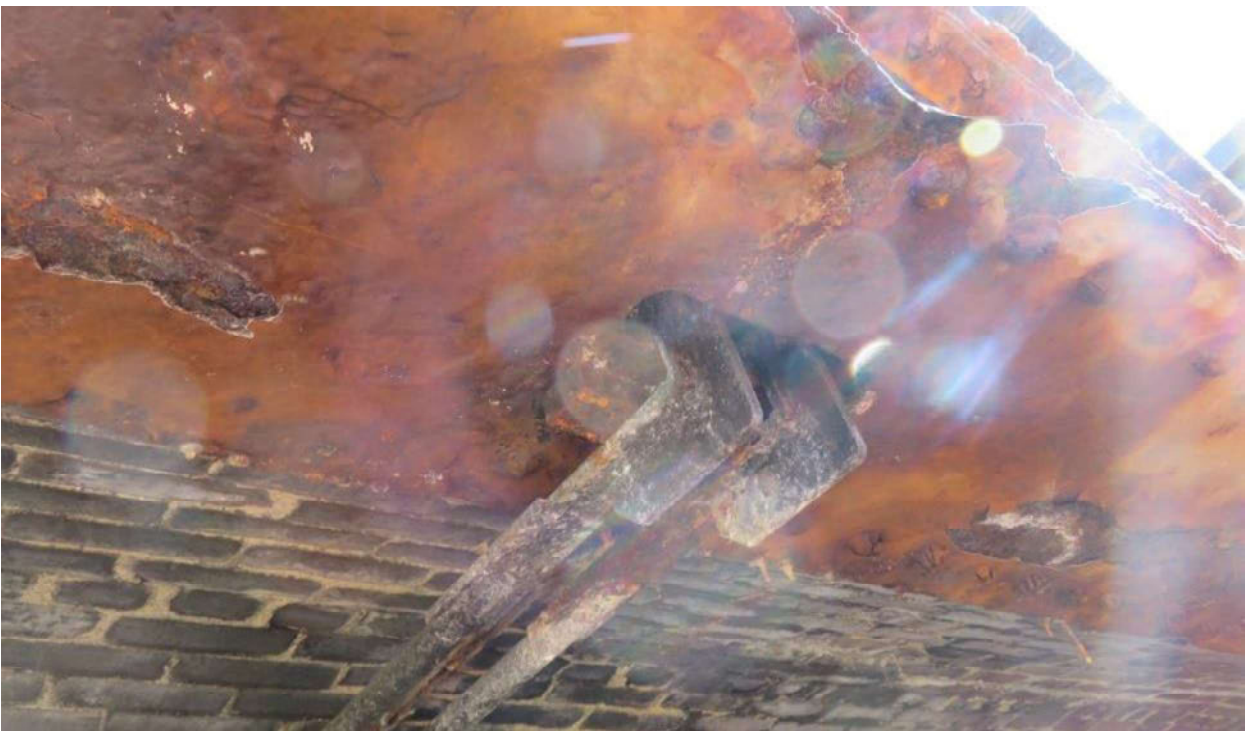
Photograph 22. North Edge Girder at Midspan – Underside of Bottom Flange

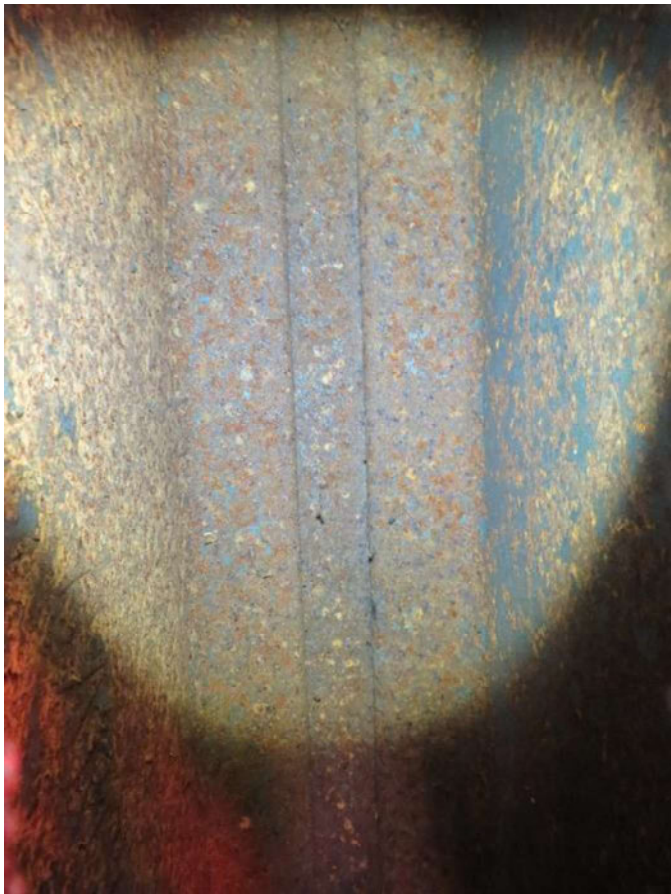
Photograph 23. North Edge Girder at Midspan – Internal Faces

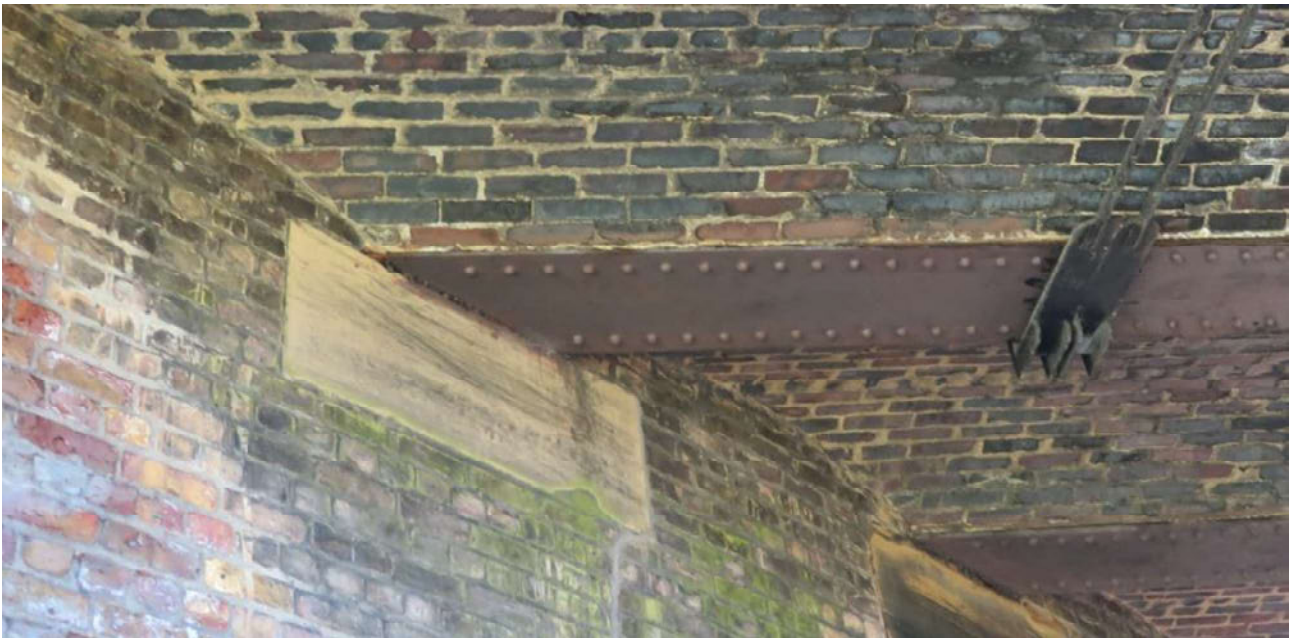
There are a series of three repointed vertical fractures connecting through the full height of the abutment below the bedstone for the second internal girder from the south. Three mortar tabs dated 5/68 were placed, and all appear to have broken and then been repointed at a later date. The repointed mortar has remained intact. There is also another repointed vertical fracture beginning below the north edge girder. The fracture begins 2m from ground level, extending vertically into the bedstone mortar joint and then continuing to the jack arch. A mortar tab dated 58 was installed but has broken. Additionally, a strain gauge has been placed, although one half has broken off.

Photograph 24. Second Internal Girder from South - Support

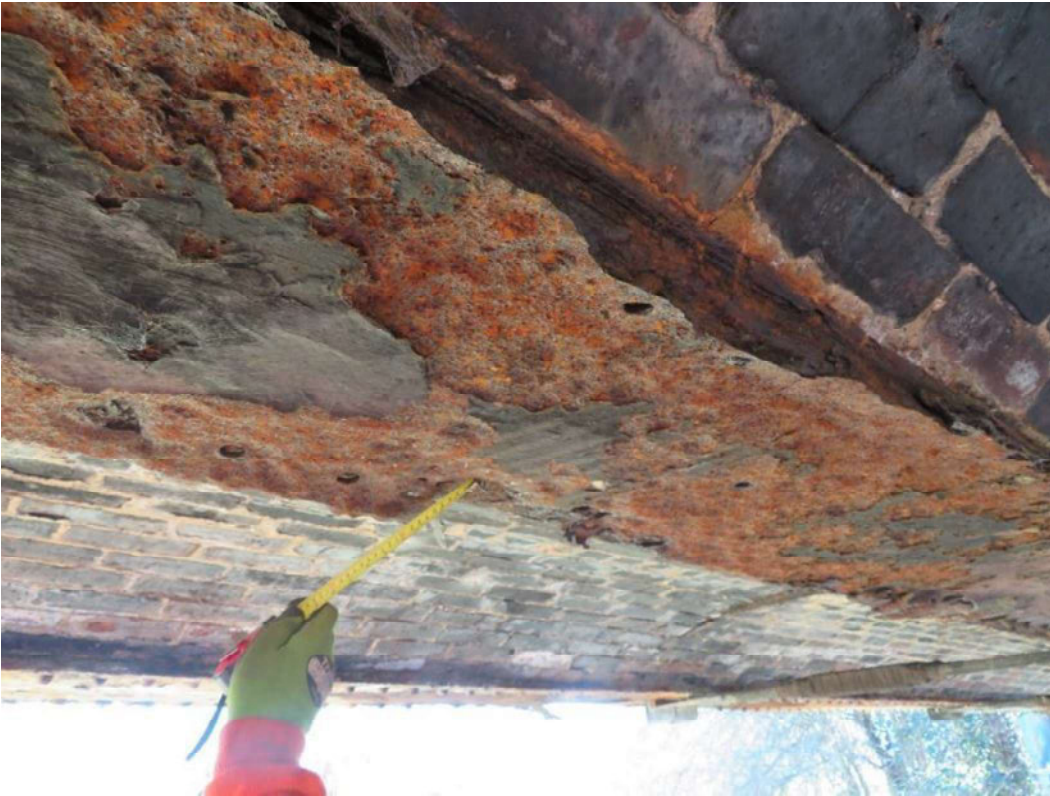
All of the internal girders were in a similar condition. At midspan, total rivet head loss has caused the bottom flange plate to become detached from the steel RSJs at the approximate location of the blast-line. Where the plate has detached, it has slightly sagged rendering it ineffective.

Photograph 25. Second Internal Girder from South - Midspan

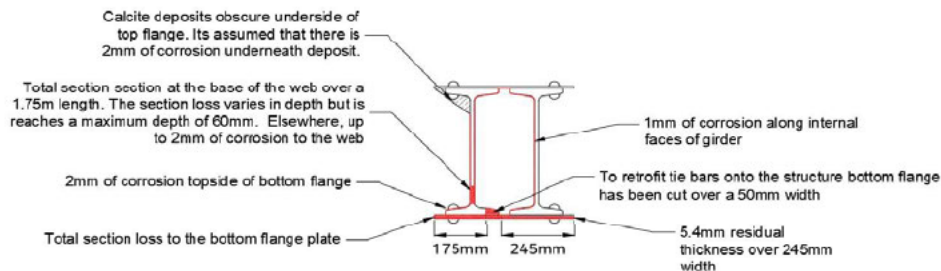
#### South Edge Girder corroded elastic section properties about x-x, at midspan

Due to the pattern of corrosion, the external RSJ (positioned left in the diagram) is assumed not to contribute to the section properties of the double-joist compound girder. As the external RSJ is not longer effective, the top and bottom flange plates are only assumed to be effective above the internal girder, reducing their section reduced by approximately half.

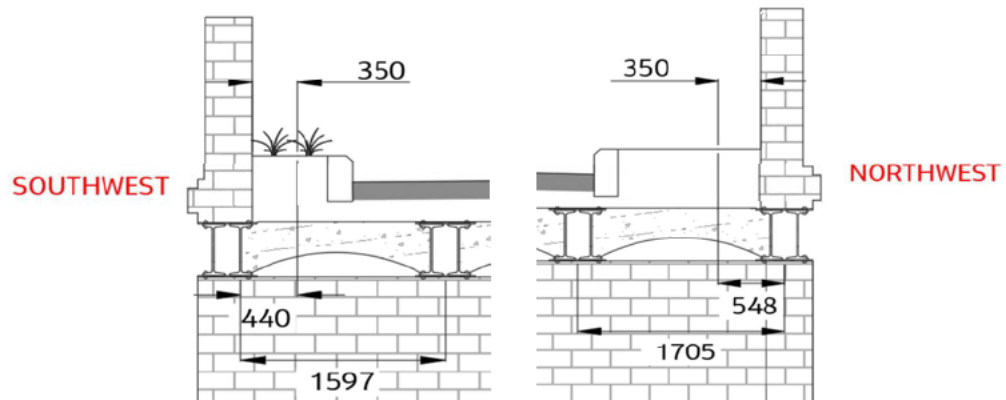
South Edge Gider is considered to carry 72.45% of a single wheel load  
\*Contribution from external girder discounted

North Edge Gider is considered to carry 67.86% of a single wheel load

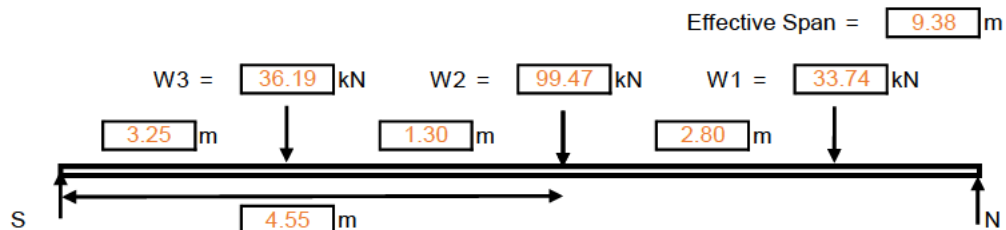
#### Bending moment - South Edge Girder

The southern edge girder has failed to support the loading induced by 44/40t of live loading. Additional calculation has been undertaken to determine the reduced live load capacity.

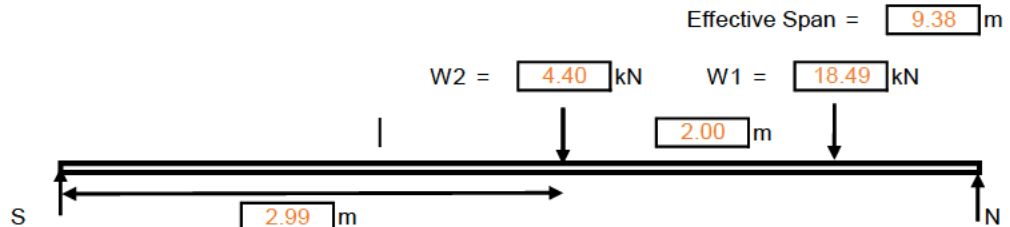
Due to the corrosion the southern edge girder has sustained the section no longer able to carry 40/44t accidental live loading. After accounting for the dead loads, there is only a residual capacity of 24.85 kNm to support live loading.
