**EAST AYRSHIRE COUNCIL
DEVELOPMENT AND PROPERTY SERVICES
ROADS DIVISION**

**ASSESSMENT REPORT
DISUSED RAIL BRIDGE NOS 1 & 97**

**Structure Ref B751/20
OS Ref. NS 400 396**

**VOLUME 1
December 2009**

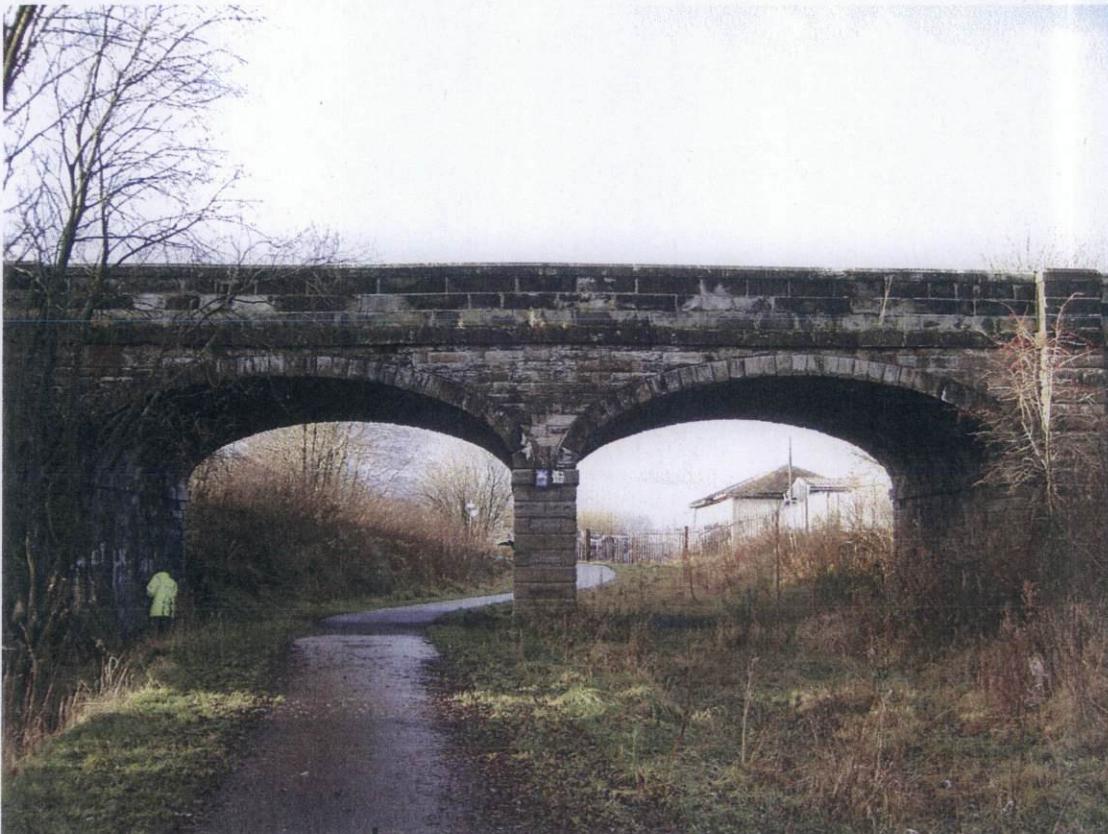
Photograph 2: East elevation

There was some minor weathering of the stonework noted particularly at the North springing of bridge 97, but is no cause for concern. (See Appendix B photographs 2,5 to 9,18)

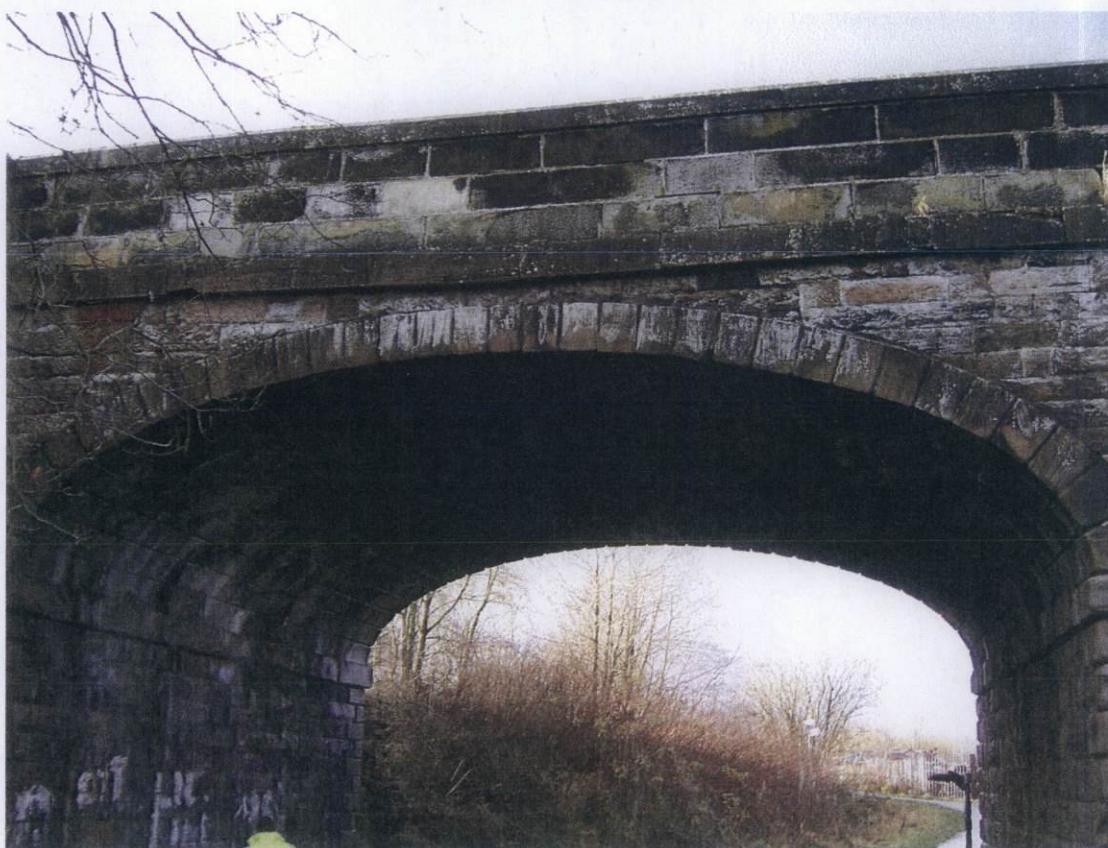
Photograph 6: South arch (bridge 1), East elevation

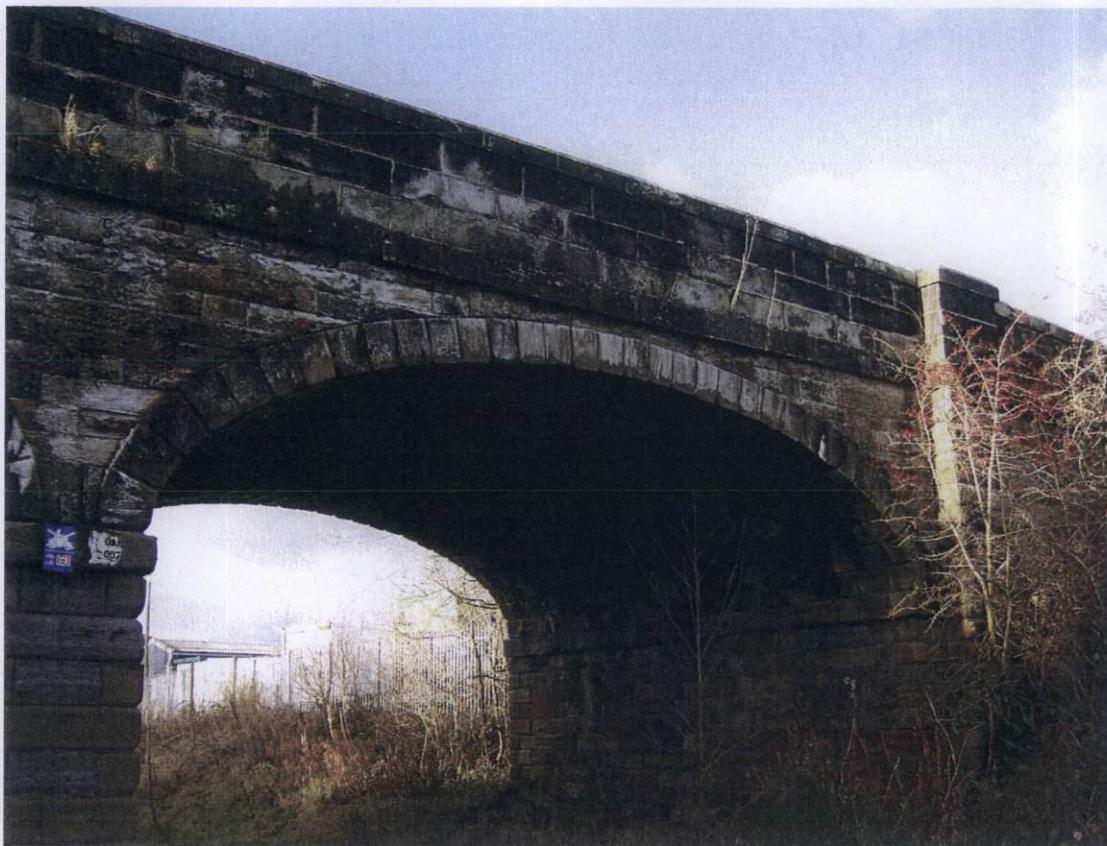
Photograph 7: North arch (bridge 97), East elevation

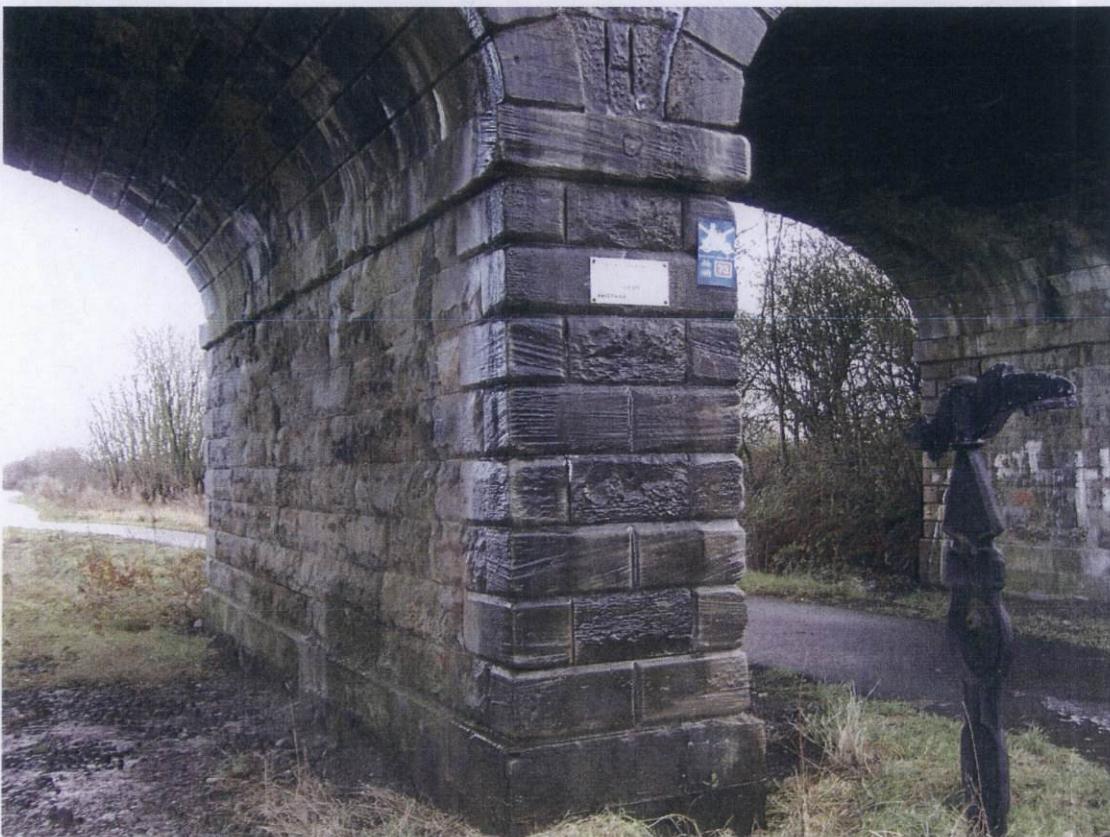
The pier was in good condition and showed no signs of weathering, cracking or movement. (See Appendix B photographs 16&17)

Photograph 16: Central pier, west elevation.

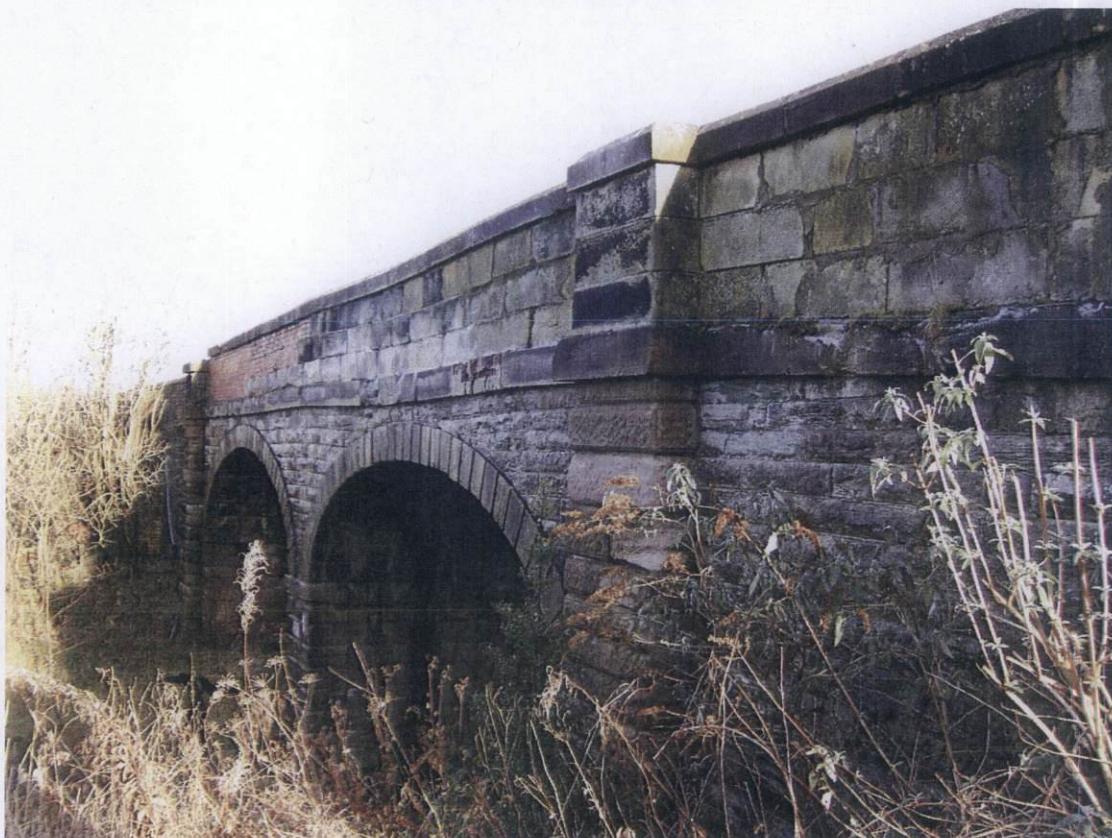
Photograph 18: West Spandrel and SW wingwall

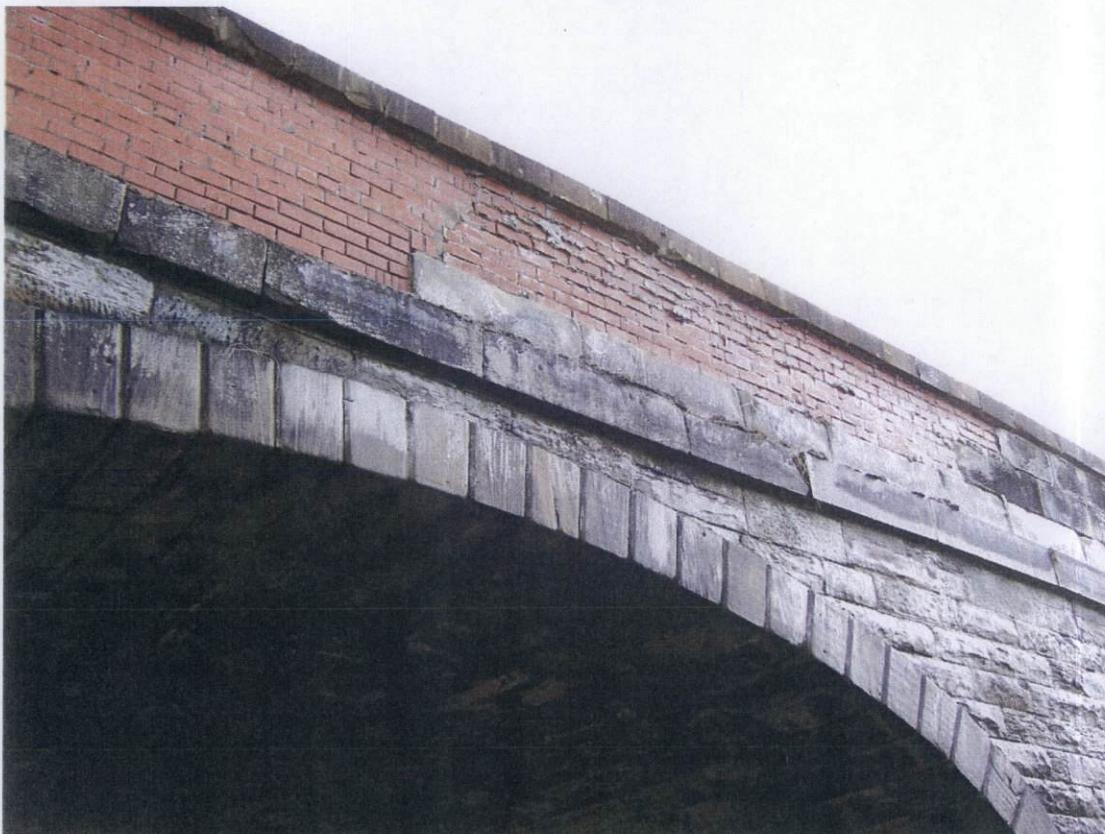
The masonry parapets were in moderate condition at the time of inspection. Some minor displacements were noted along mortar joints. The brickwork repairs to the outer face of the northwest parapet, although visually poor, appear to be structurally adequate. There are loose copestones at northeast corner of the parapet. There is a noticeable 'dip' in the line of both east and west parapet lines over bridge 1. Further inspection however, does not show any corresponding sag in the arch barrel profile and is therefore no cause for concern, see 5 below. (See Appendix B photographs 20,22,23,25&27)

Photograph 20: West spandrel/parapet. North span

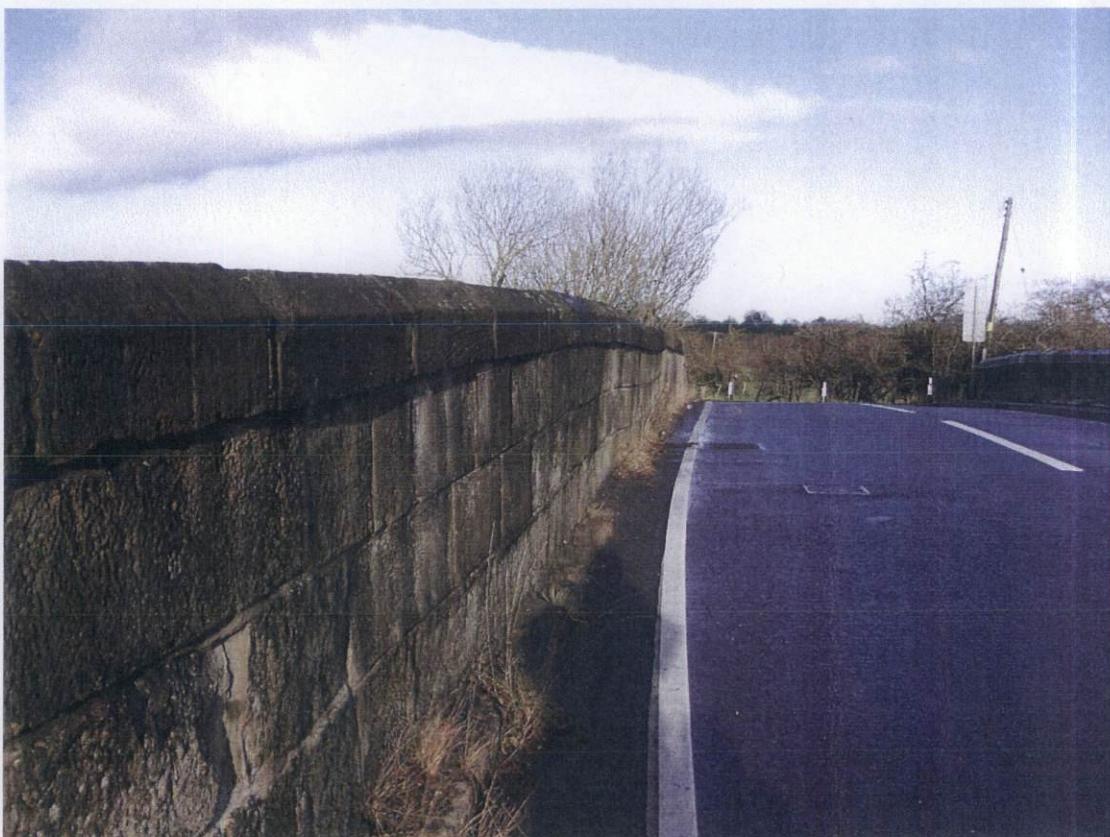
The overall defect rating for this element is **1A**.(See Appendix B photographs 22,24&28)

Photograph 22: West parapet

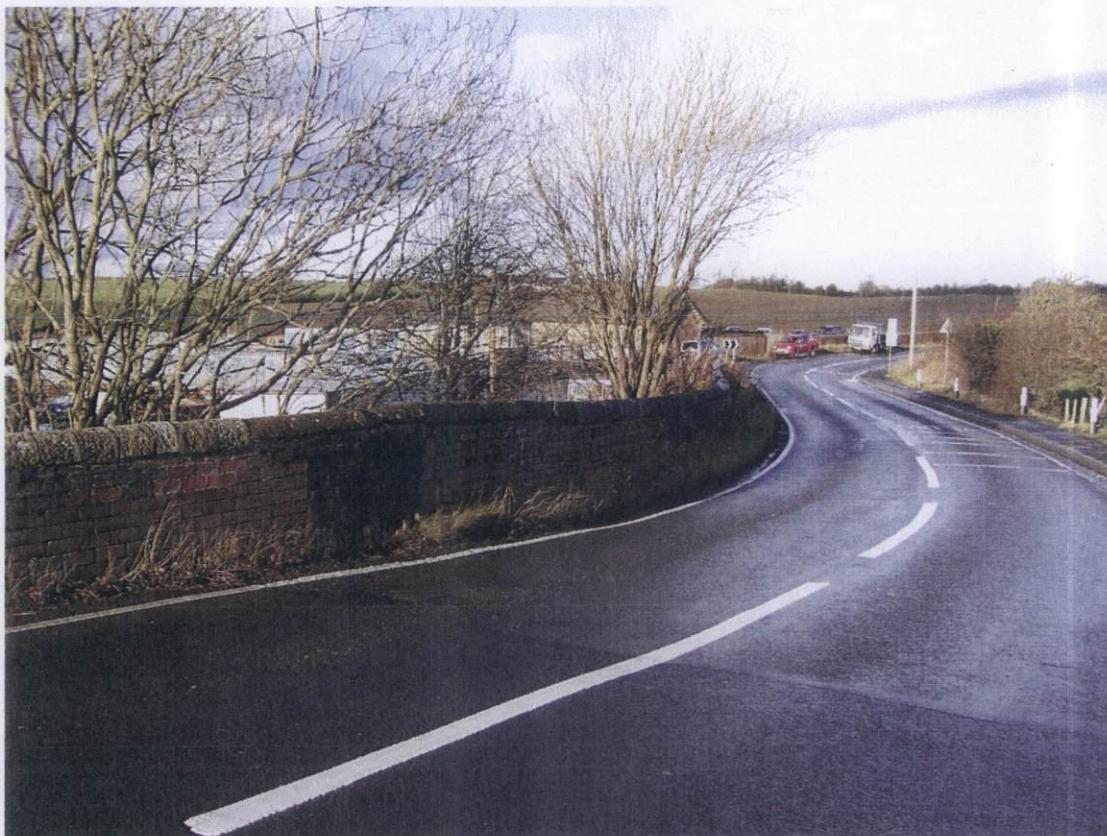
Photograph 24: North West approach wall

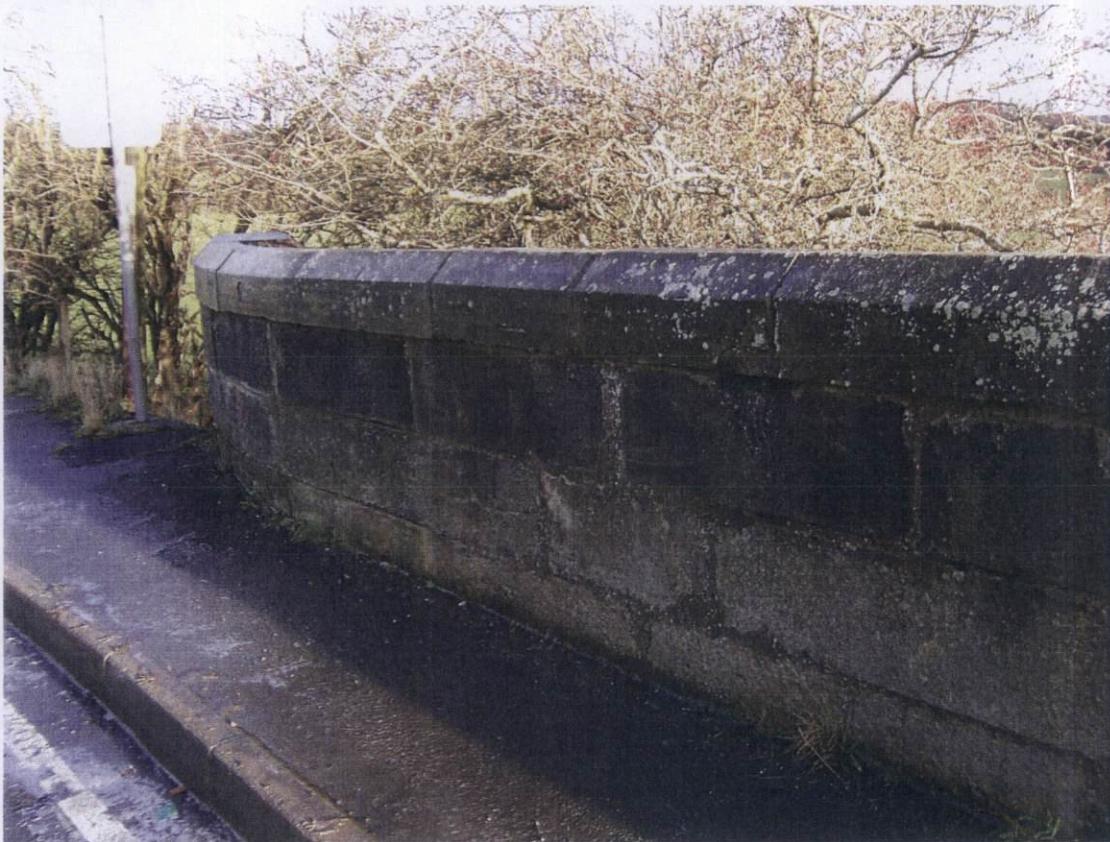
The footway surfacing and kerbs were in good condition. Some minor vegetation growth was noted at the West side of the carriageway. (See Appendix B photographs 25&26)

Photograph 25: East parapet. North end

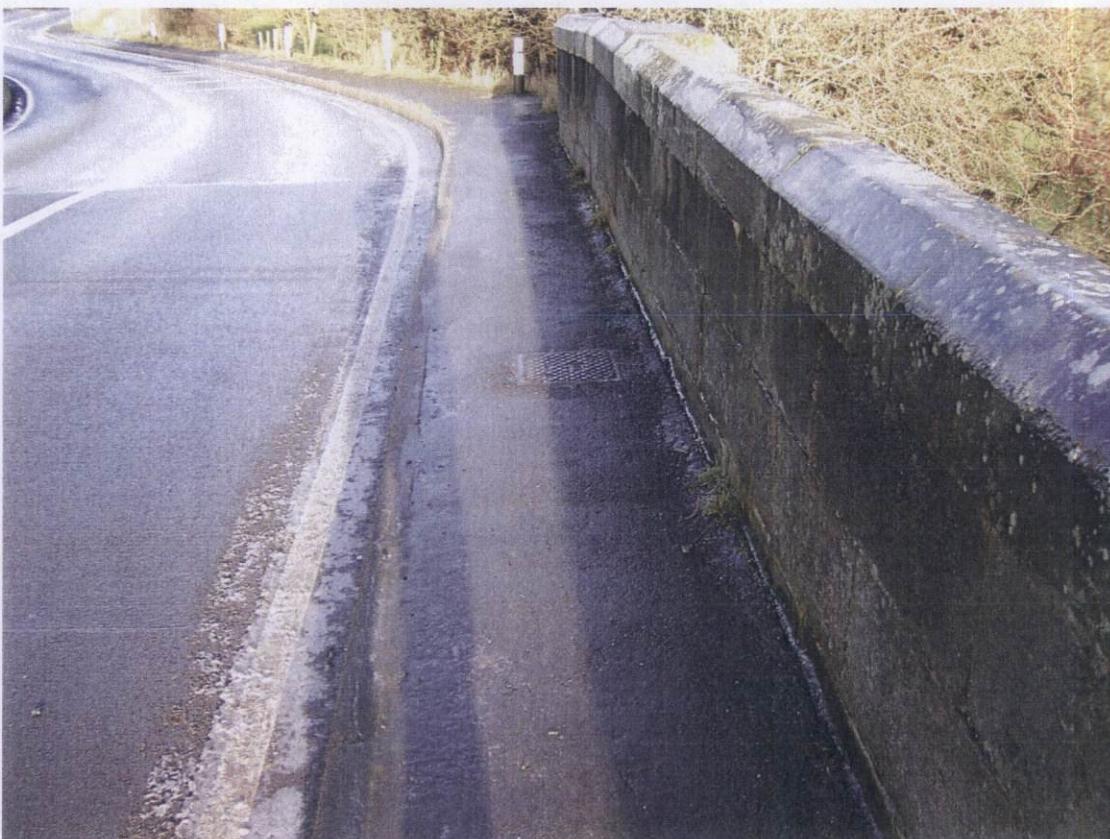
Photograph 26: North east spandrel wall

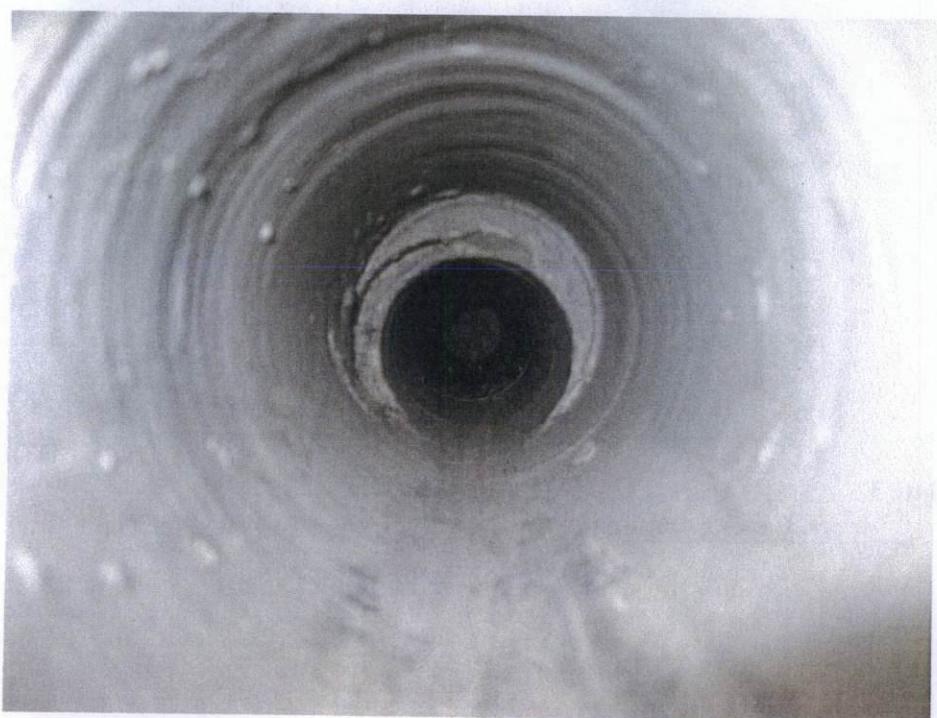
Plate 5.

Bridge Ref 01
View of South Springing Corehole

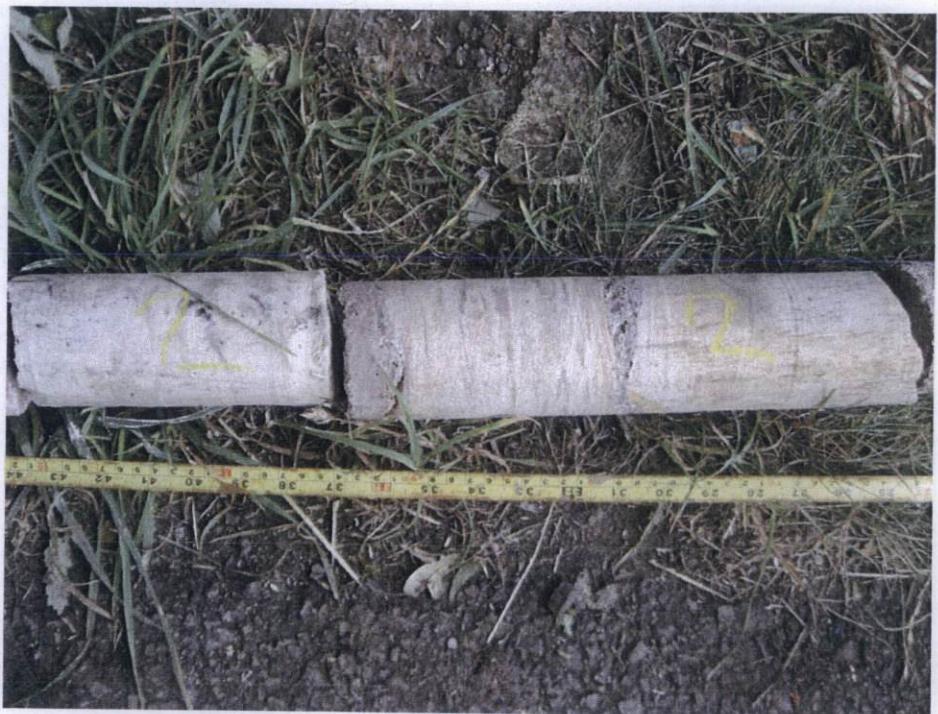
Plate 9.

Close Up View of South Springing Core, Centre Section

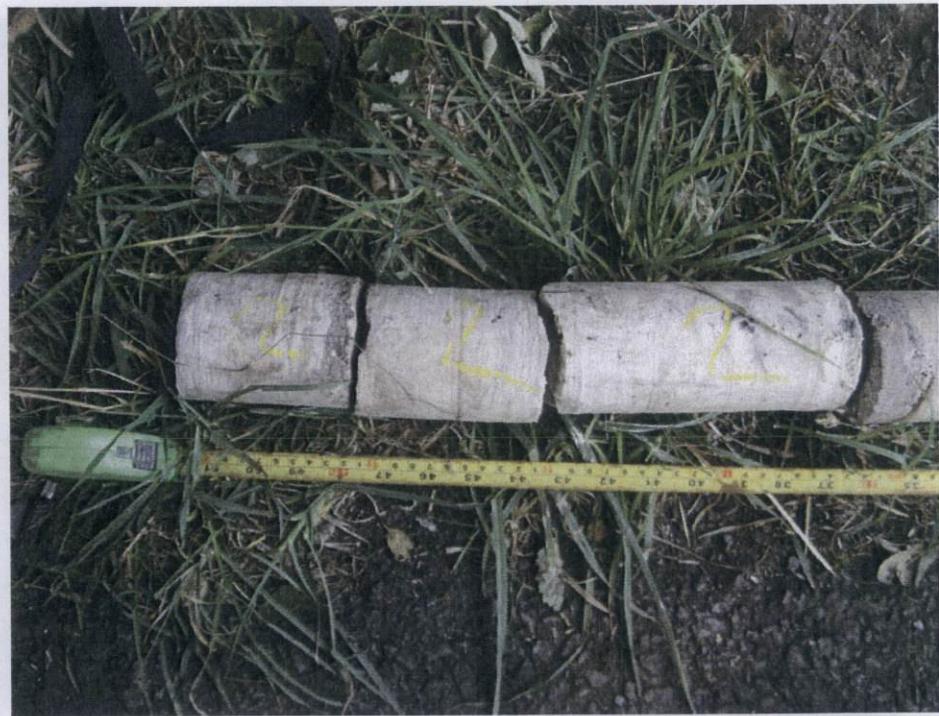
Plate 10.

Close Up View of South Springing Core, Centre Section

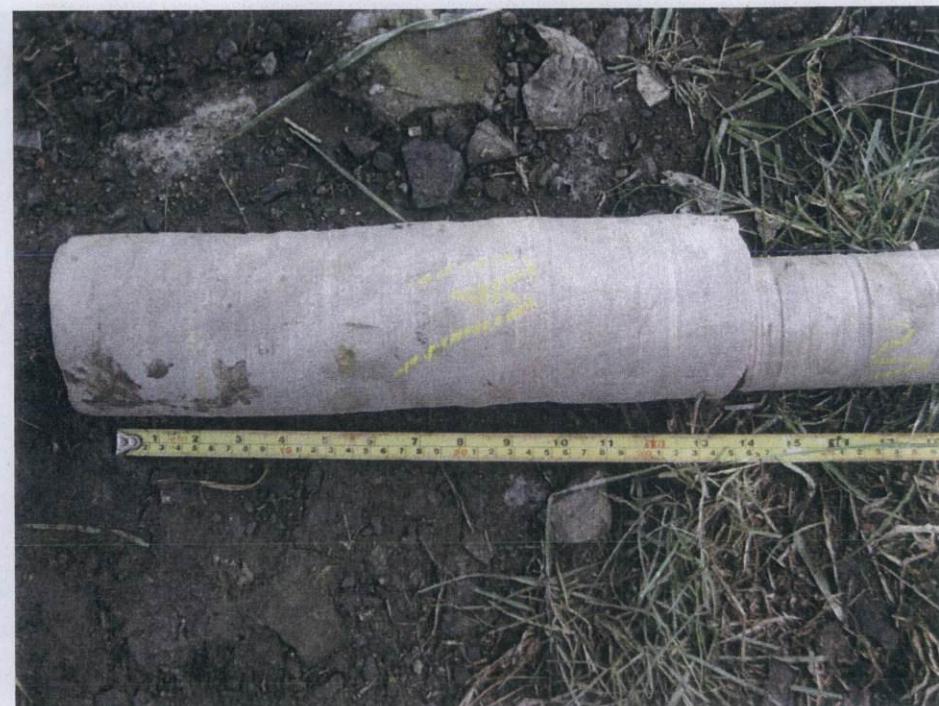
Plate 11.

Close Up View of South Springing Core, Inner Section

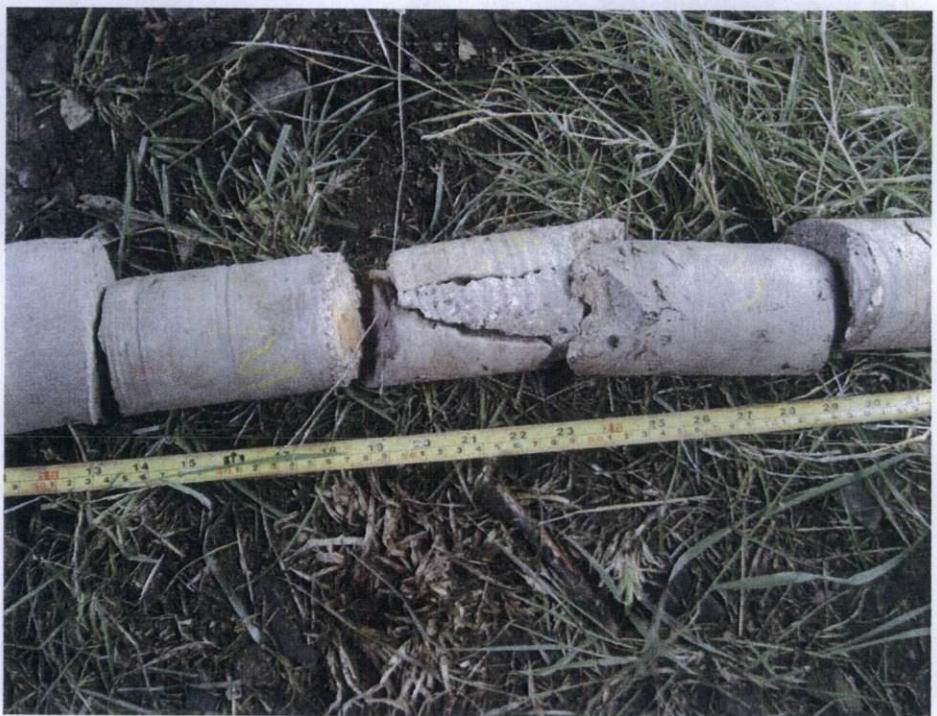
Plate 12.

Close Up View of South Quarter Point Core, Outer Section

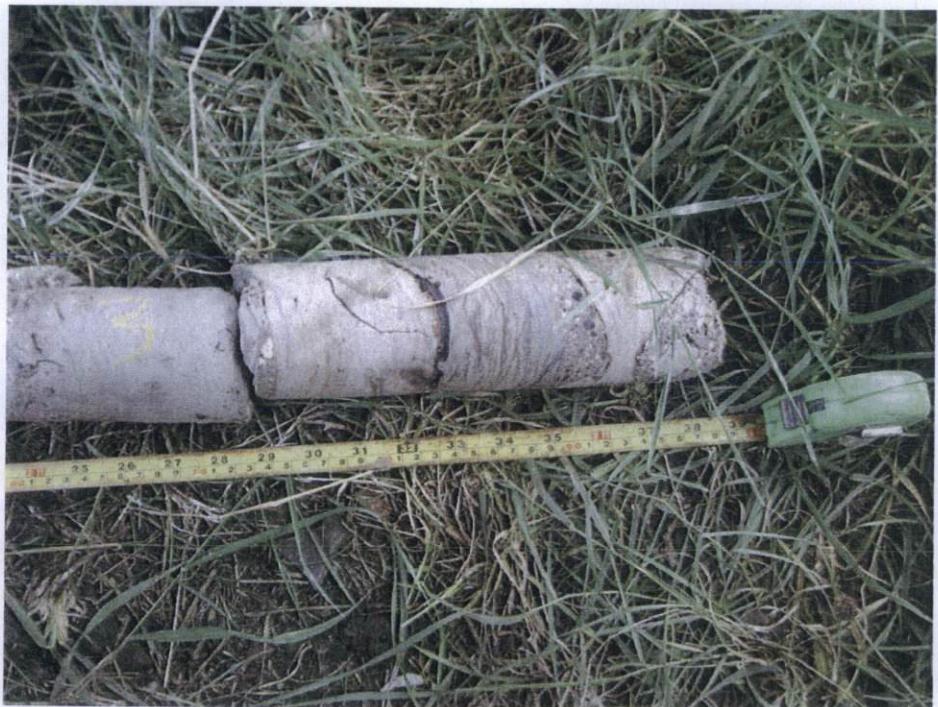
Plate 13.

Close Up View of South Quarter Point Core, Centre Section

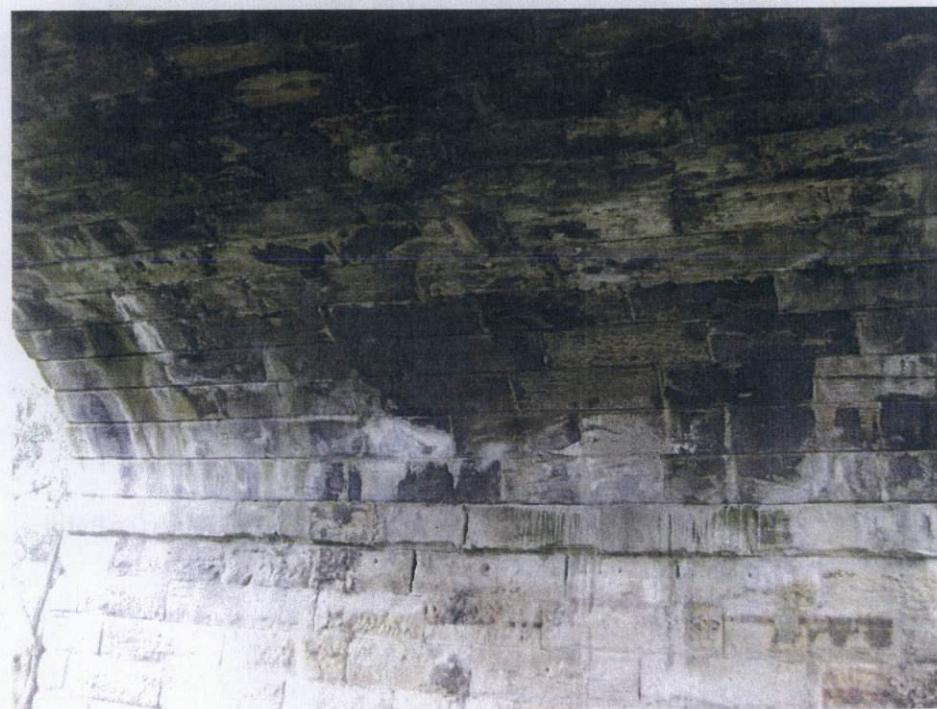
Plate 15.

Bridge Ref 97
General View of the North Springing

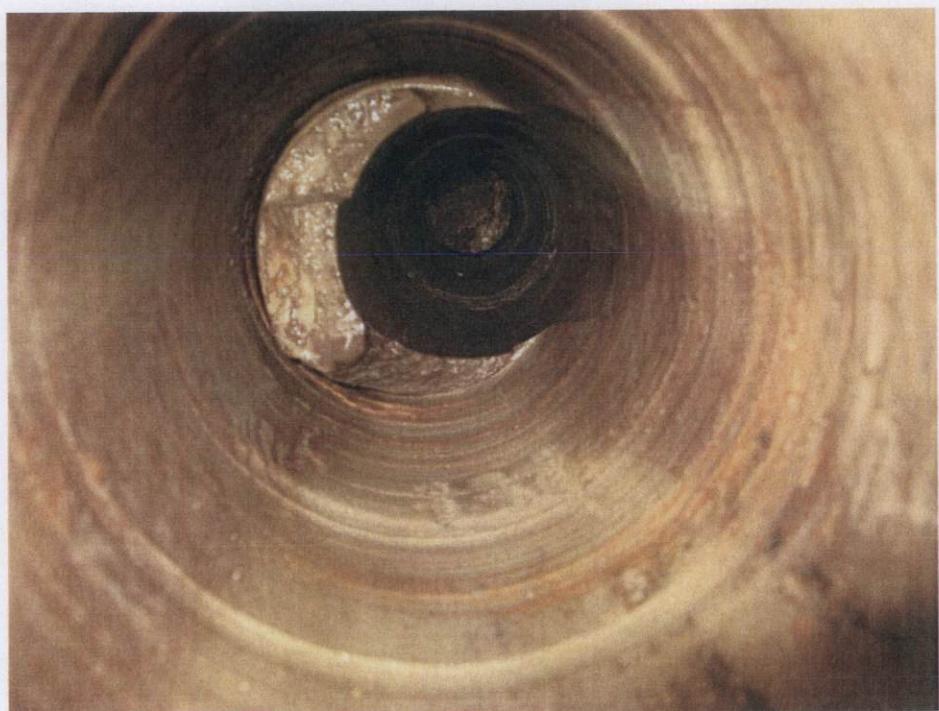
Plate 18.

Bridge Ref 97
View of North Springing Corehole

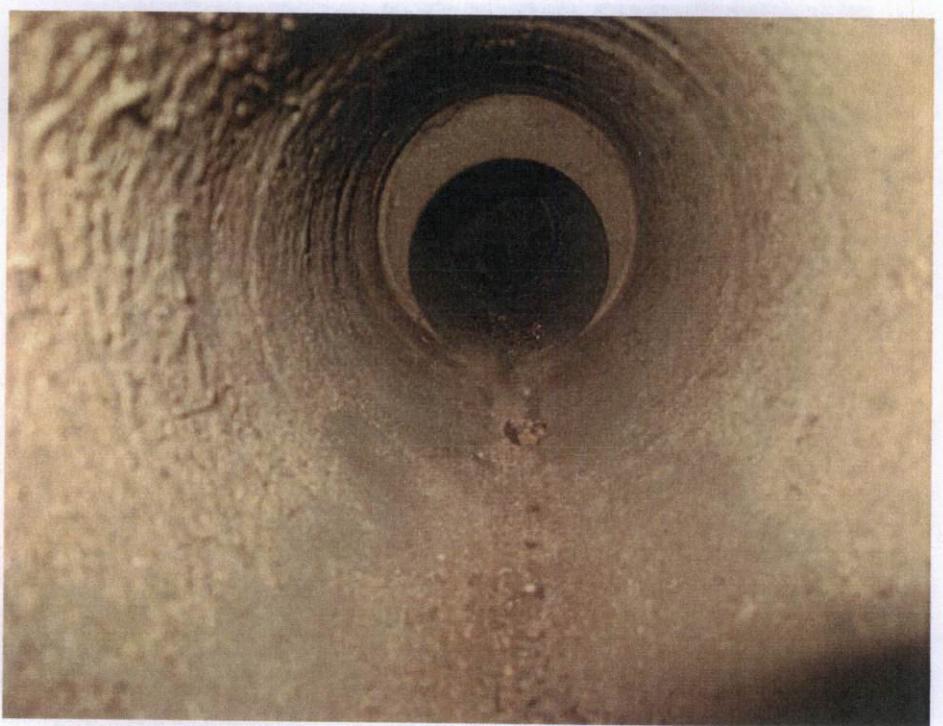
Plate 19.

Bridge Ref 97
View of North Quarter Point Corehole
